Opel Frontera B (6B) Engine: 2.2 i With Kelsey + Hayes ABS

ABS control lamp illuminates

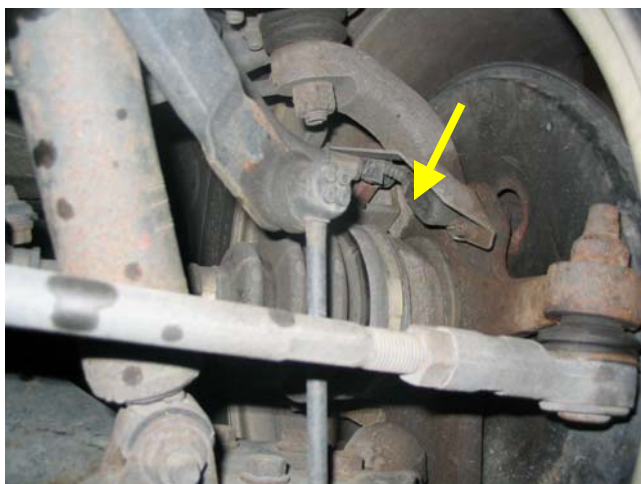
If the ABS control lamp illuminates on these vehicles, the cause could be a defective wheel-speed sensor (See Fig. 1 for an example). As a readout of the fault memory of the Kelsey+Hayes ABS can be taken with only a few test units, an alternative is to test the sensors with the aid of a multimeter. The fuses should be checked beforehand, and the sensors and their electrical plug-connections checked with regard to secure fit and corrosion. The wiring should be checked to make sure that it is not damaged. Furthermore, make sure that the wheel-bearing play is not too great and that the pulse wheel is not damaged/contaminated. The air gap of the sensors is not adjustable. After removal of the electrical plug-connections, the resistance of the sensors can be measured with the multimeter. The ignition must be switched off beforehand.

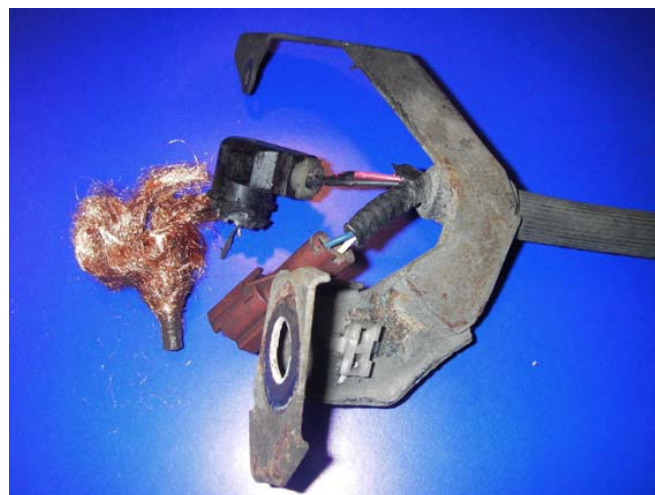
Fig. 2

If the values are not reached, a sensor defect can be assumed. The holder of the sensor is often so corroded that the sensor can be removed only with considerable mechanical assistance, in the course of which the sensor is totally destroyed (Fig. 2). Before fitting the new part, the sensor holder must be cleared completely of rust and dirt.

Under no circumstances should the new sensor be pressed into the holder using force. After replacing the sensor and carrying out a detailed functional test, the fault memory should be deleted.
