Mercedes Benz C-Class (W203) From 23.09.2002

Headlamp cleaning system switches off automatically when switch has been activated

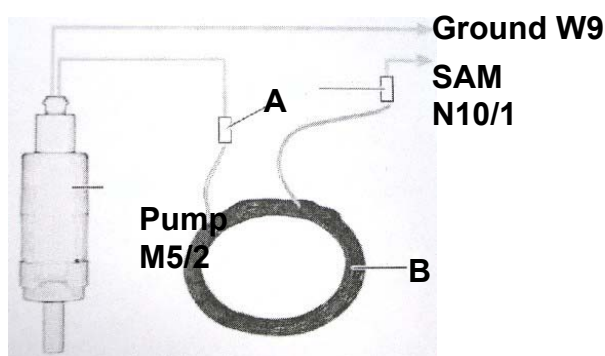
Fig.1

If the above-mentioned complaint is made, this could be caused by poor system communication between SRA and the front SAM (control unit). This poor communication between the SAM (N10/1), the electrical lead and the SRA pump (M5/2) results in a great difference in the voltage characteristic of the SRA pump high peak, low peak being interpreted by the SAM as a fault. This has the effect of switching off the SRA pump.

- Wind a 2.5 mm² wire about 4-5 m long around your hand and then fix it in the form of a circle using insulation tape (Fig.1)
- This wire is used as a resistor and inserted between the SRA pump and the SAM at the front in series using solder connectors (A) (Fig.1)
- Then fix the resistor (B) near the washing water tank (Fig.2)
