## **Mercedes Benz E-Class (W 210, W 211) All vehicles with halogen bulbs**

### **Low beam does not work**

# Bulletin

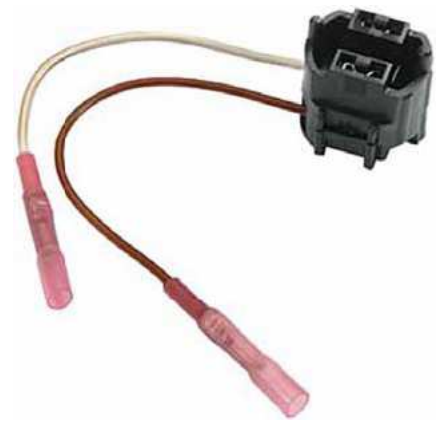
If there are complaints about the above-mentioned fault, the cause could be a defective plug-connection. Due to high temperatures on the headlight plug, caused by the low beam being switched on permanently (e.g. taxi use) and lack of air cooling due to forward motion, it may be that the contact pressure of the cable lugs decreases. Through increased contact resistances between the pole shoes and the bulb contacts, the plug becomes hot and melts together. In this case, proceed as follows:

- Disconnect the earth strap on the battery.
- Remove the cover from the rear headlight housing.
- Remove the bulb with plug from the headlight.
- Cut off the cables approximately 80 mm behind the plug and strip the insulation from the cable ends of the vehicle harness.
- Crimp a repair plug (Hella part no.: 8KB 863 949-011, see illustration) to the vehicle harness and then shrink the insulating splices using a hot-air hair dryer.
- Insert a new H7 bulb in the reflector and connect to the plug.
- Refit all removed parts in reverse order.
- Check that the headlight works.
- Delete possible faults from the fault memory.
- Check the headlight adjustment.
