Renault Clio 2

All vehicles with fog lights

Water in the fog lights

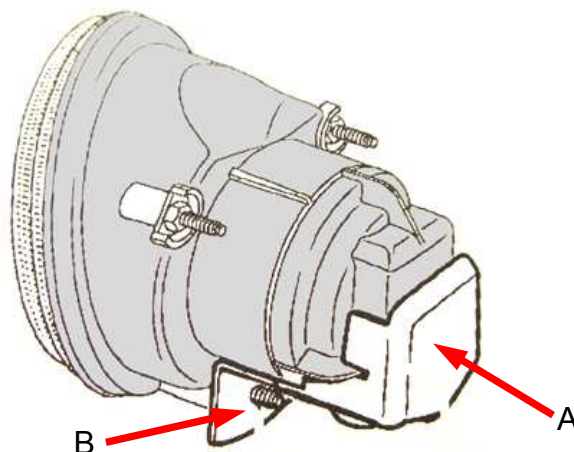
If there are complaints about the above-mentioned fault, the cause could be the cable seal of the fog lights. In this event, a conversion set consisting of a modified cable loom + two protection caps is available from the manufacturer.

- Raise the vehicle.
- Remove the front apron.
- Dismantle the rear panelling of the fog light, drain the water and, using a hair dryer for example, remove fogging present in the light.
- Replace the old cable loom with the new one.
- Mount the protection covers (see illustration, Item A) with the aid of a fastening screw (see illustration, Item B) on the underside of the fog lights.
- Refit removed parts in reverse order.
- After this, readjust the fog lights.
