Fogging of combination rear lamps

Cover lenses of combination rear lamps fogged

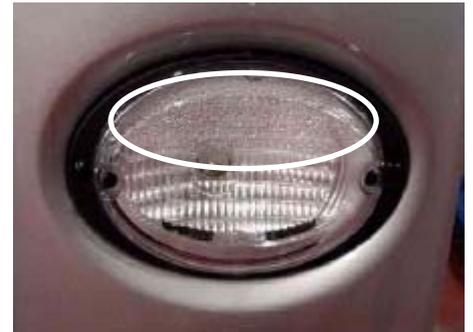
Fig. 1

In the event of a fogged cover lens, the light exit field should dry out within a certain period when the bulb is switched on. This duration of this process can however vary due to ambient temperature and relative humidity. According to physical laws, this process is normal, and, from a technical point of view, harmless, as the reflector is protected against the influences of fogging. When the bulb is switched on, the air inside the lamp warms up. Thanks to the combination rear lamp ventilation, the expanding, warmed up and dry air is driven out of the combination rear lamp housing. After the bulb is switched off, the air in the combination rear lamp slowly cools down again.

Air which is saturated with moisture is thereby “sucked“ from the outside into the interior of the lamp. Due to this fact, condensation on the inside of the cover lens may occur in the event of high humidity levels and higher temperature differences inside the lamp. In particular, this situation arises more often at cold times of the year and during damp weather. If, however, the fogging is so severe that water drops form on the cover lens (see Fig.1), or a build-up of water can even be seen in the lower area of the lamp (see Fig.2), the seal should be checked for damage and, if necessary, replaced. A check for the possible “clogging“ of the ventilation opening(s) of the lamp should also be made. The lamp can be dried by blowing it out using oil-free compressed air. If however, following this, water still collects in the lamp, then the lamp must be replaced.
