***Headlamp Comparison!***

***Test report for Motorists.***

***Hella original parts compared  
with other headlamps.***

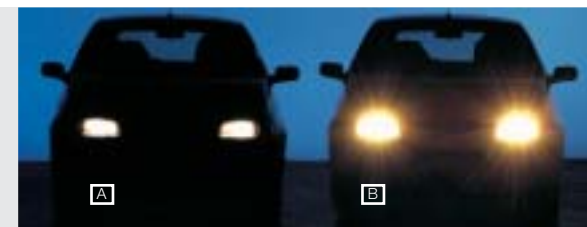
- Dipped beam: Non-homogeneous road illumination.
- Glare far too high at 2.73 Lux (lx) (a maximum value of 1 lx is allowed in series production – 0.7 lx in the type approval test).
- The headlamps can hardly be adjusted.
- Dipped beam left and right: The range is drastically reduced since the beam is too low / the maximum in the area in front of the vehicle gives drivers the impression they are "driving on rails". Legal requirements are not met.
- Main beam left: The maximum is too low and oriented to the right.
- Main beam right: The maximum is oriented to the right.

A shows the correct beam pattern of the Hella halogen dipped beam. B is a product of inferior quality which clearly causes excessive glare. In addition, the beam pattern is very speckled. The test subject has a significantly reduced visible range near the left-hand side of the road.

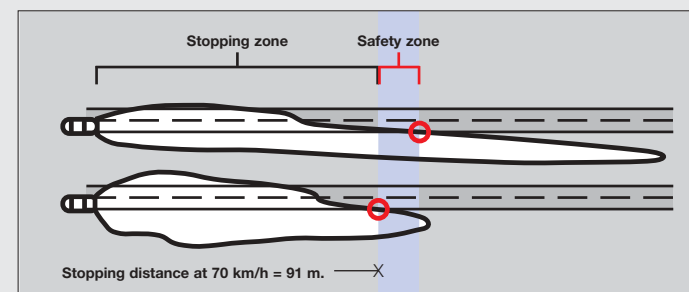
- Dipped beam: Non-homogeneous illumination of the road
- Main beam: Directed to the left to extremely varying degrees/leading to two light fingers on the road/non-homogeneous illumination of the road/reduced visible range.

A bird's eye view of the halogen beam pattern. The non-homogeneous road illumination can be seen clearly.

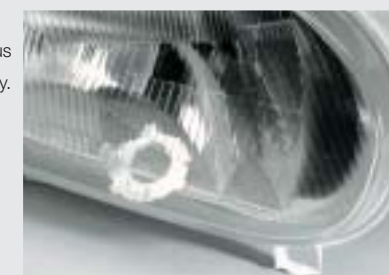
- The bulb shield had already fallen off following the horizontal test.

The broken off bulb shield can be clearly seen inside the headlamp housing.

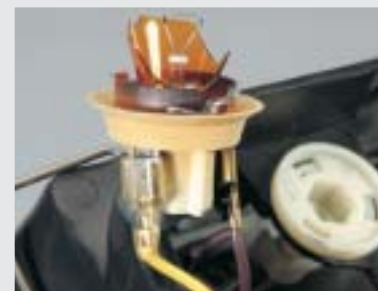
- The BL lens reveals serious deformation following the test.
- The metallization on the cover frame is damaged above the BL function.
- The front area of the BL bulb holder has turned dark brown.
- The cover frame reveals minor deformation above the FL function.
- In addition, a visible film is formed on the inside of the cover lens when the headlamp is switched on.
- Since the headlamp revealed serious damage after the first part of the test, no further heat tests were carried out with this test subject.

The headlamp with dismantled, and defective, direction indicator.

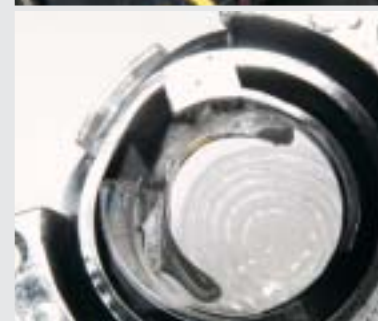
- Deformation of the indicator lens changed the beam pattern. The indicator could no longer be recognised.
- Discolouration of the indicator bulb holder is an indication of excessive material strain. At some stage the bulb will no longer be able to be replaced.

The deformation of the test subject's indicator lens can be seen quite clearly. The bulb has been destroyed by material contact.

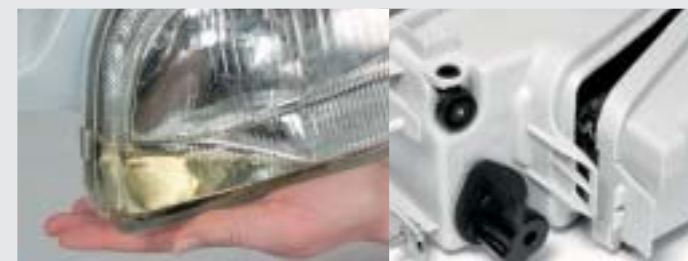
- The housing locking cap cannot be locked tightly enough in place to enable it to stay in place on the housing for more than 5 minutes.
- Since this means the housing was not sealed during the heat test, these tests can only be evaluated with reservations.

The wrong housing cap design on the test subject leads to it not being able to be locked in place tightly. This allows water to penetrate the headlamp housing.

The housing material of the test subject does not comply with the specification. It is not rigid enough.

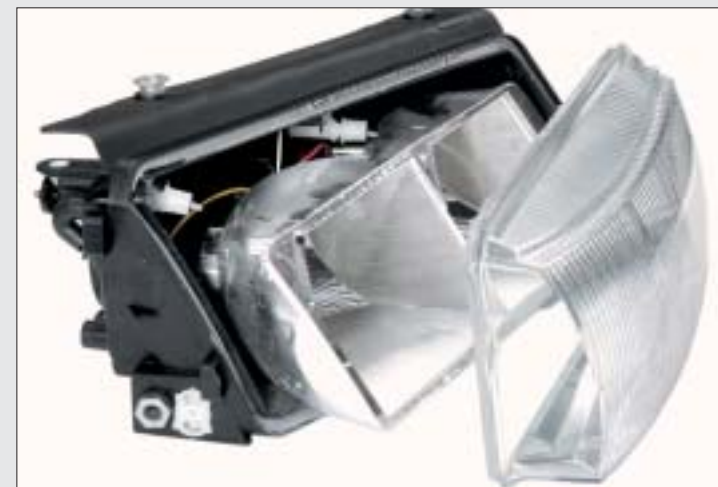
- Following the test in the vertical direction, all three screws for attaching the adjustment elements and the adapter for the HL actuator had been torn out of the reflector.
- The test in the horizontal direction could then no longer be carried out.

- The reflector has lost all the guidance it had had in the housing. It can knock around in all directions during driving.
- This leads to extreme glare and loss of visible range.

The broken reflector brackets of the test subject can be clearly recognised.

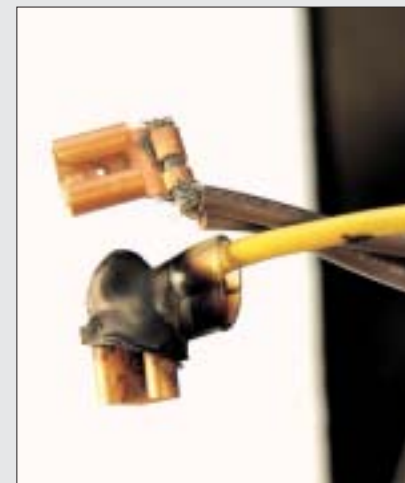
- Following the test, the bulb shield coating had flaked off over a large area at the top.
- Pronounced film formation can be seen on the FL reflector above the PO function.
- There is extensive film formation in the whole BL area on the reflector, which can even be seen with the lights switched off.
- Plug burnt on H7-bulb, lack of insulation can lead to short circuit. Fire hazard!

- The cable insulation is charred. This leads to a short circuit and loss of the light function.

Insufficient material properties on the test subject lead to excess load on the plug. The upper plug contact is not sufficiently crimped. This causes contact resistance and a reduction in light output.
