Audi TT - Returning side direction indicator to good working order | HELLA

Audi TT

Model year: 2002

Returning side direction indicator to good working order

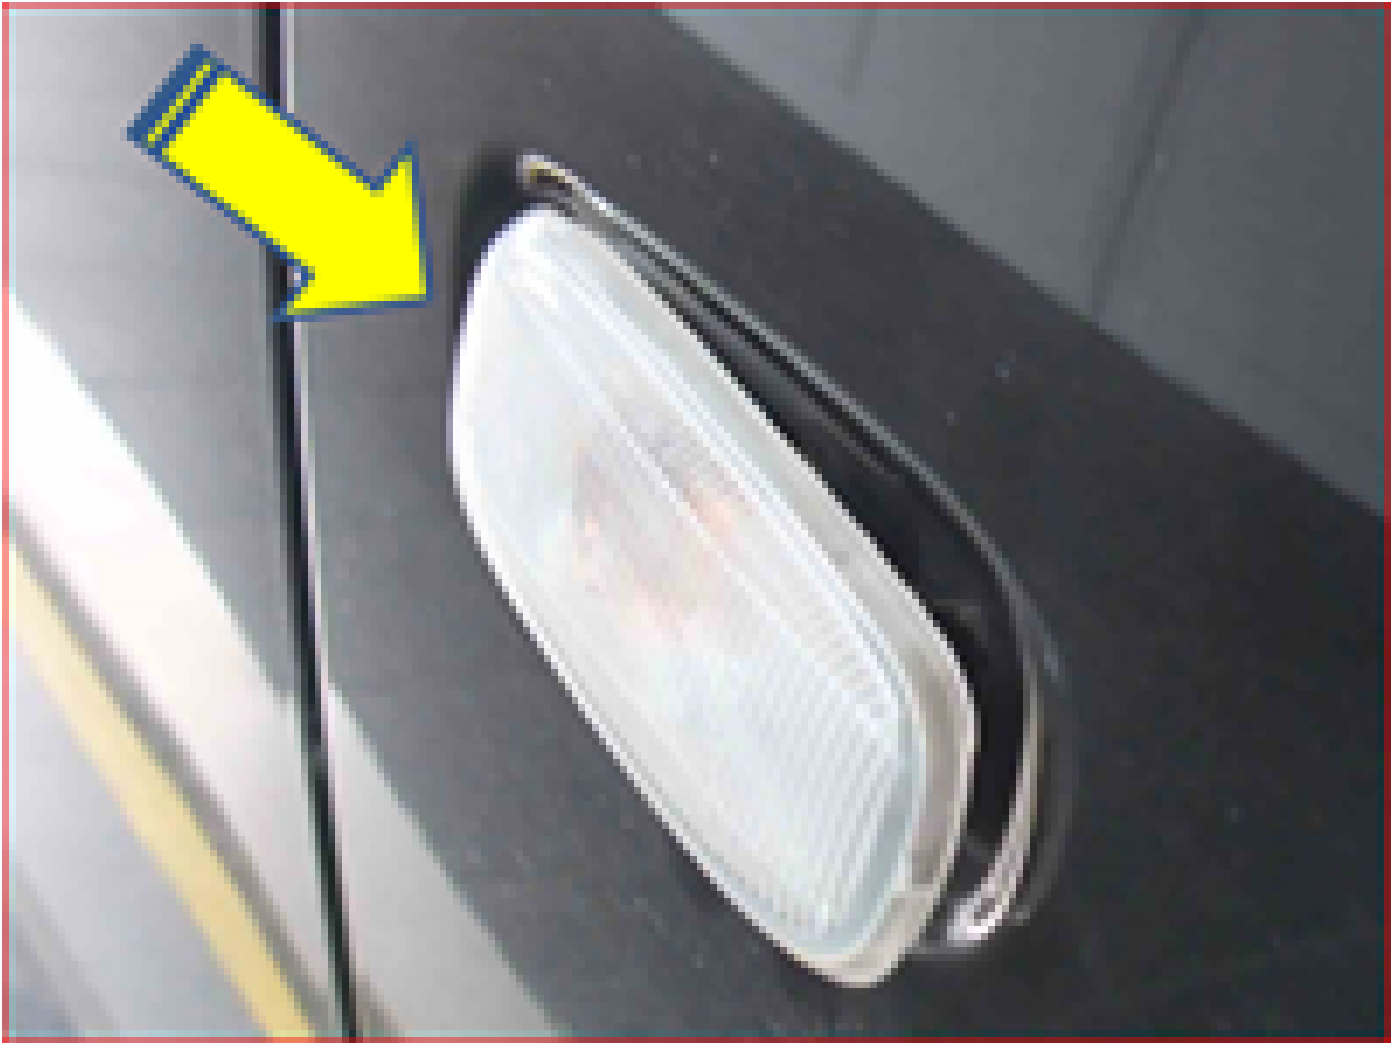
Fig.1

If the above-mentioned vehicle is found to have a defect in the additional side direction indicator (Fig.1) or in the bulb holder, this must be repaired as follows.
