Design of a brake hose

SERVICE INFORMATION FOR HAND-BRAKE CABLE

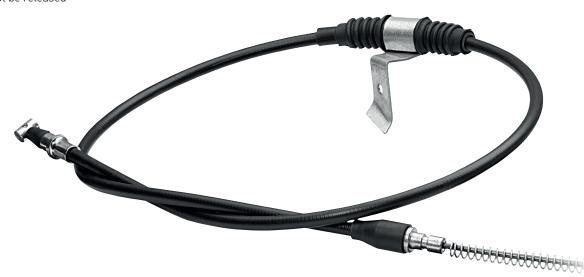
There are two main types of steel cable installed in hand-brake cable systems (see figure).

Top: Steel cable comprising several cable strands Bottom: Steel cable comprising braided wires

Only tested, high-quality materials are used to manufacture HELLA hand-brake cables. The steel cable used - with its special properties with respect to robustness and flexibility - is also always chosen in direct relation to the vehicle and braking system fitted.
