| BRAKE DISCS

BRAKE DISCS IN OEM QUALITY

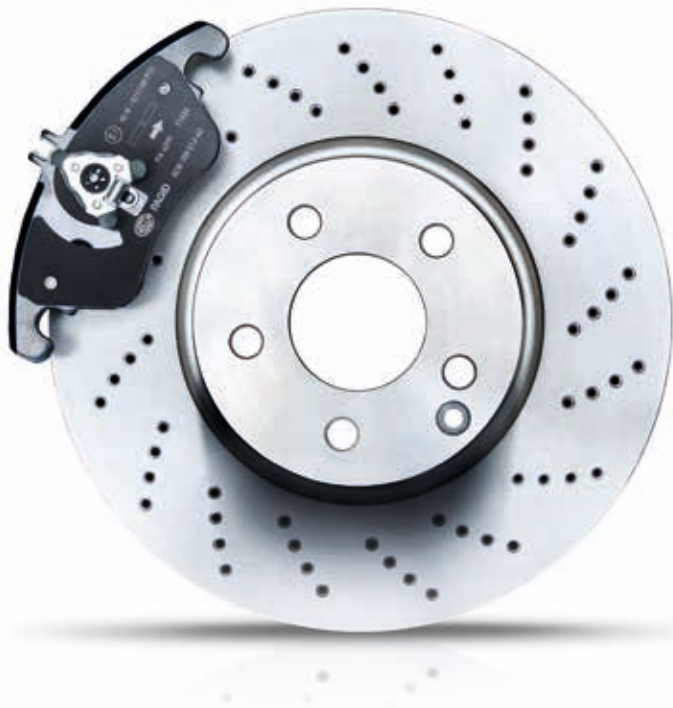
Our more than 750 HELLA PAGID PRO brake discs differ from standard products thanks to a special material composition and coating that ensures 100 % corrosion protection. An extra step that pays off for everyone. For car drivers, PRO brake discs also offer enhanced performance in addition to the attractive appearance. When installing, you save labor, time and money as the coating already applied eliminates the need for protective oil and the considerable amount of time it takes to remove it.
