# Opel Astra J - Airbag indicator lamp lights up | HELLA

**Astra J**

**Model year: 2010 - 2012**

## **Airbag indicator lamp lights up**

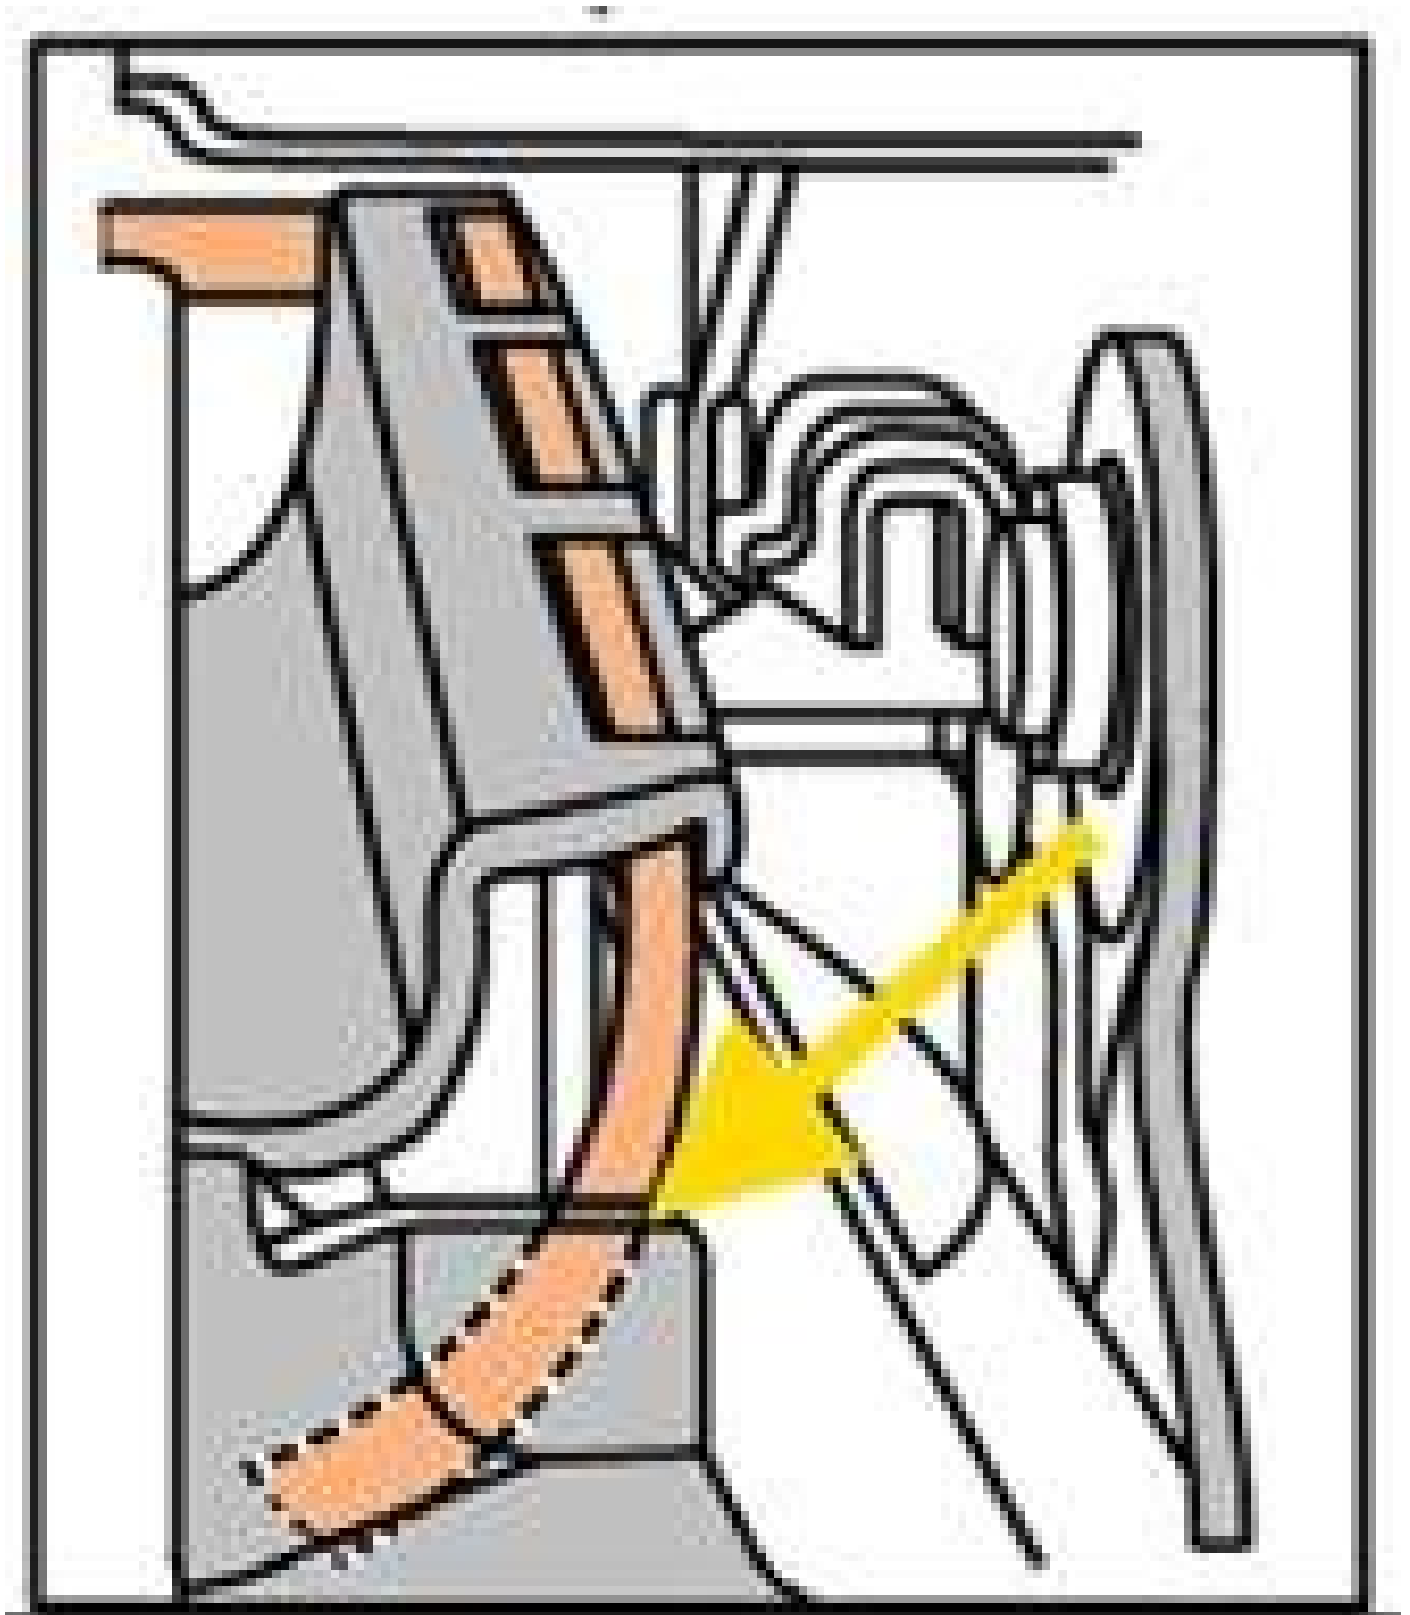
Figure 1

A possible cause could be a damaged cable strand in the airbag system (in the area of the rail system of the front seat adjustment).

If a cable strand is laid incorrectly (marked in figure 1), it may be damaged.

Check the cable strand for damage. In doing so, check in particular for signs of abrasion.

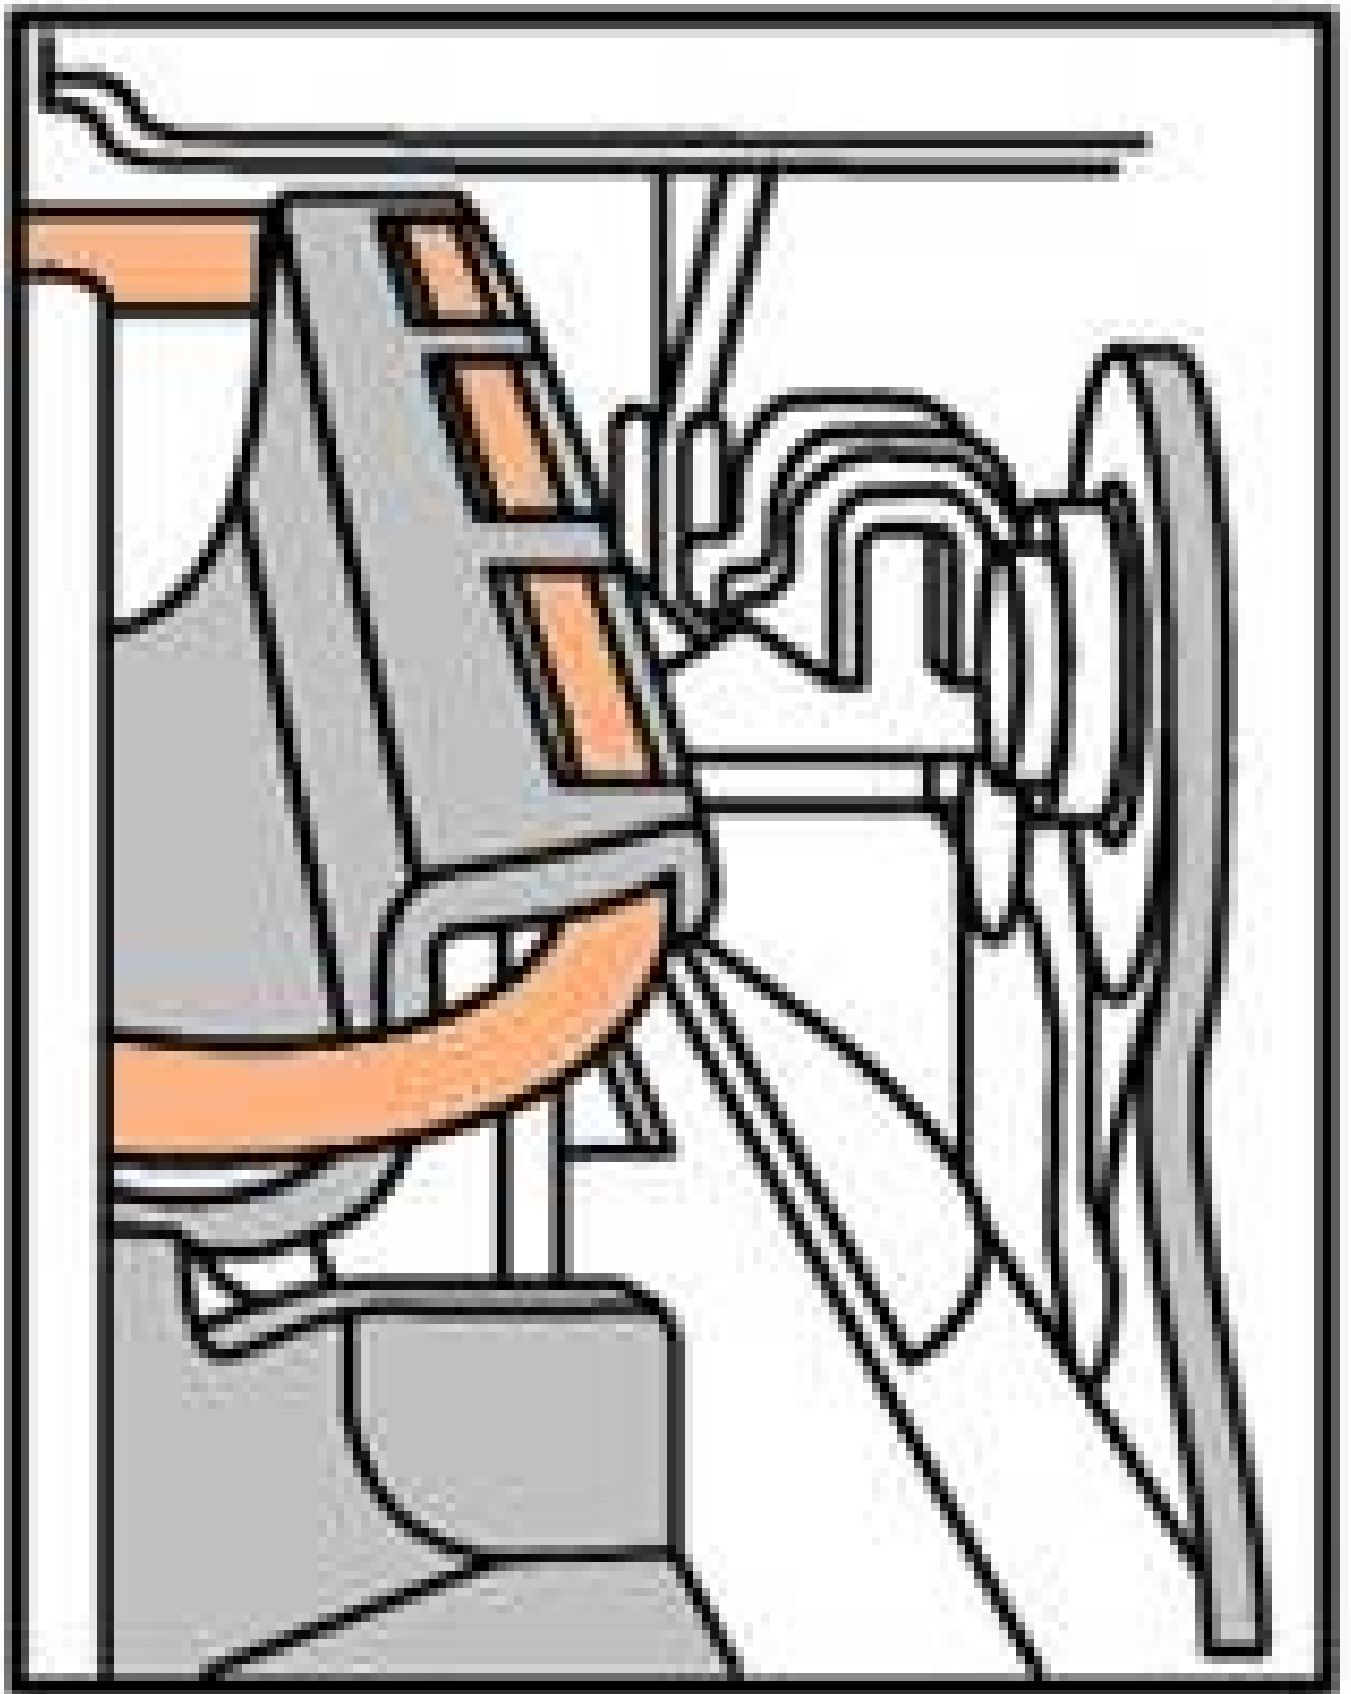
Figure 2

(make sure the cable strand is correctly installed)

- Replacing the belt tensioner unit
- Re-installation and fastening of the cable strand

- Replacing the seat rail cover

- Finally, read out and erase the error memory
