# **BMW i3 (I01) - Noises in the area of the doors | HELLA**

**i3 (I01)**

**Model year: 2013**

## **Noises in the area of the doors**

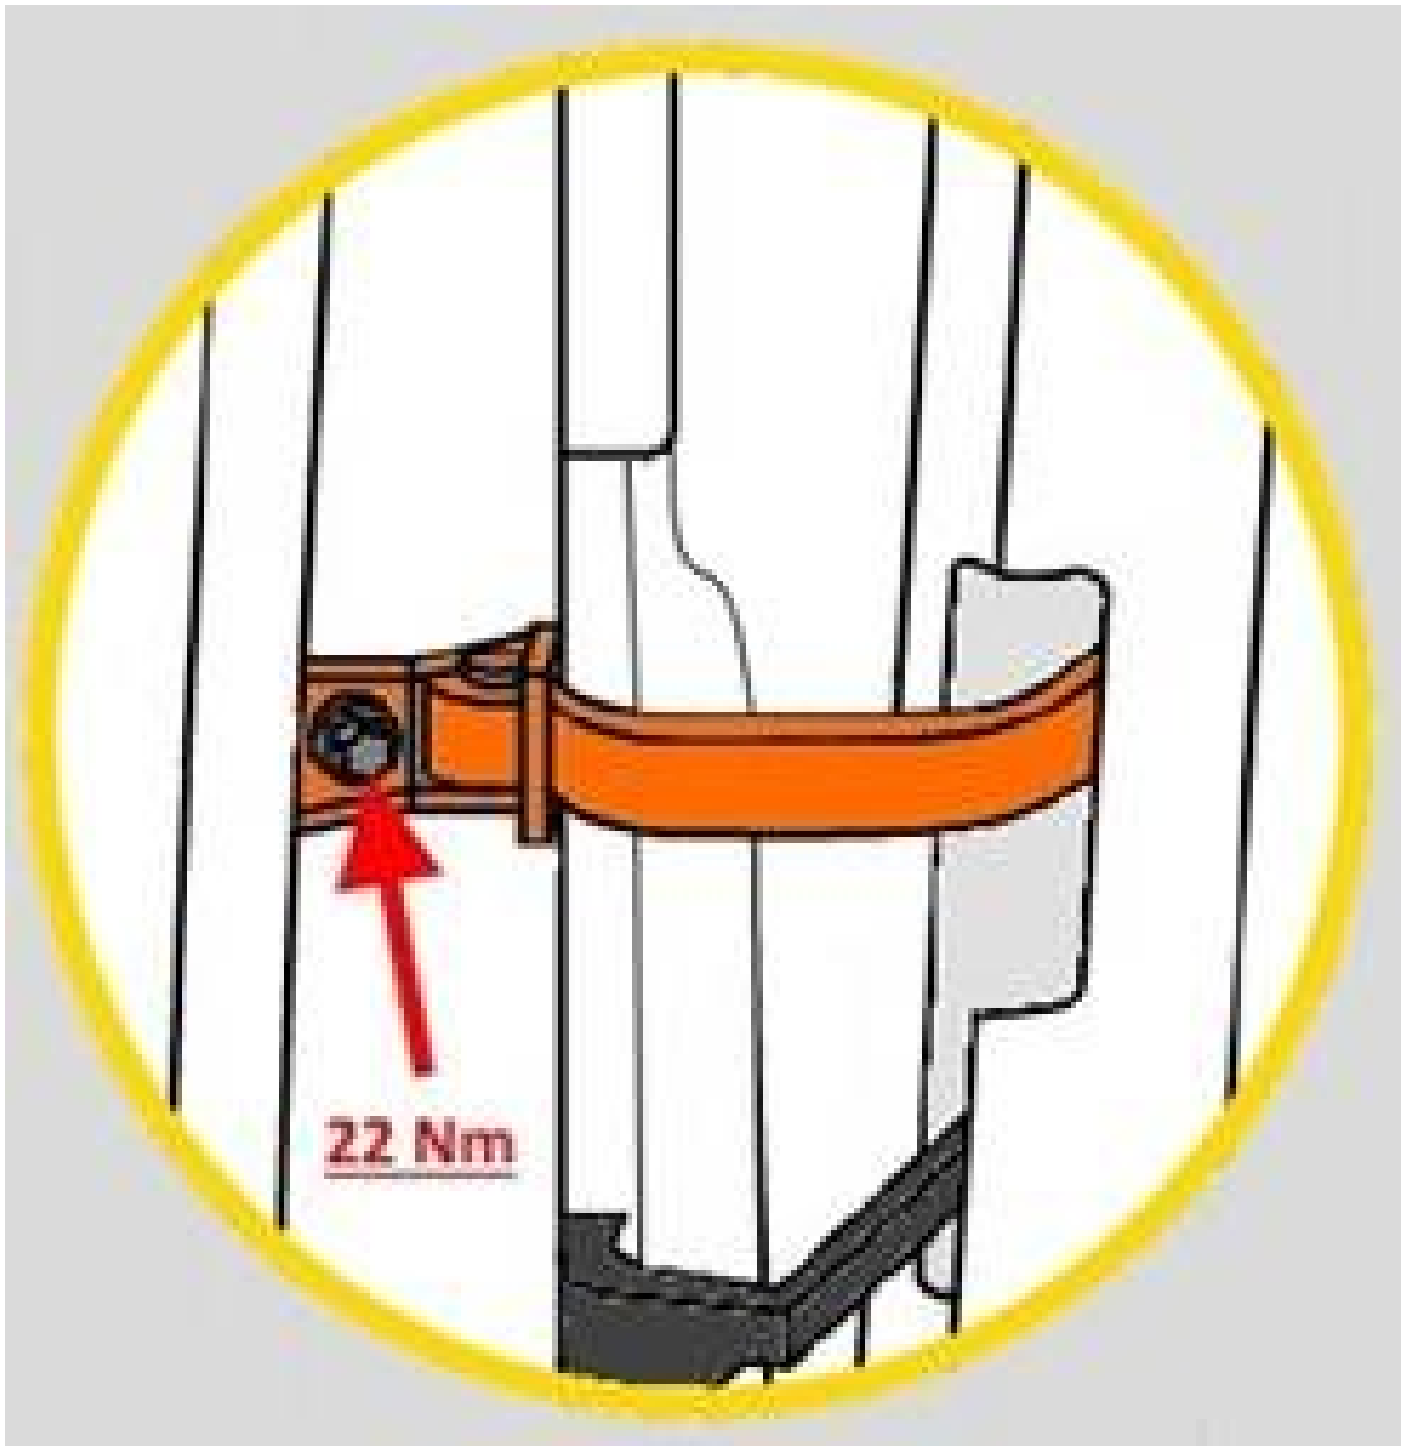
A closer look at the door mechanism revealed that the fastening screw of the door check strap had come loose.

-Fixing screw (ASA M8x22) OE No. 07147248803

- Disassemble the fixing screw
- Check the mounting hole and the screw for damage (thread, etc.) and repair or replace if necessary
- Tighten the fixing screw to torque as specified by the vehicle manufacturer (22Nm) (see picture)
- Repeat this procedure for all doors
