# VW Beetle - non-functioning parking aid

## Data sheet

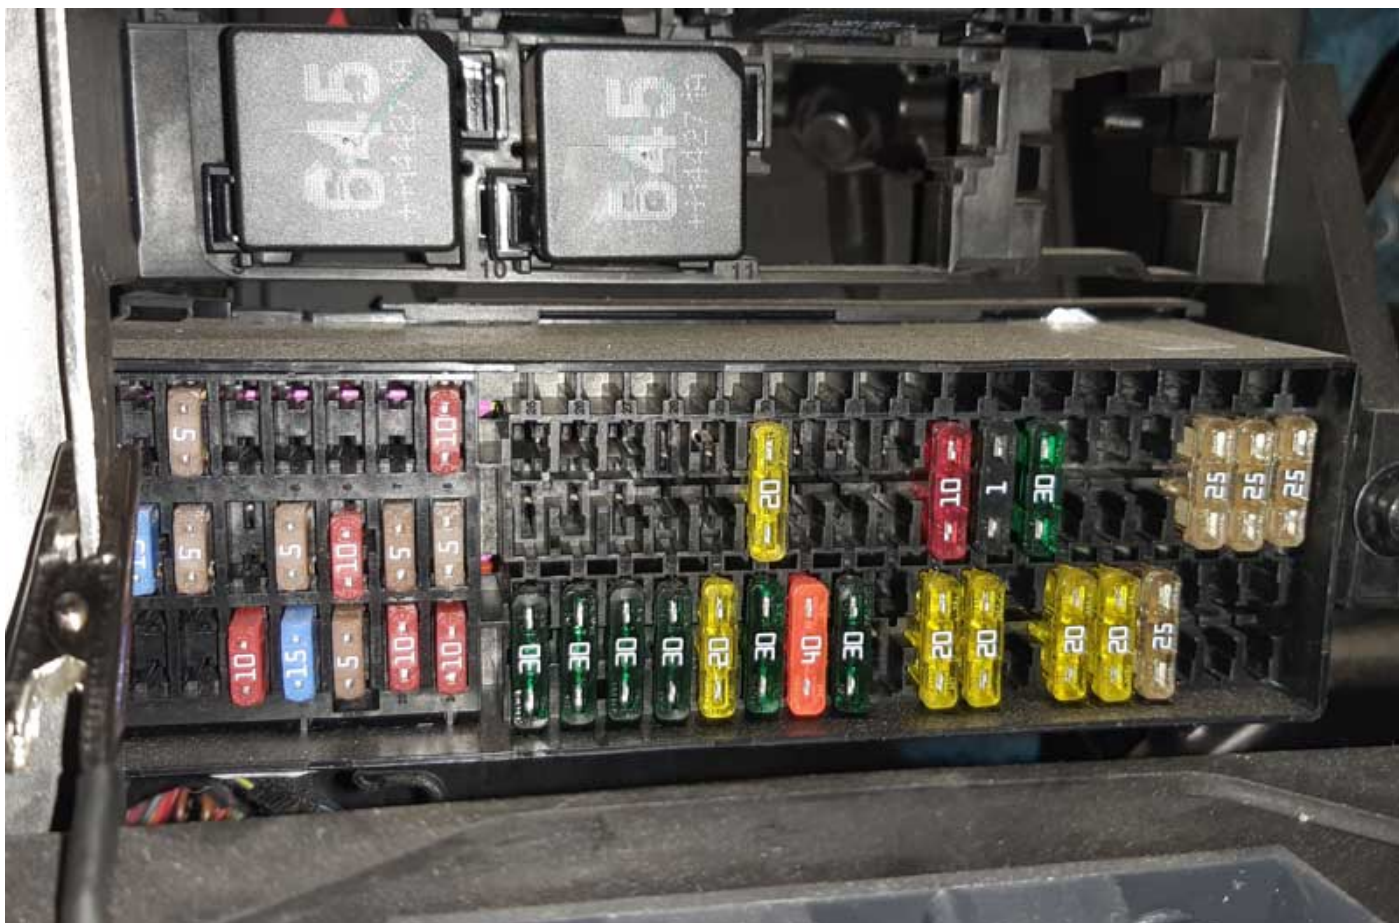
In this case, the cause is not necessarily to be found with the software or with the electronic components. The first thing to do is to check the fuses in the fuse box located in the driver's footwell ([Fig. 1](#)).

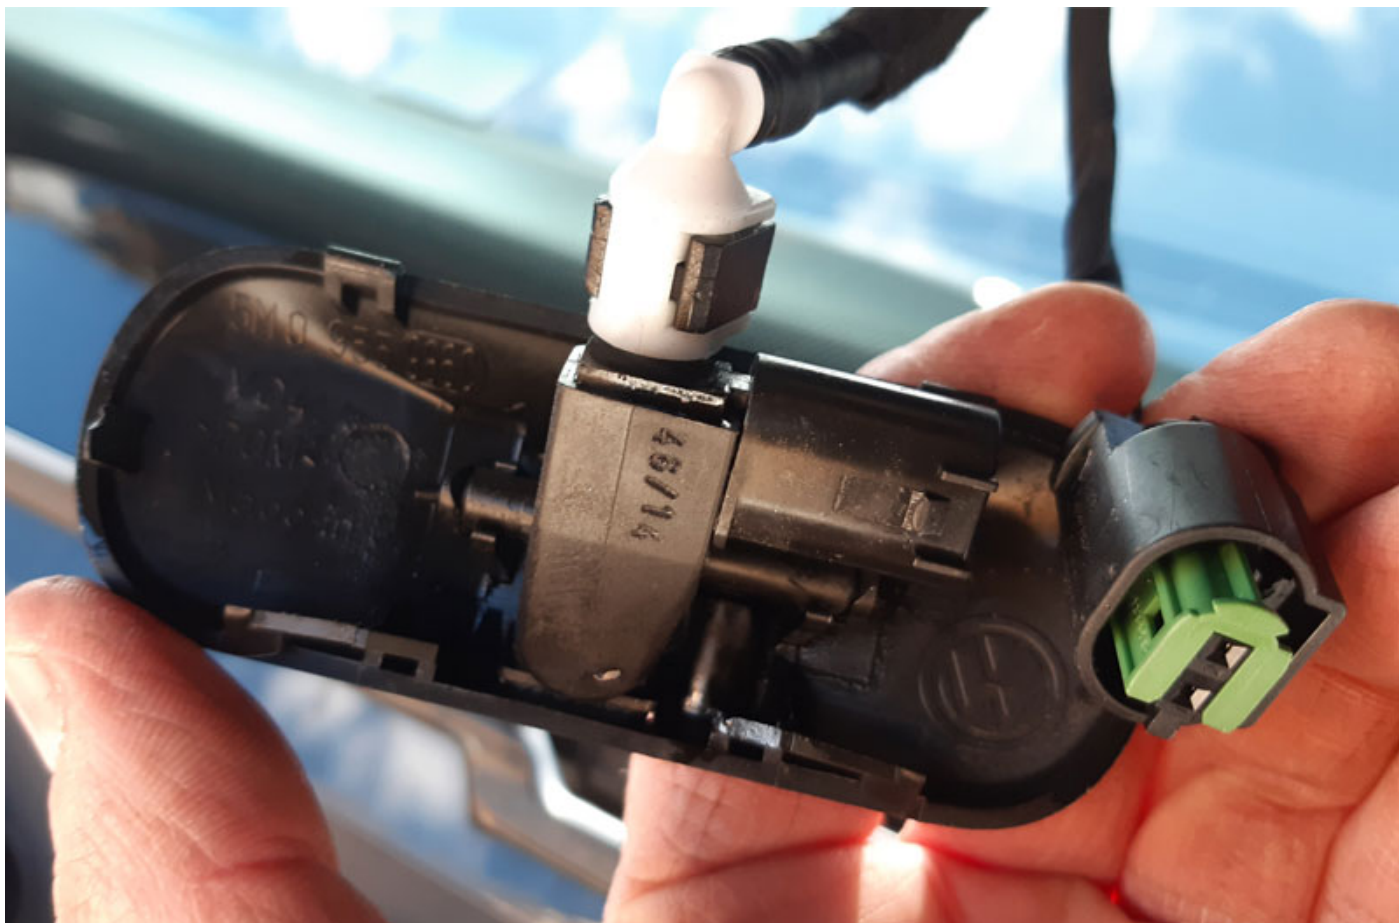
In most such cases, the fuse for the electrically heated wiper washer nozzles is defective ([Fig. 2](#)). The cause of this is a short circuit in the heating element of the wiper washer nozzle with the result that not only the fuse but also the nozzles must be replaced.

After replacing these components, functioning of both the parking aid and of the "start/stop" feature is restored.
