# Skoda Fabia II - Dysfonctionnement ; feu clignotant latéral | HELLA

**Skoda Fabia II**

Années de fabrication: 2007 - 2014

## Dysfonctionnement ; feu clignotant latéral

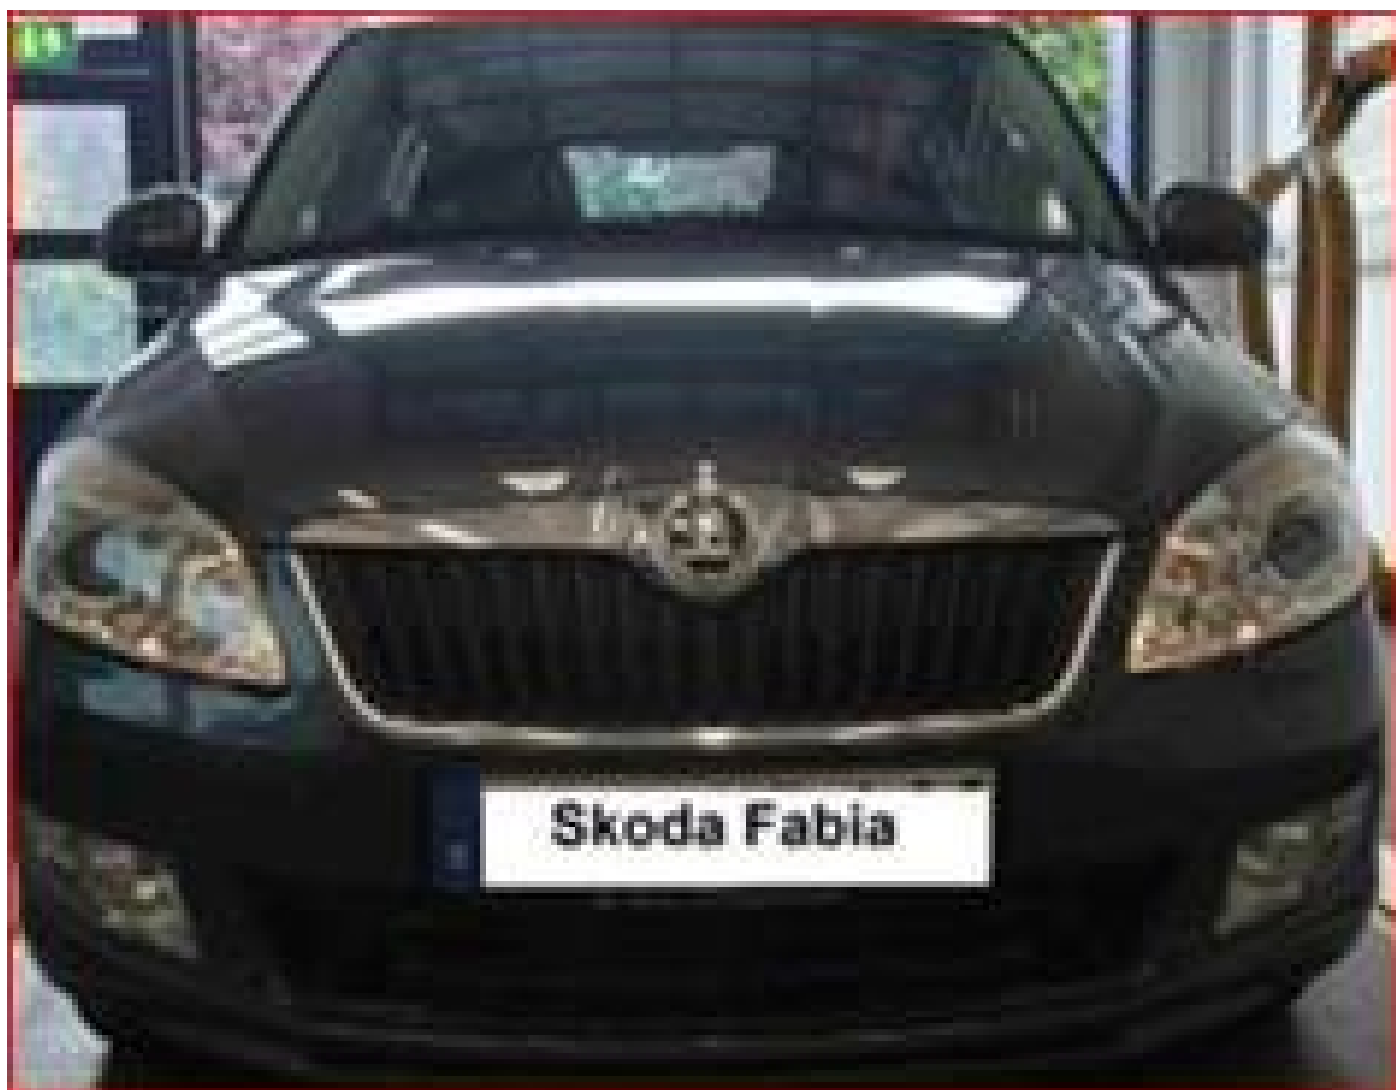
Fig. 1

En cas de détection d'une panne du feu clignotant latéral ou répéteur de clignotant (fig. 2) sur le véhicule susmentionné (fig. 1), un câble défectueux peut être en cause.
