# **Skoda Fabia II - Functional failure; side direction indicator | HELLA**

**Skoda Fabia II**

Model year: 2007 - 2014

## **Functional failure; side direction indicator**

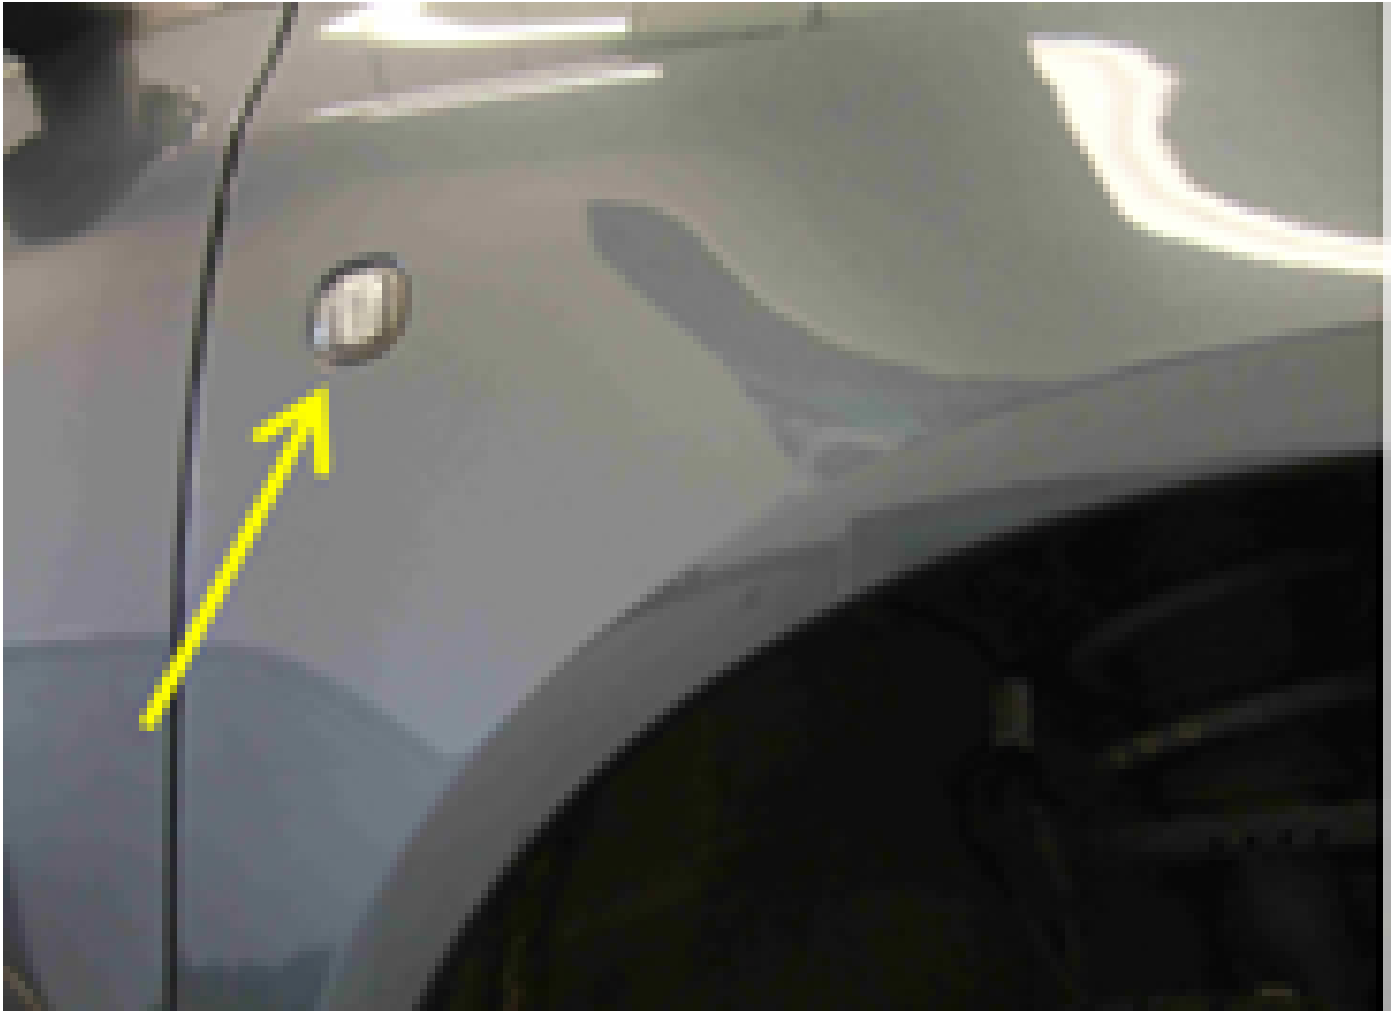
Fig. 2

If the above-mentioned vehicle (Fig.1) is found to have a malfunctioning side direction indicator (Fig.2), this may be caused by a defective connection cable.

- For fault analysis, disassemble the wheel and the wheelhouse covering. Repair and return the defective cable to full working order. Then ensure that the cables are laid correctly (edge protection).
- Check fuses and replace if necessary.
