# Electrical exhaust gas recirculation valve | HELLA

## Failure causes and troubleshooting

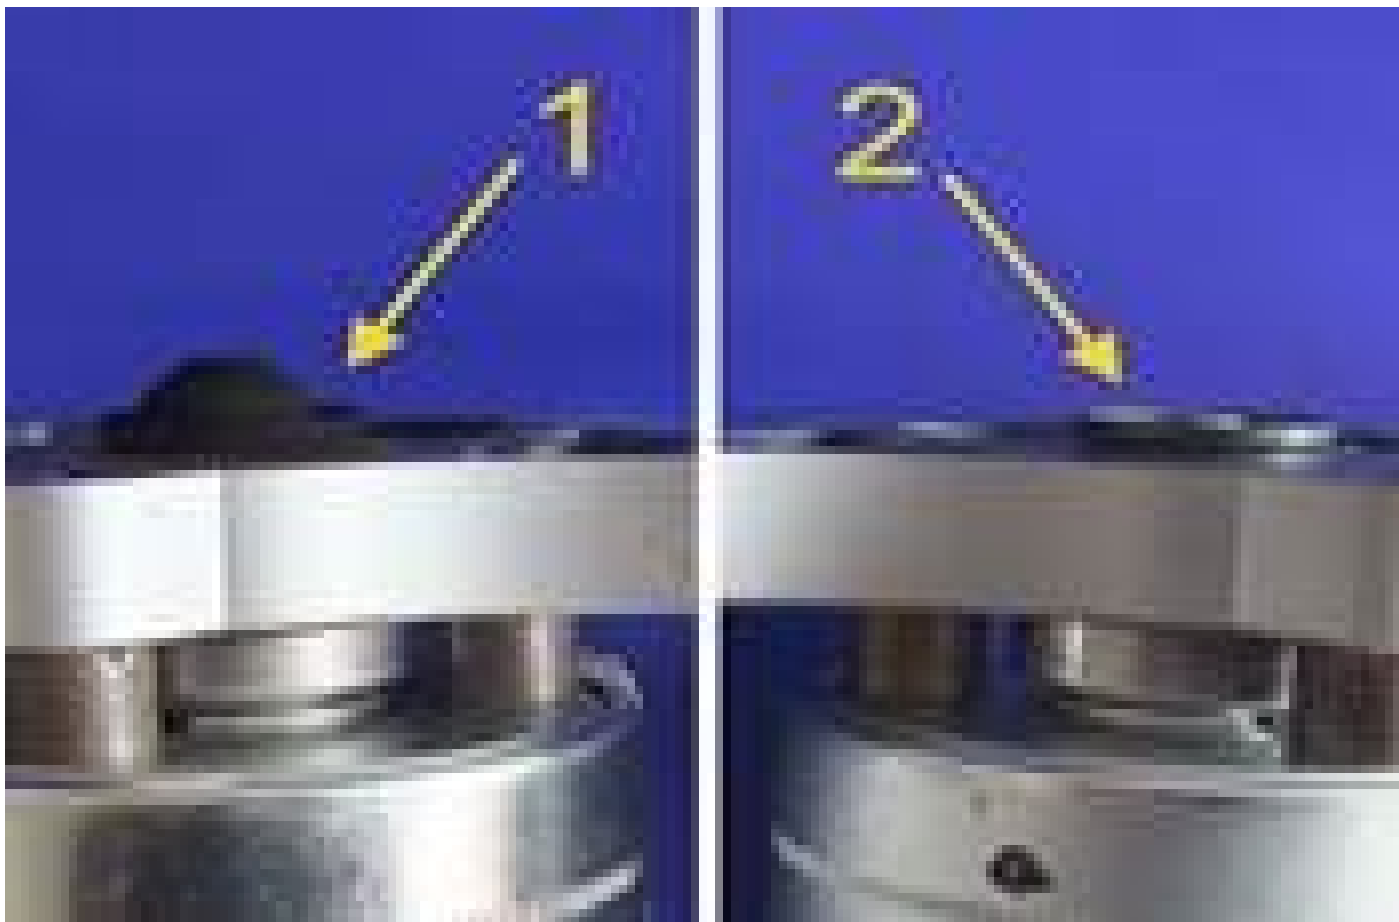
As can clearly be seen in the image, the contaminated EGR valve (1) is already open in de-energized state.
