# BMW 530d GT F07 - driving dynamics control failure

## Communication fault in the driving dynamics control unit

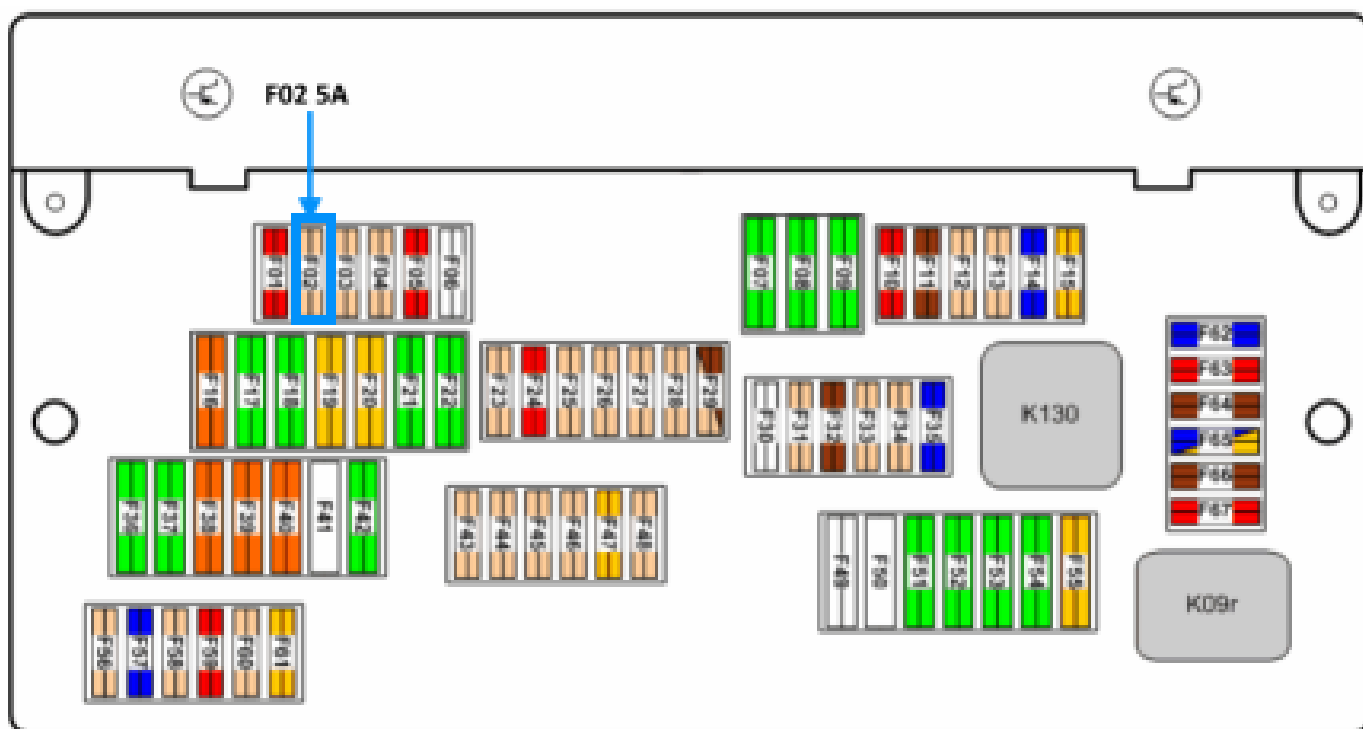
Einbauort der F02 Sicherung beim BMW 530d GT F07

The fuses should be carefully checked as the first troubleshooting step. Pay particular attention to fuse F2 (5A) in the central electrical system in the passenger compartment. This not only safeguards the power supply to the driving dynamics control unit, but also the power supply to the door handle sensors.

The 5A fuse must be removed and visually checked for defects. If there are no obvious defects on the fusible wire, a continuity test can be carried out with a suitable measuring device for a more precise check. If the fuse is visually defective or measurements are out-of-spec, a possible cause may be a defective door handle sensor.

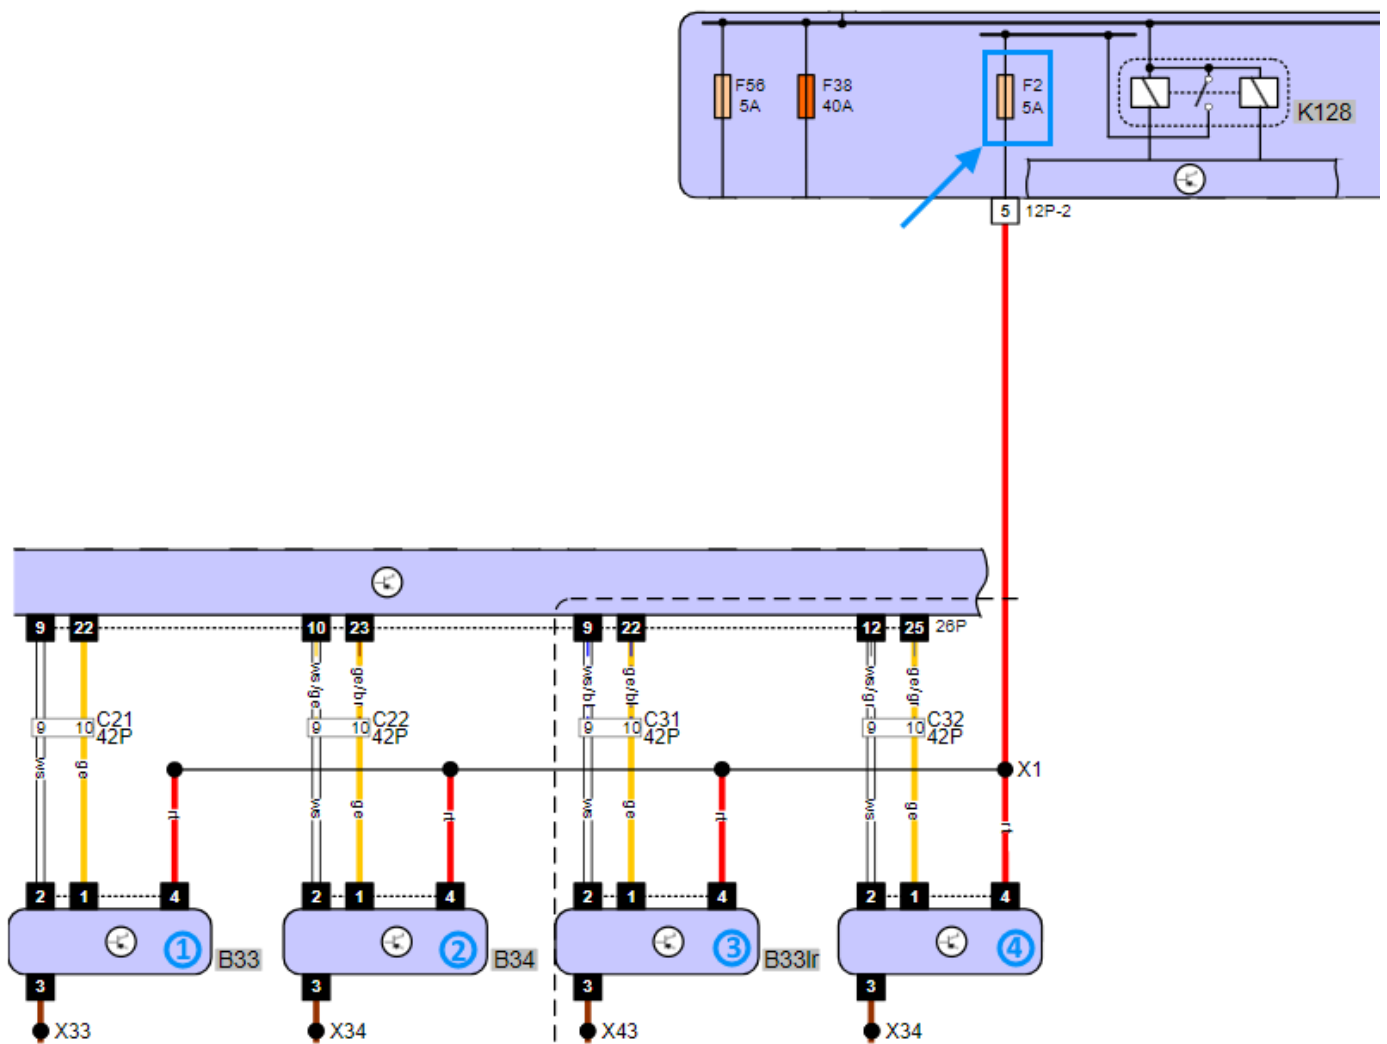
Caption of circuit diagram: 1-4 = Door handle electronics

Water ingress into the door handle and the resulting corrosion on the plug connections can cause short circuits. This triggers fuse F2 (5A). To check, the door handles must be dismantled in accordance with the manufacturer's instructions.

If corrosion or water ingress is visible at the plug connections, the affected door handle electronics must be replaced and the plug connections repaired if necessary.

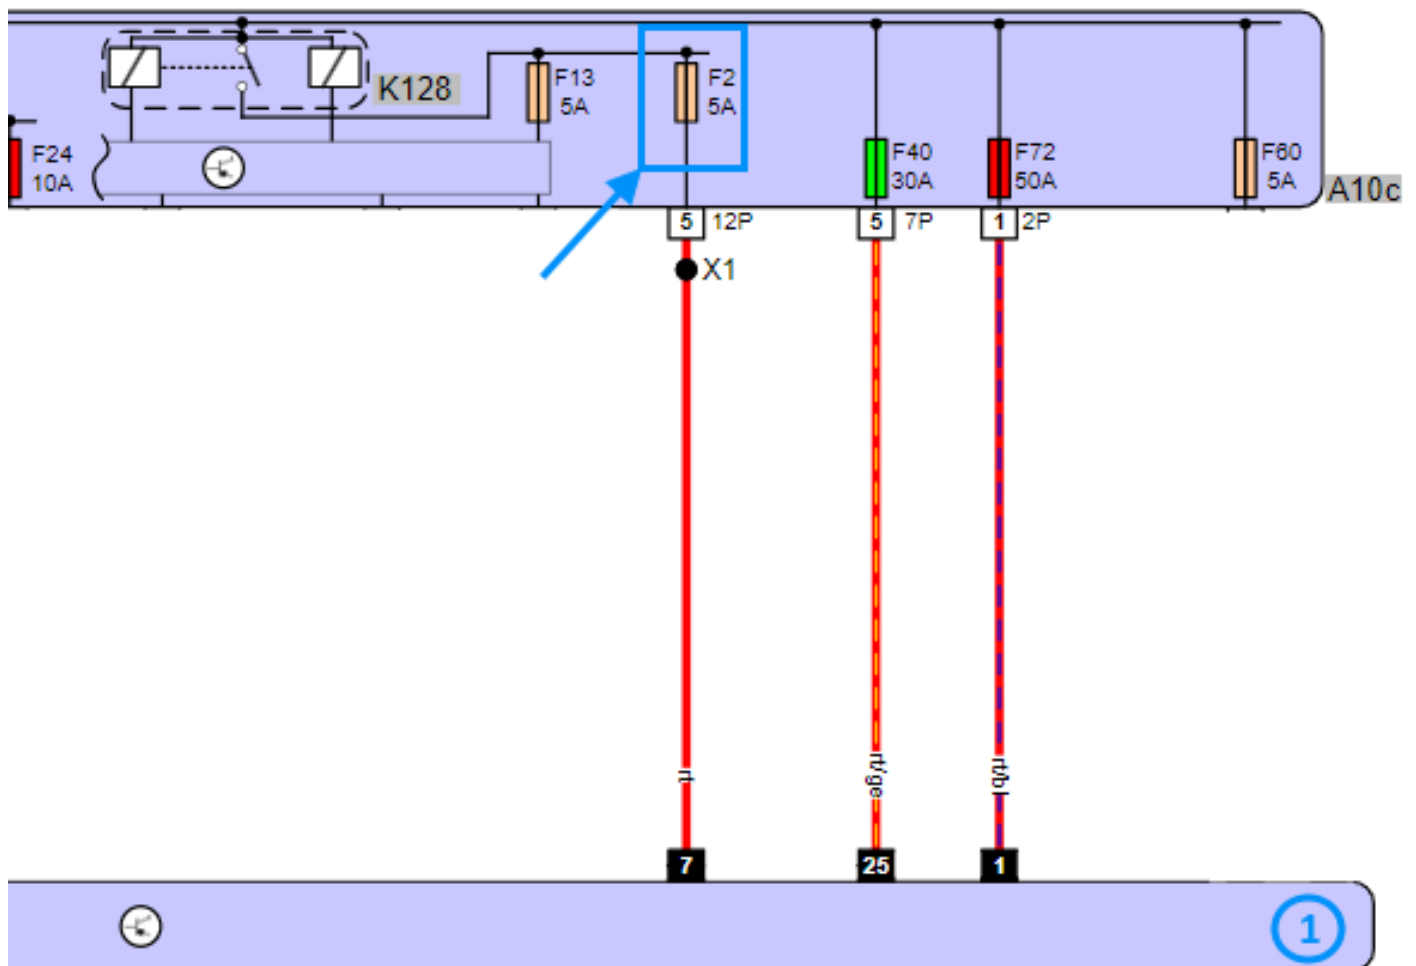
Caption of circuit diagram: 1 = Driving dynamics control unit

With the above vehicle type, the warning lamp for the driving dynamics control system in the instrument cluster may light up. The control unit diagnostics has detected that communication with the control unit of the driving dynamics control has been disrupted. It is no longer possible to read out the fault memory of this control unit.
