# **Opel Astra-G, Opel Zafira, Vectra-B - Irregular engine running | HELLA**

**Opel Astra-G, Vectra-B**

**Opel Zafira**

**All models with X18XE1 engine**

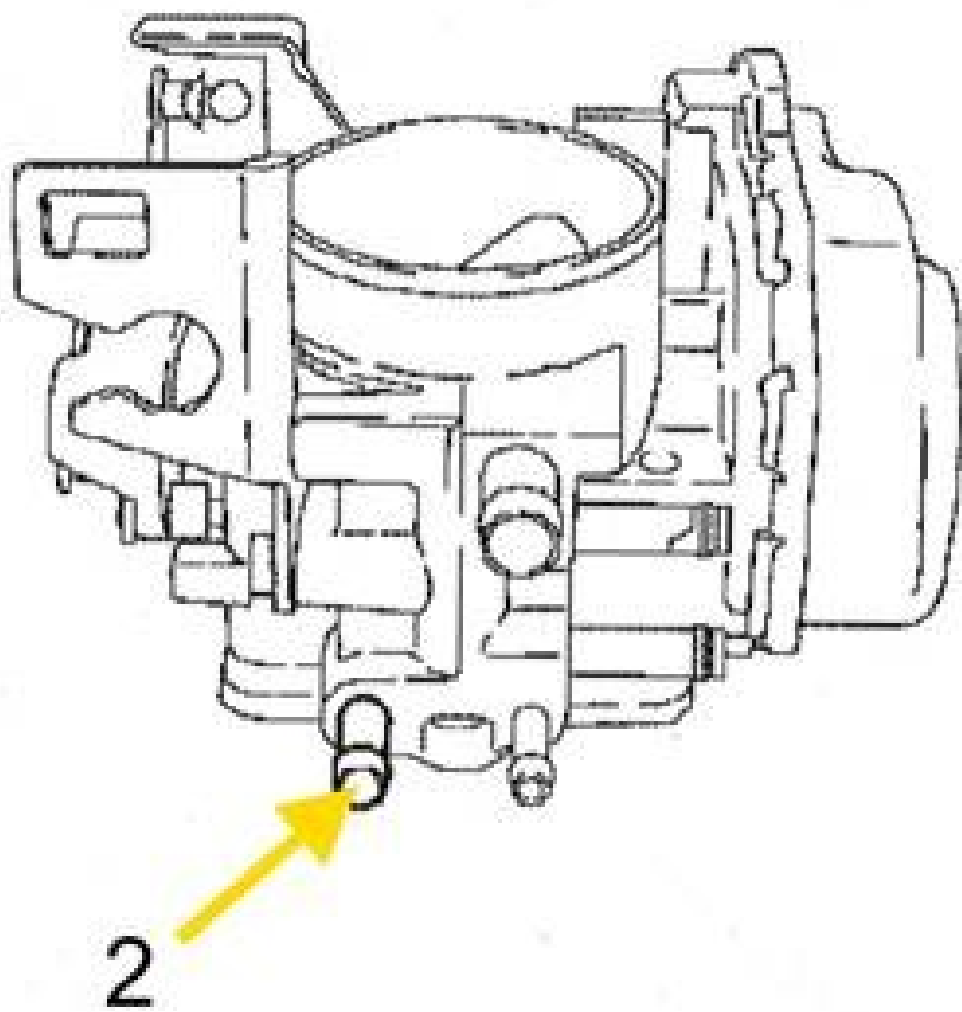
If the above-mentioned symptoms occur on these vehicles, this may be caused by a dirty throttle valve. In this case, check the blow-by hole and, if necessary, drill open to 2mm. Afterwards, the ECU must be reprogrammed with a software modified for this purpose. The ECU software can only be updated by an authorised dealer.
