## Opel Astra-J Sports Tourer: display code 16

| Symptom | Display code 16 |

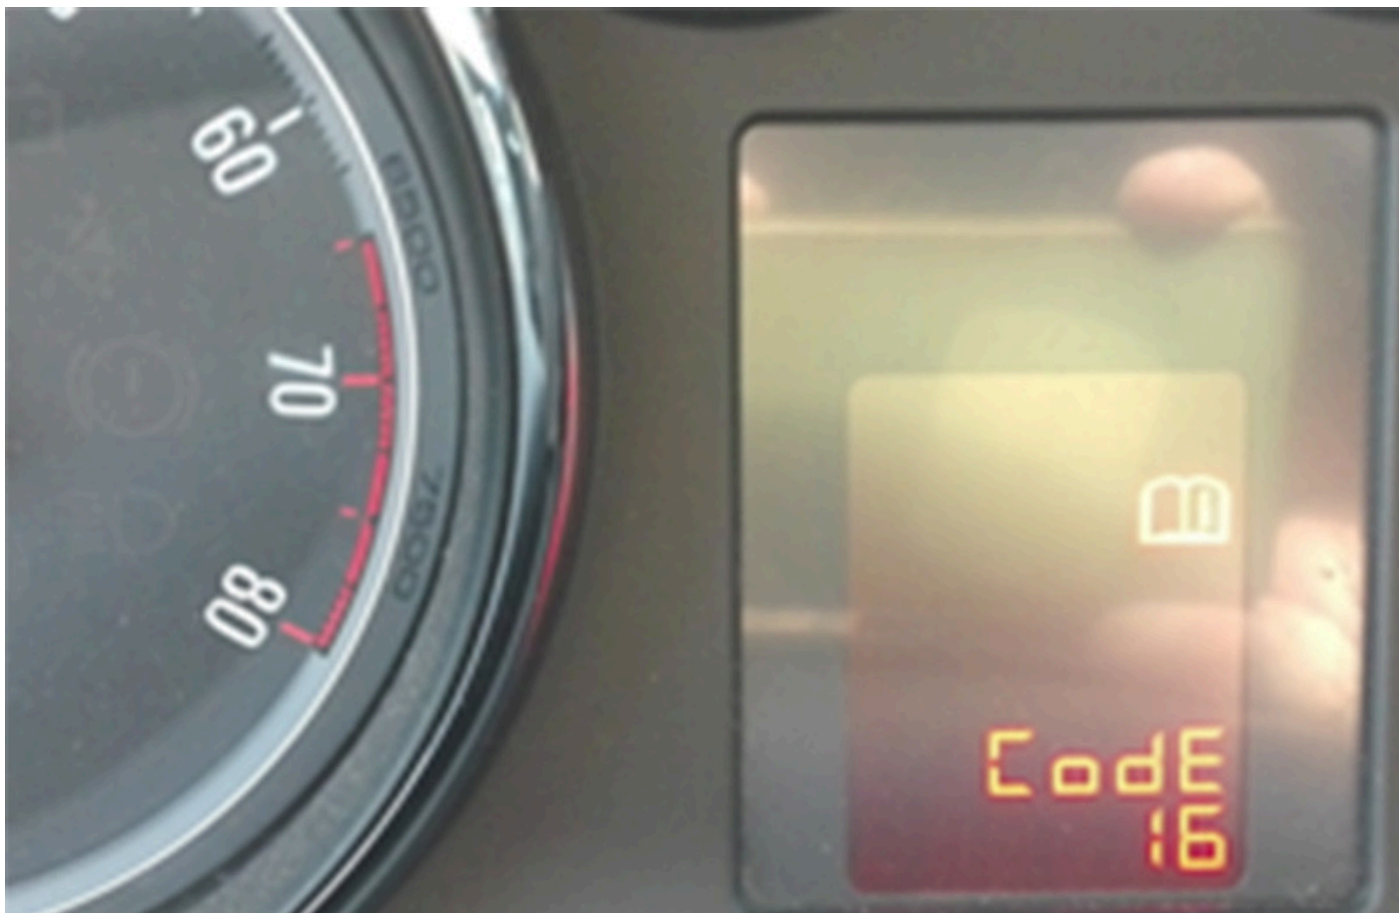
Code 16 appears on the display ([Fig.1](#)) with information, see operating instructions. Error code Diagnosegerät\_B3881 corresponds to faulty tail light lamp or circuit.

Fig. 1: Code 16 appears on the display
