# **Opel Corsa C - Instrument display with intermittent loss of function | HELLA**

**Opel Corsa C**

**From model year: 2003**

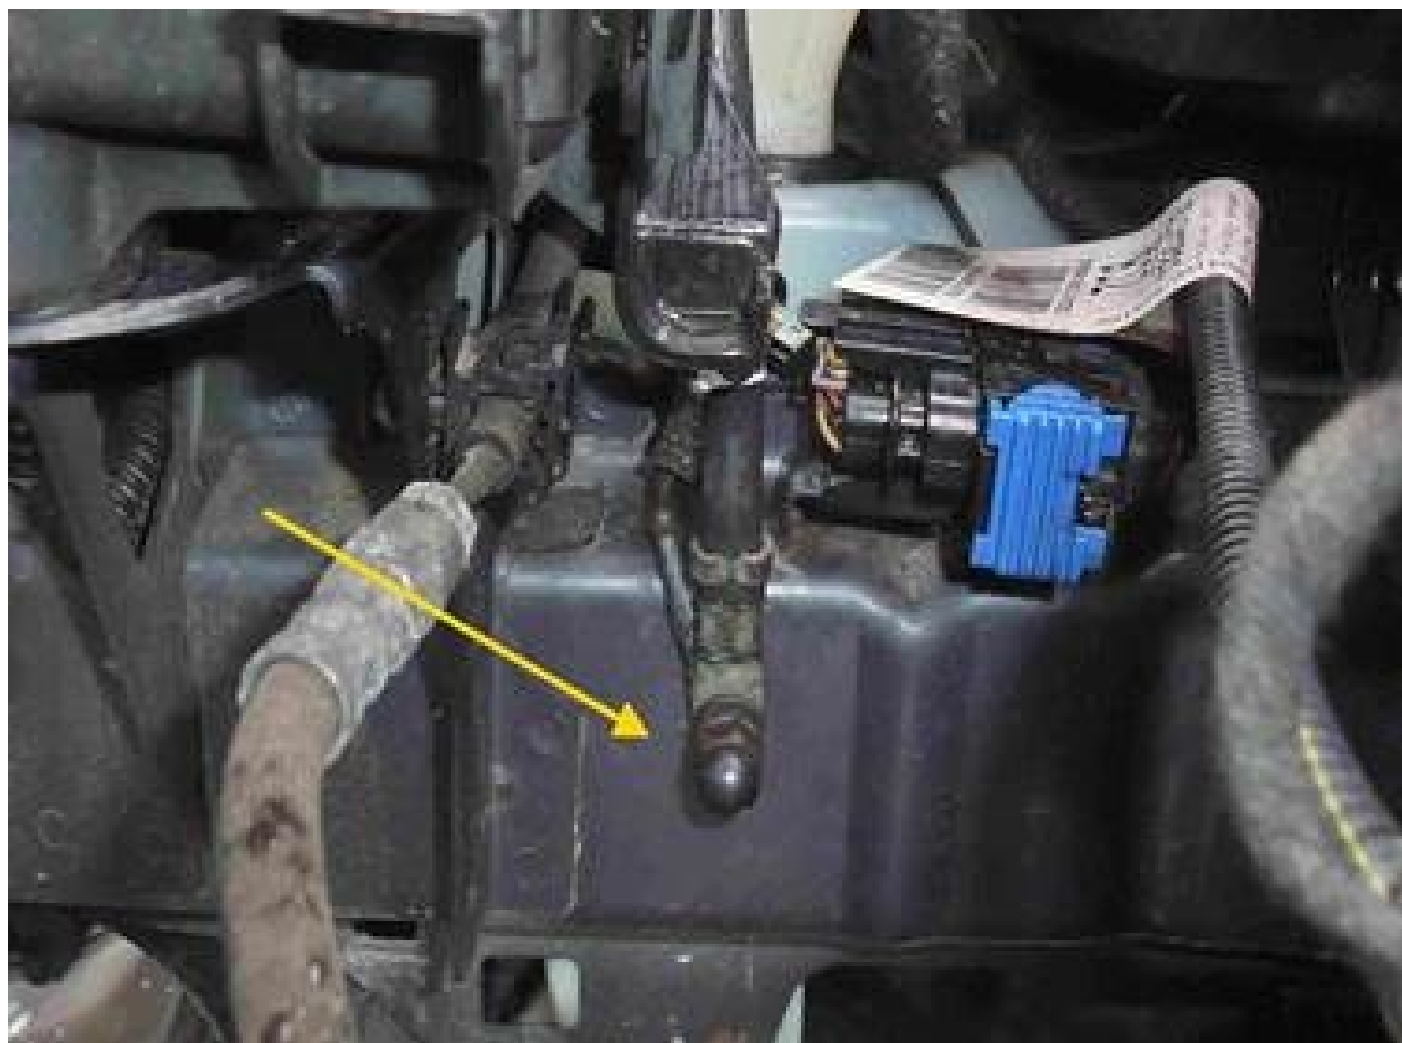
If a malfunction or intermittent failure of the instrument display (which remains until the next ignition cycle) while driving is complained at for these vehicles, a possible source of fault is the earth connection.

Check the chassis earth point in the engine room (see photo). Check here that the cap nut is tightened and the cable connections are corrosion-free and tight.

If the earth cable connections are loose, install an additional spring washer/circlip to secure the attachment of the earth connection.
