# VW Beetle - non-functioning parking aid

## Data sheet

| Symptoms | Failure of backup and warning alarm / parking aid |

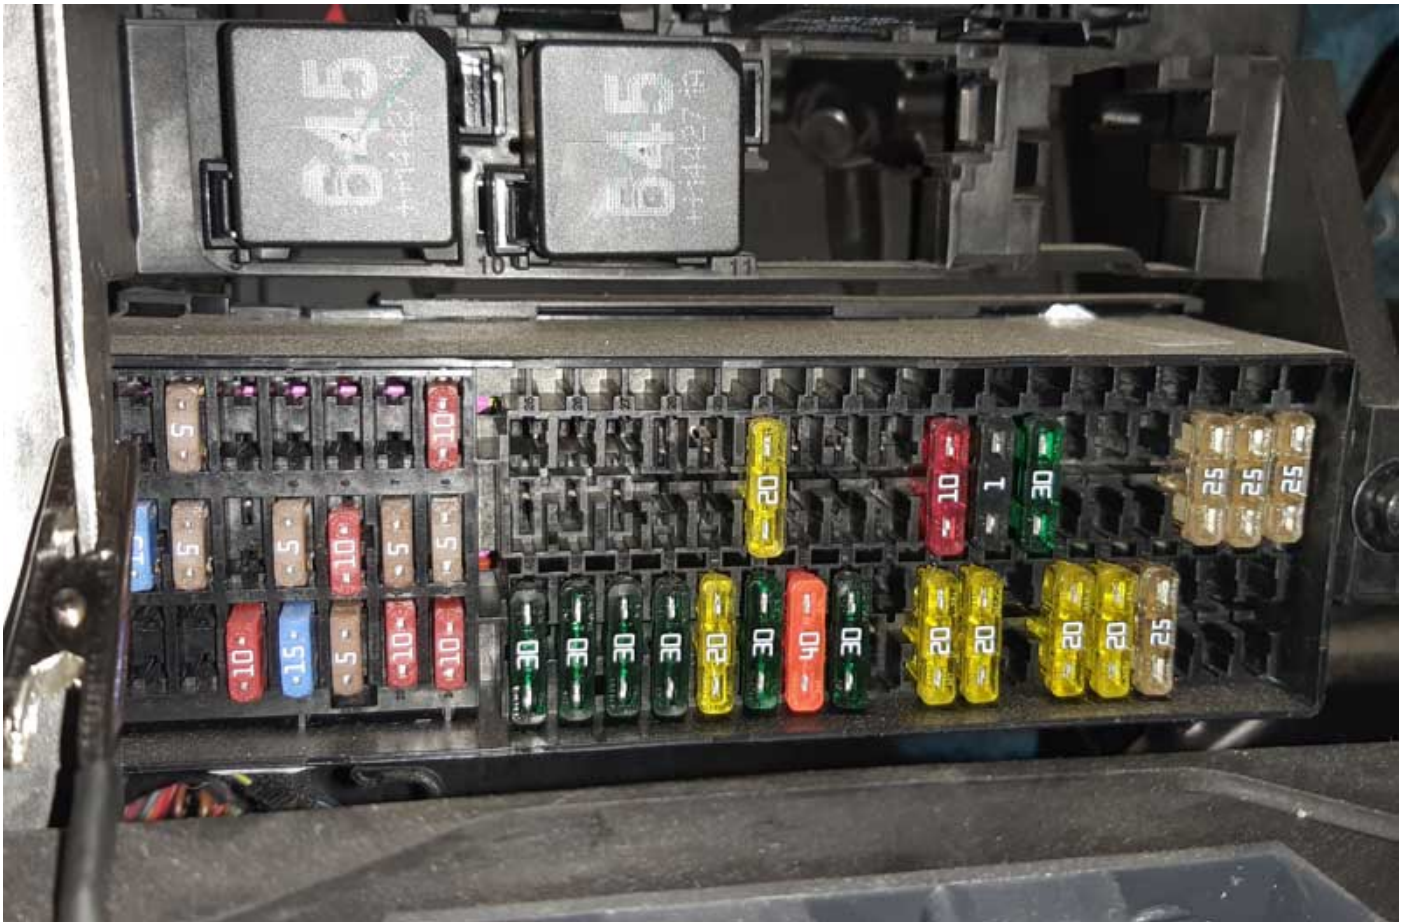
In this case, the cause is not necessarily to be found with the software or with the electronic components. The first thing to do is to check the fuses in the fuse box located in the driver's footwell ([Fig. 1](#)).

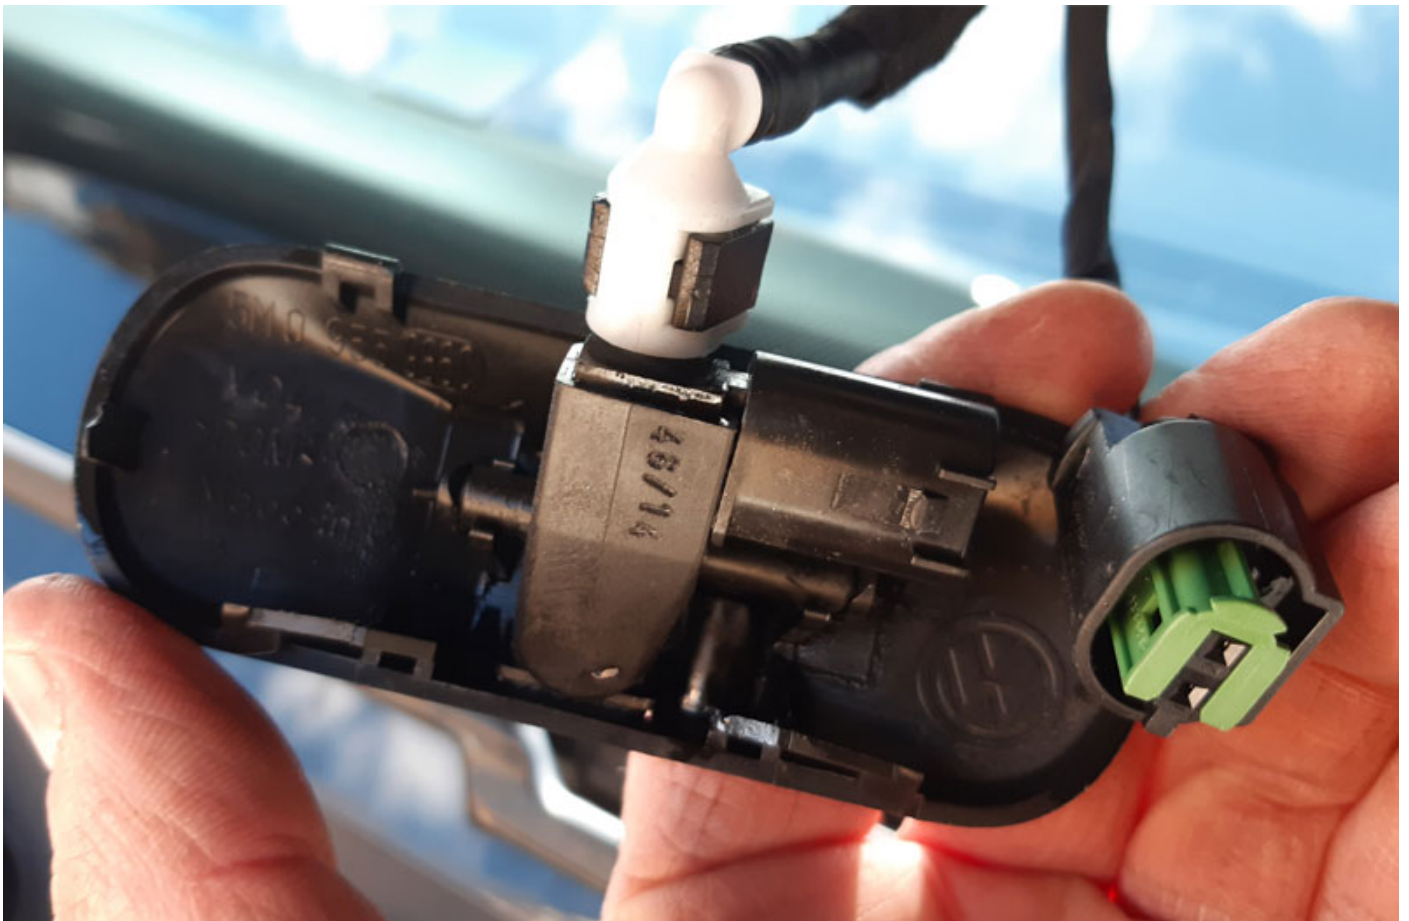
In most such cases, the fuse for the electrically heated wiper washer nozzles is defective ([Fig. 2](#)). The cause of this is a short circuit in the heating element of the wiper washer nozzle with the result that not only the fuse but also the nozzles must be replaced.

After replacing these components, functioning of both the parking aid and of the "start/stop" feature is restored.
