## VW T5 - coolant thermostat

### Data sheet

## Operating temperature is not reached, thermostat and coolant flange

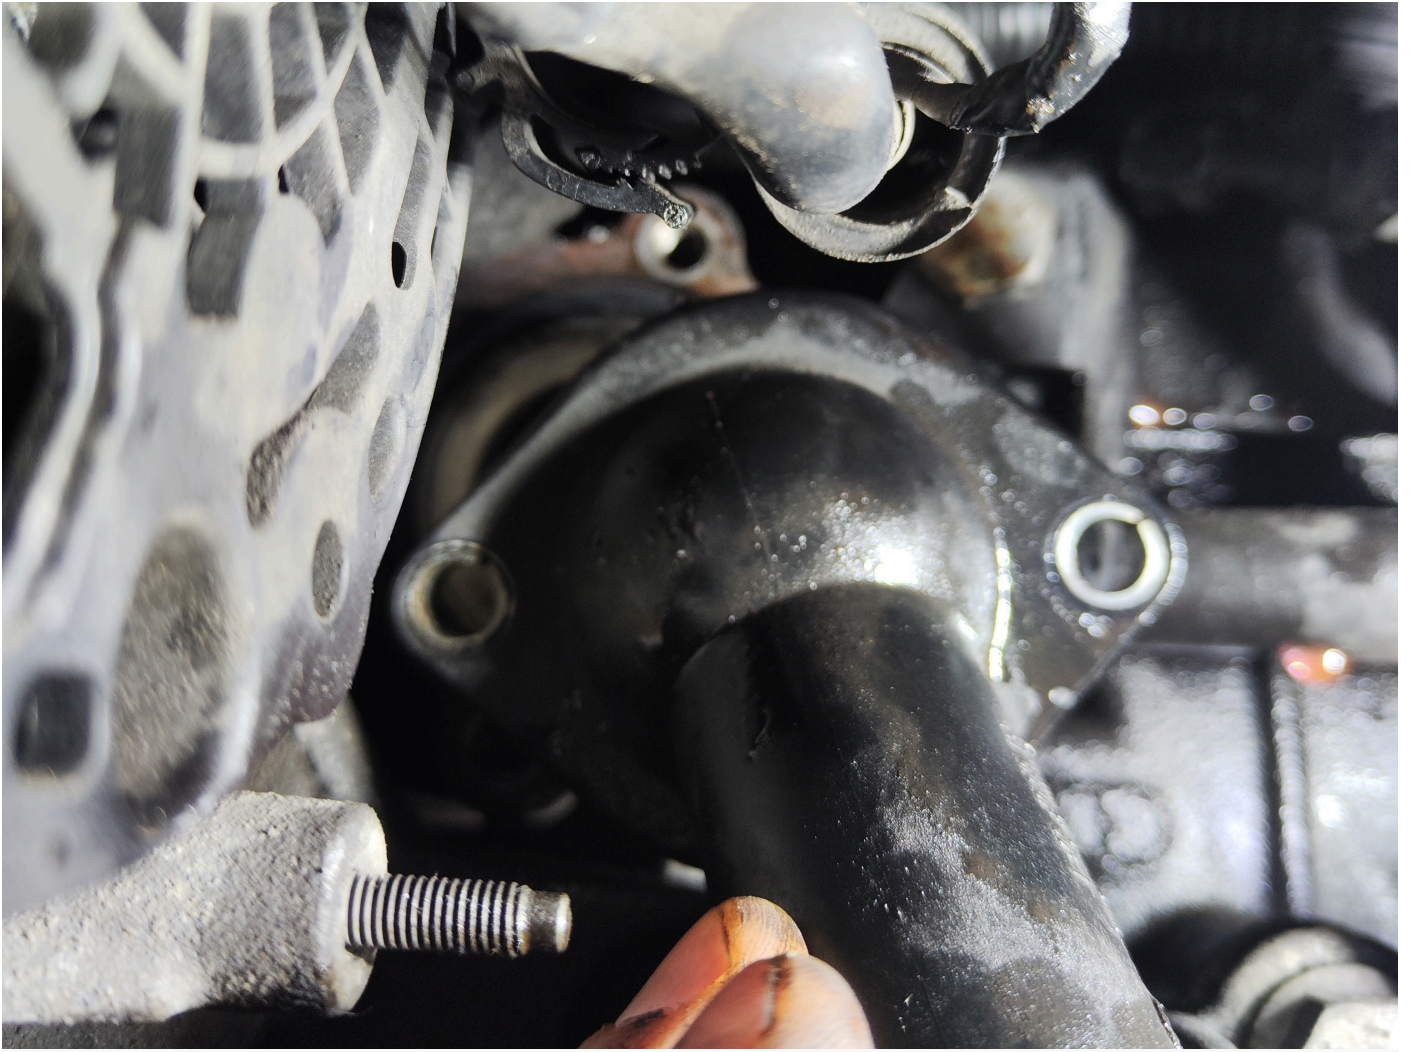
Before installing the new thermostat, the coolant flange should be inspected.

Coolant flange T5

It is then advisable to replace the flange.

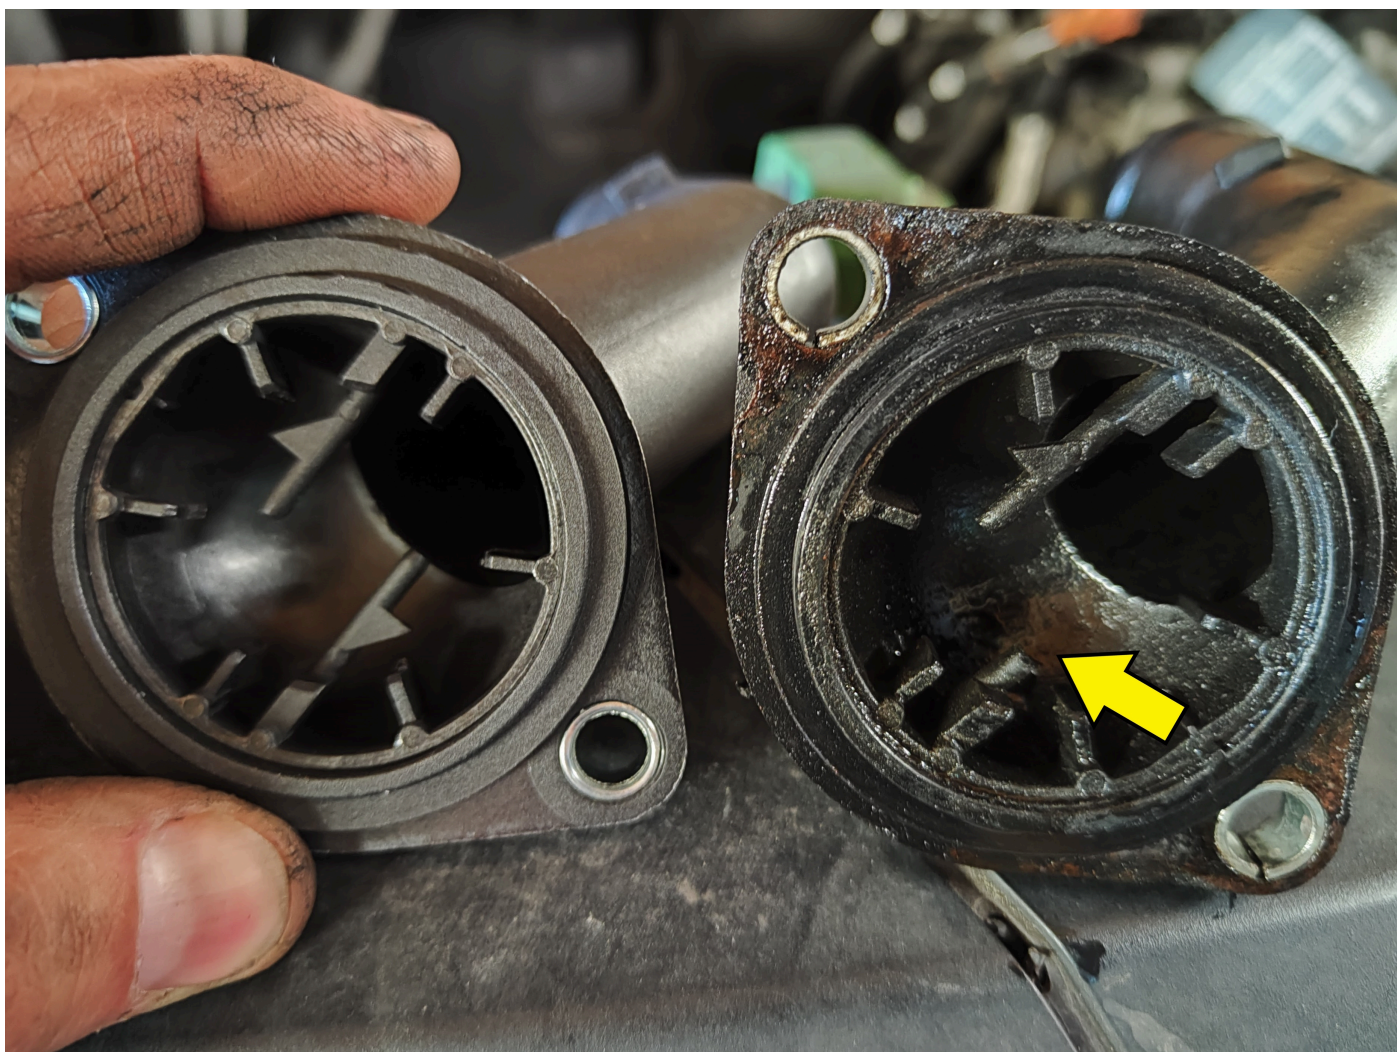
Part of the plastic guide (installation aid) often breaks off here.

Plastic guide for T5 coolant flange
