# Coolant pumps | HELLA

## General

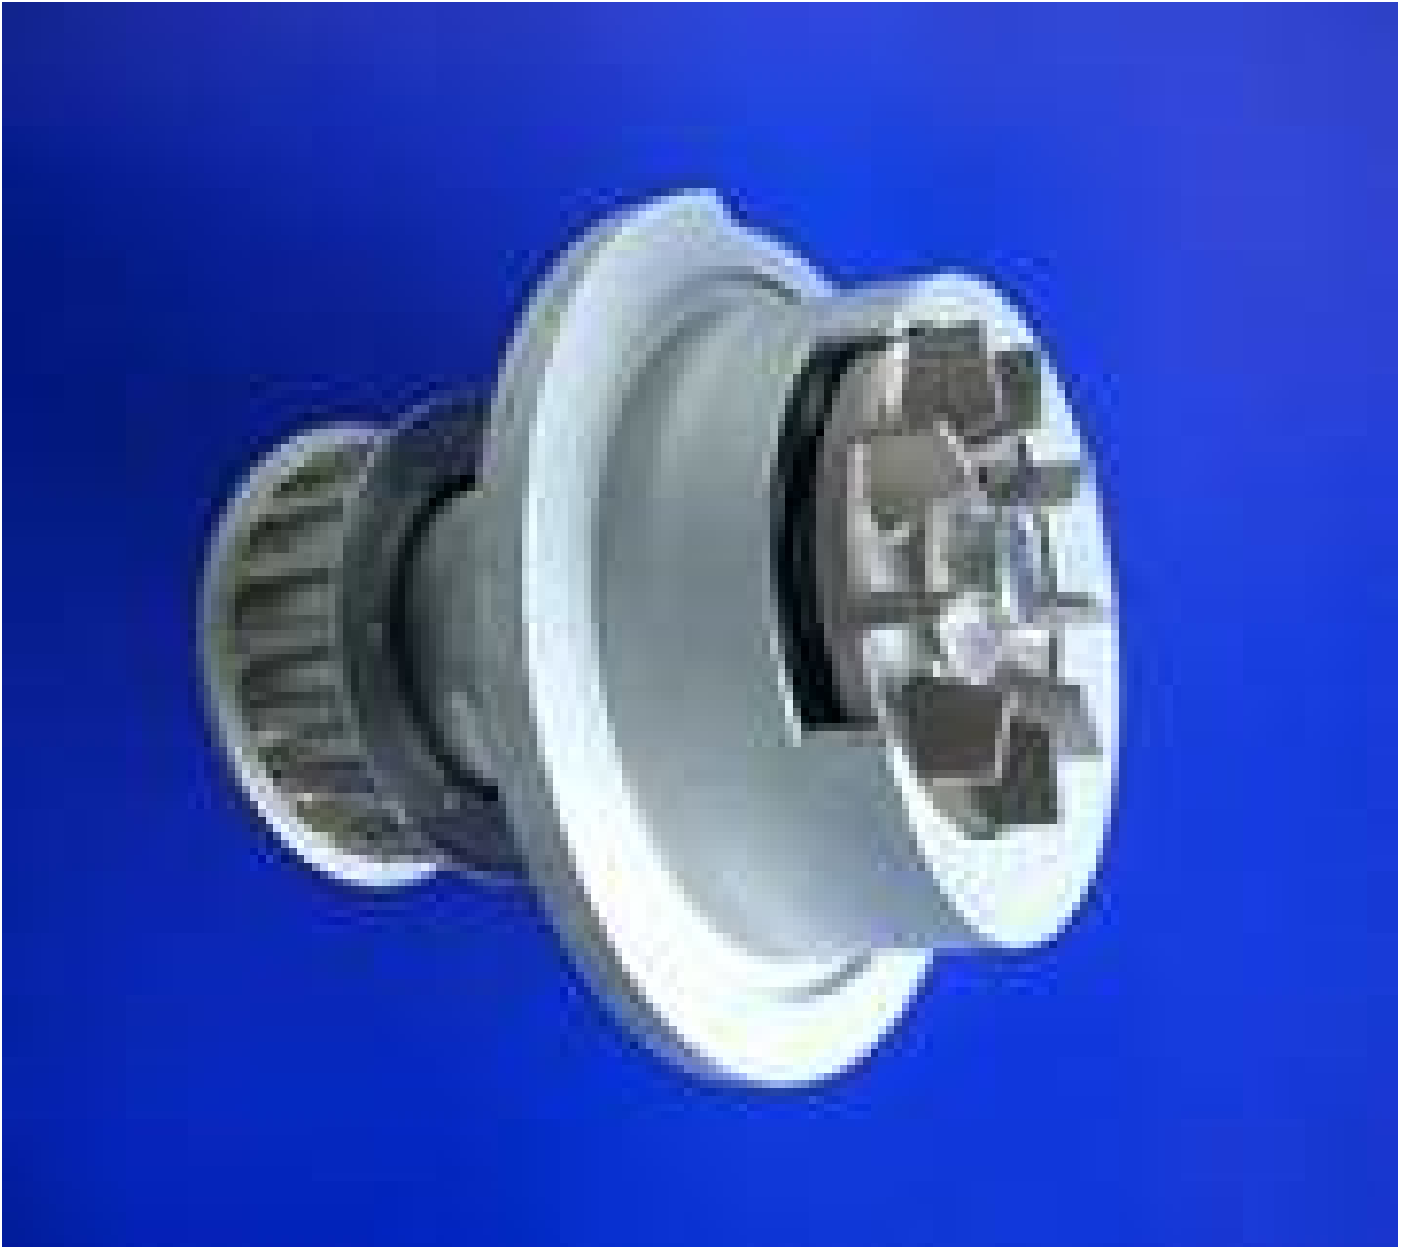
Figure 1

Coolant pumps (Figure 1) are mostly driven mechanically, by a toothed belt or V-ribbed belt, and transport the coolant through the engine's coolant circuit. The pumps can be flanged directly to the engine or also installed away from it. The designs are quite different. Coolant pumps must withstand huge variations in temperature (-40 °C to approx. +120 °C). Changing speeds (500 - 8000 rpm) and pressures of up to 3 bar require high stability of bearings and seals.
