# BMW i3 (I01) - Fejl i radiomodtagelse | HELLA

**BMW**

**i3 (I01)**

## **Fejl i radiomodtagelse**

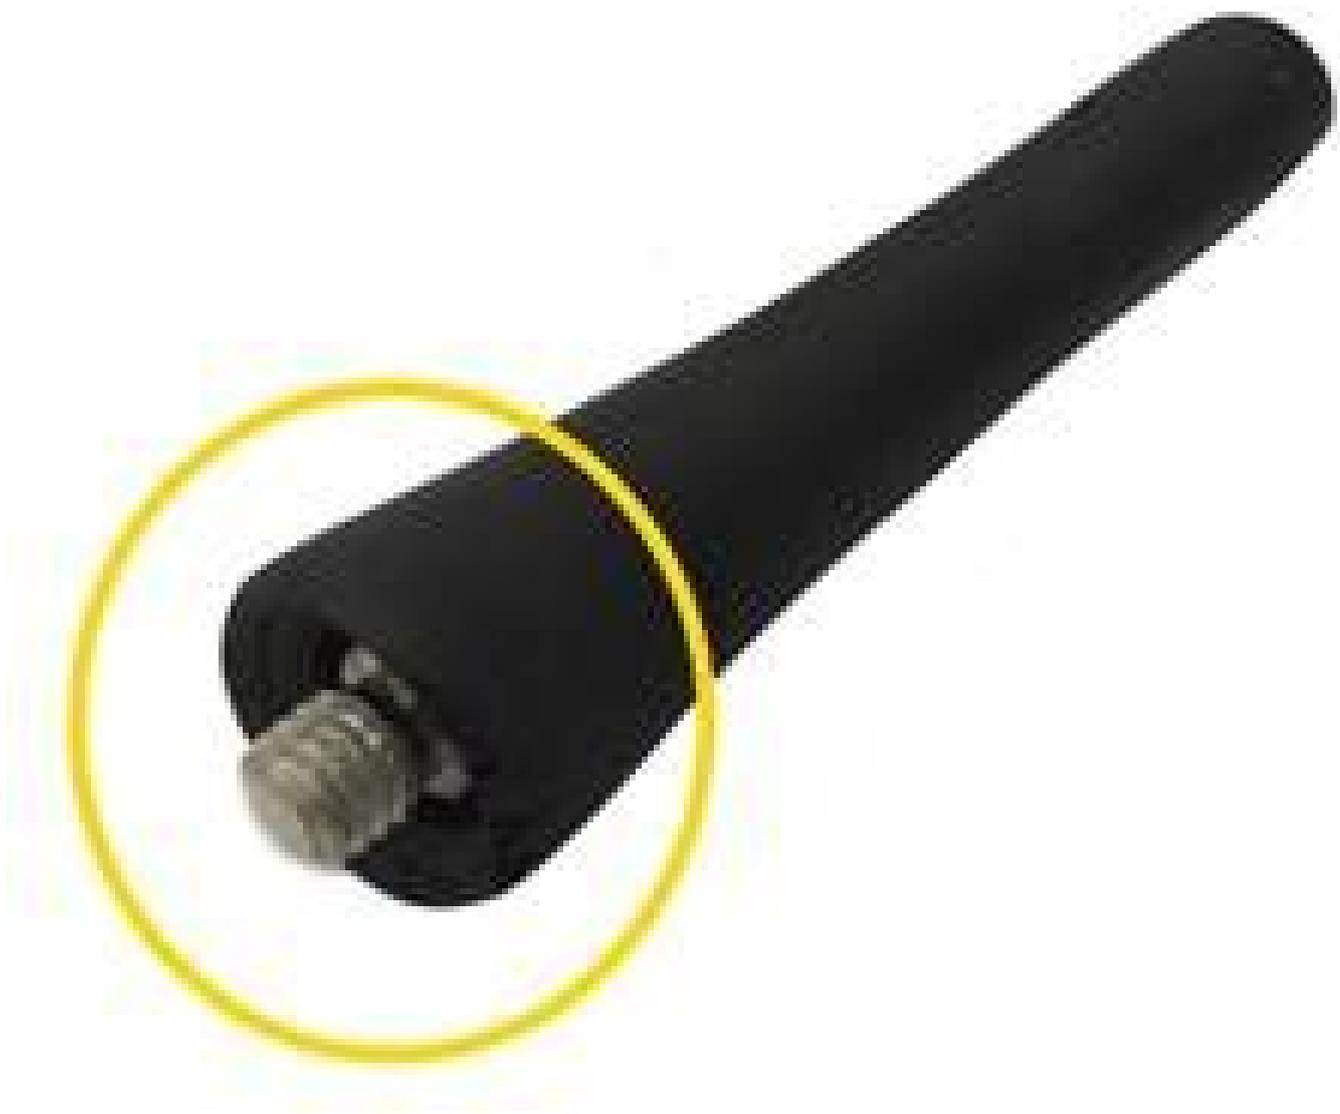
Ved nærmere betragtning af tagantenneenheden viste det sig, at antennestangen er beskadiget (revne i eller brud på gevindstangen), hvilket er årsagen til det ovennævnte problem.

- Afmonter antennestangen.
- Kontrollér gevindet på antennestangen (se foto) samt gevindgangen i tagantenneenheden med henblik på beskadigelser, og reparer eller udskift evt.
- Montér den nye antennestang.
- Kontrollér radioens funktion.
