Ford Focus - Tab af motoreffekt | HELLA

Focus

Model year: 2004–2011

Motor 1.6 16 V (HXDA)

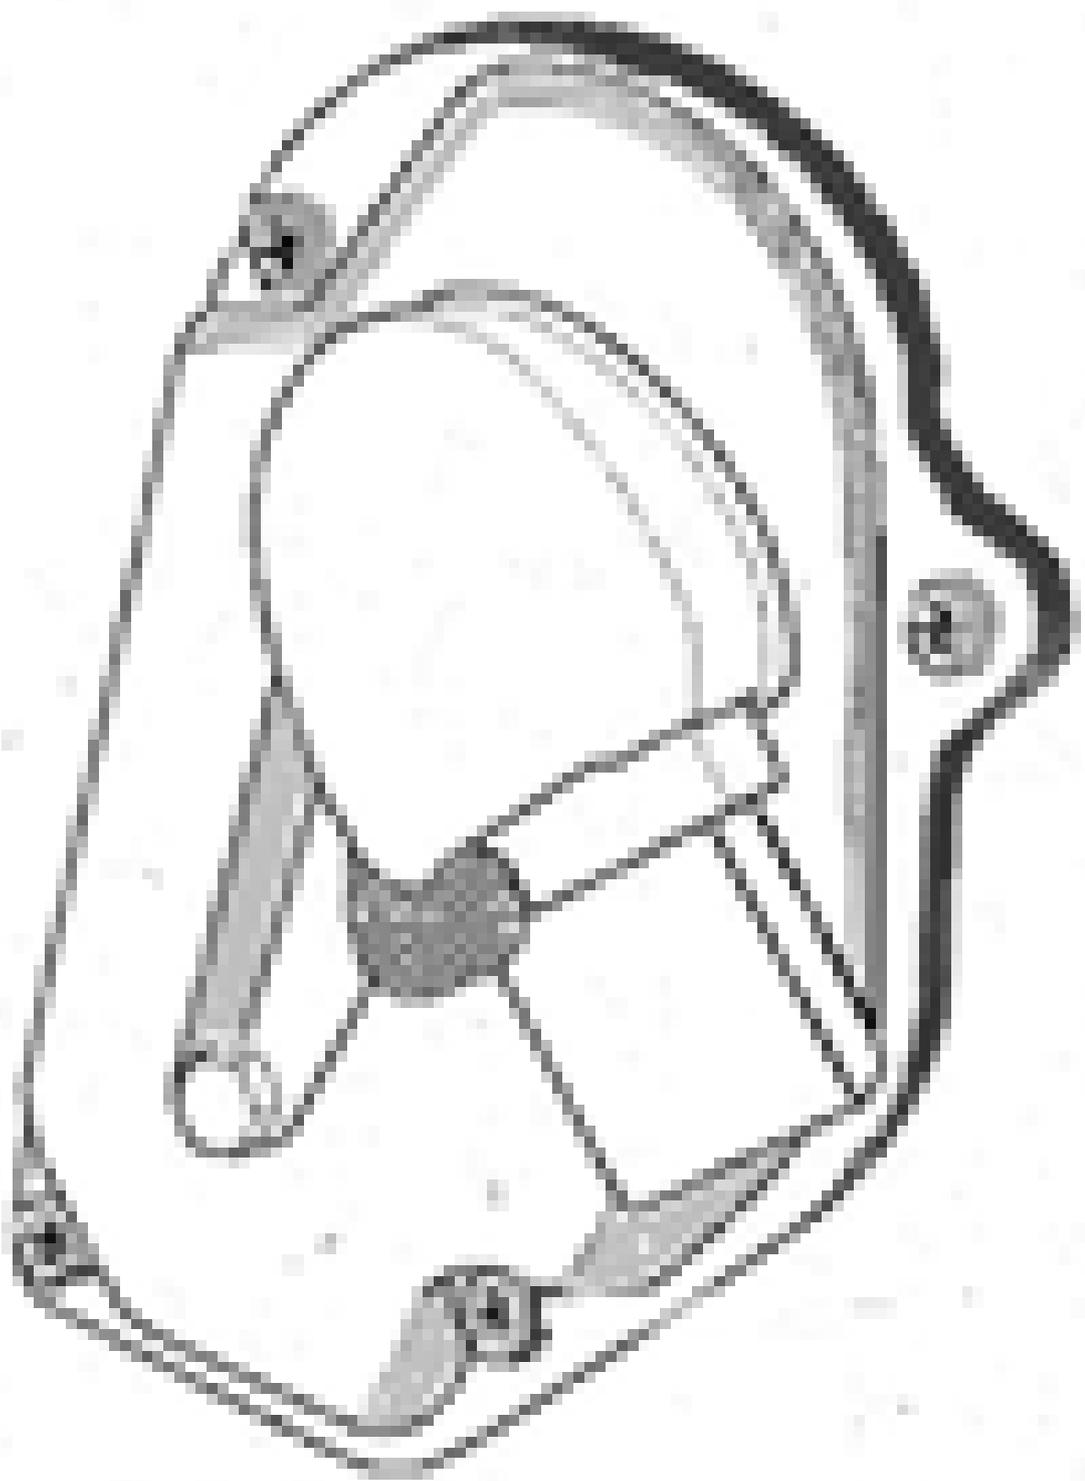
Fig. 1

1 unit: 1483794 Throttle valve sensor (fig. 1)

Additional tests must be carried out in relation to the stored error codes. The throttle body (operate the throttle valve manually 3 to 5 times and check that it springs just before the closed position). Check the wiring harness for damage, and the plugs, and plug contacts for corrosion. If necessary, replace all components (see table for spare part overview). The tightening torque of the fixing screws is 1.6 Nm.
