Jaguar XK-Type, XJ-Type, XF-Type - Klimaanlægget køler ikke tilstrækkeligt | HELLA

Insufficient cooling from air-conditioning system

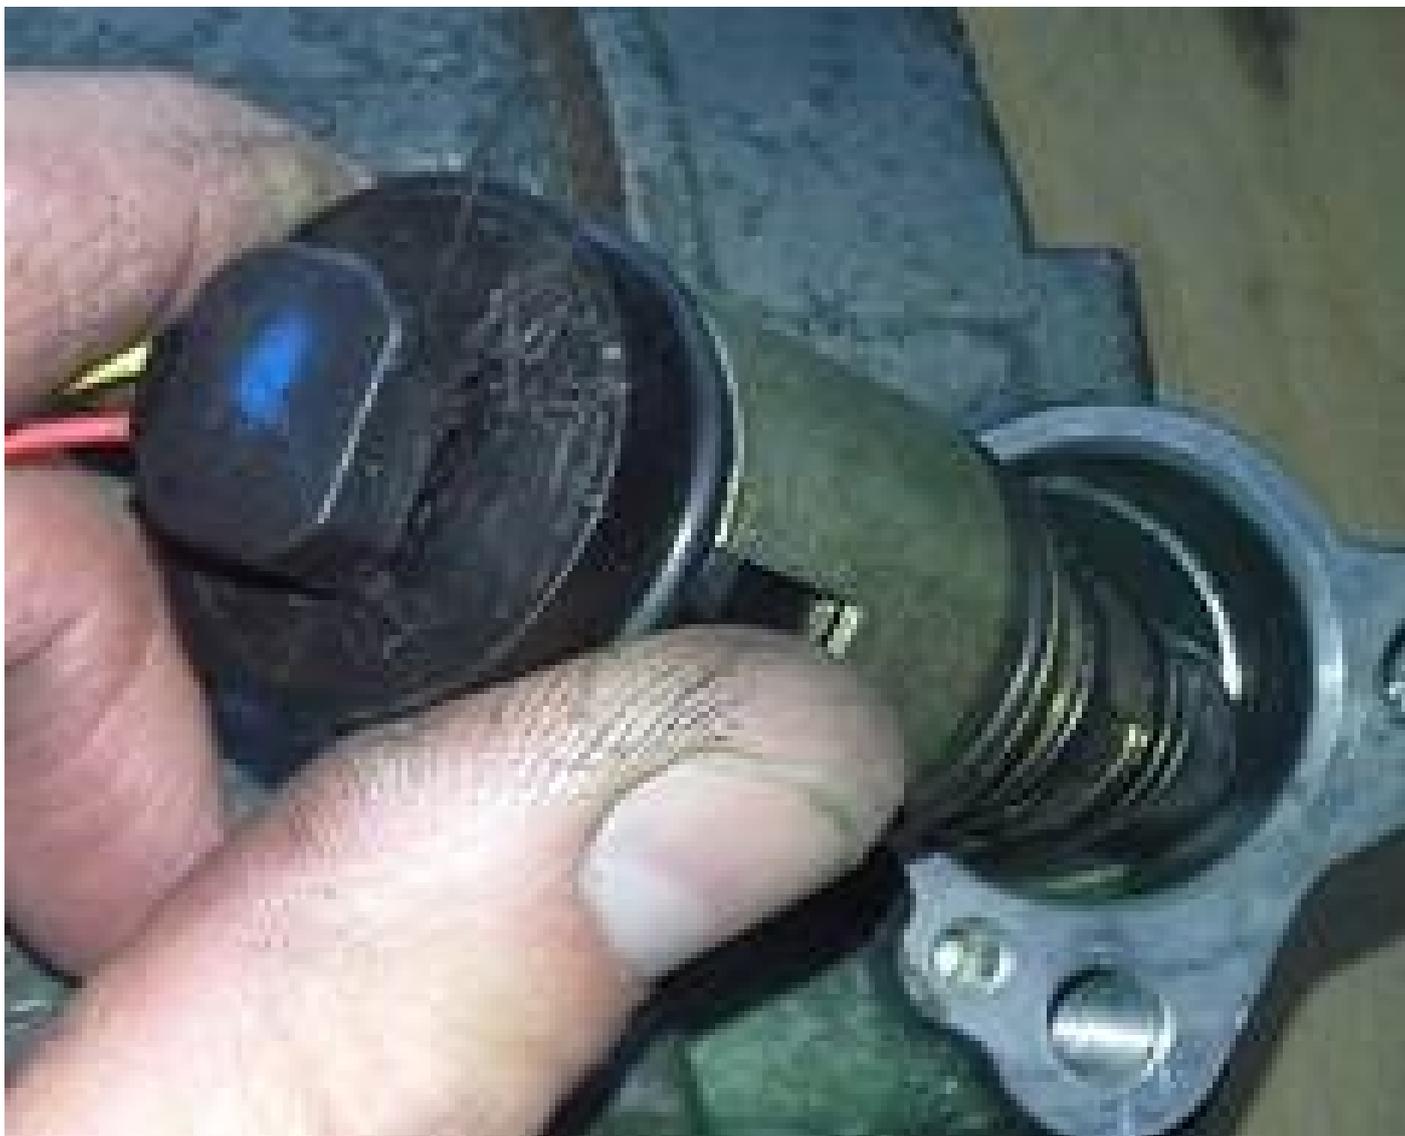
The figure shows an example of an electronically actuated pressure control valve

To replace the compressor pressure control valve, proceed as follows:

- Drain off refrigerant
- Remove compressor (usually required)
- Clean area around control valve
- Remove circlip from valve
- Carefully remove control valve
- Check the area of the compressor into which the new valve is going to be inserted for damage and soiling
- Moisten the seal rings on the new valve with compressor oil, and insert the new control valve
- Fit circlip
- Fit compressor
- Carry out leak test
- Fill air-conditioning system and perform a functional test
