Jeep Commander - Fejl ved recirkulationsspjældet | HELLA

Commander

Model year: 2006

Recirculation air flap malfunction

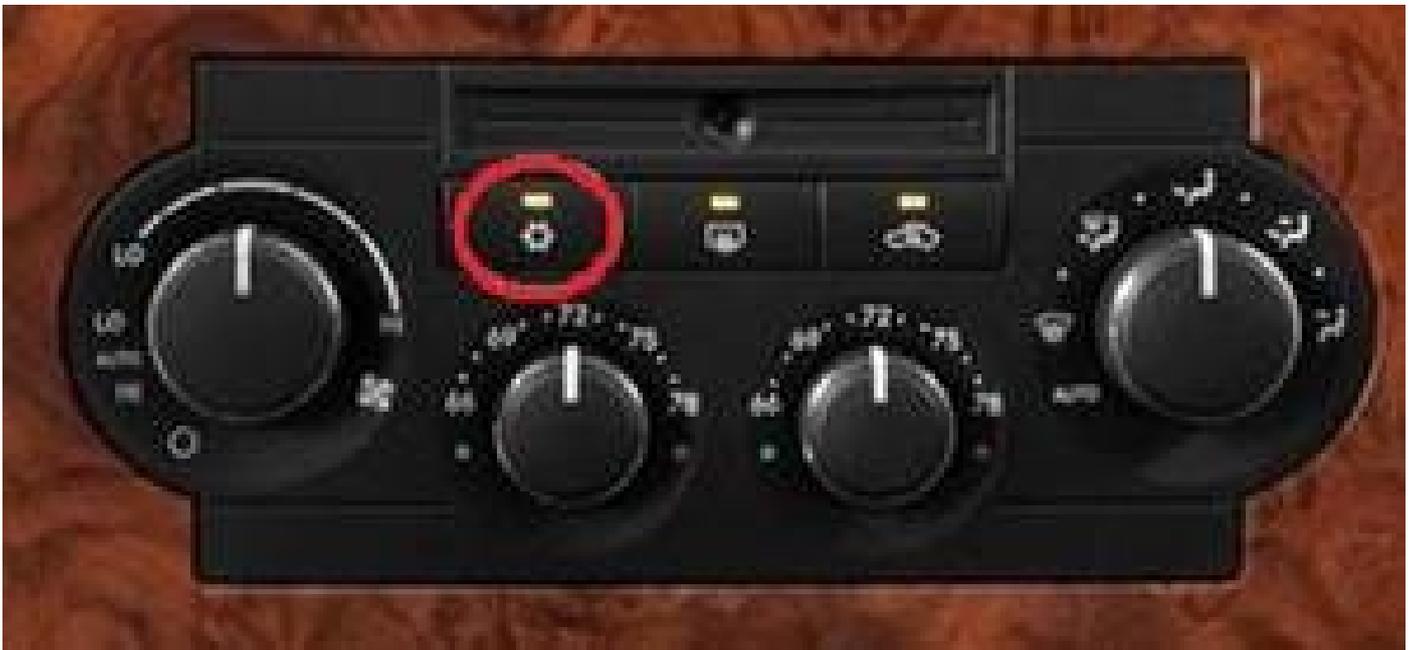
Figure

With the above vehicles the function indicator of the AC button (Figure) may suddenly start flashing at higher speeds. In addition, the recirculation air flap is repeatedly opened and closed, often noticeable by a squeaking noise.

In this case the fault should not be sought in the recirculation air system, but the flap control. Replacement of the control unit (Figure) can often rectify the problem.
