KIA Ceed - Manglende motoreffekt | HELLA

Cee'd

Model years 2006 to 2012

Engine has no power

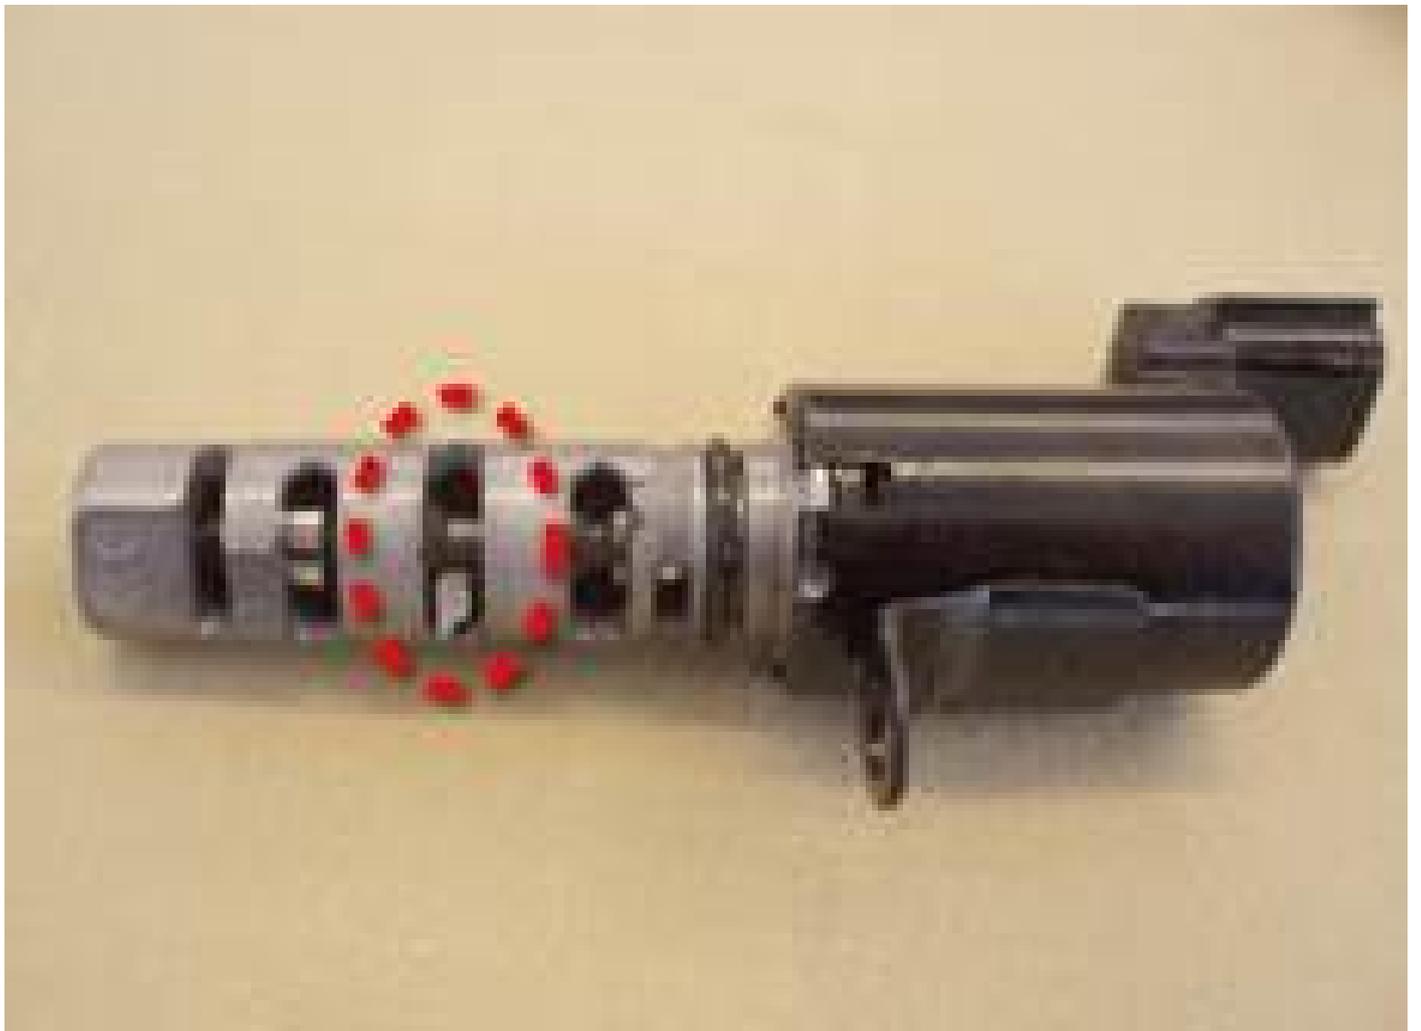
4. If the readings are not OK, the actuator must be replaced. If the readings are OK, remove the camshaft actuator and check it for mechanical damage. In some circumstances, metal debris may deposit in the actuator, making adjustments no longer possible (see figure). In this case, blow out the actuator with compressed air, for example.
