Lancia Ypsilon - Klimaanlæg / display udetemperatur | HELLA

Ypsilon

Model year: 2003 - 2011

Air-conditioning system/Display for outside temperature

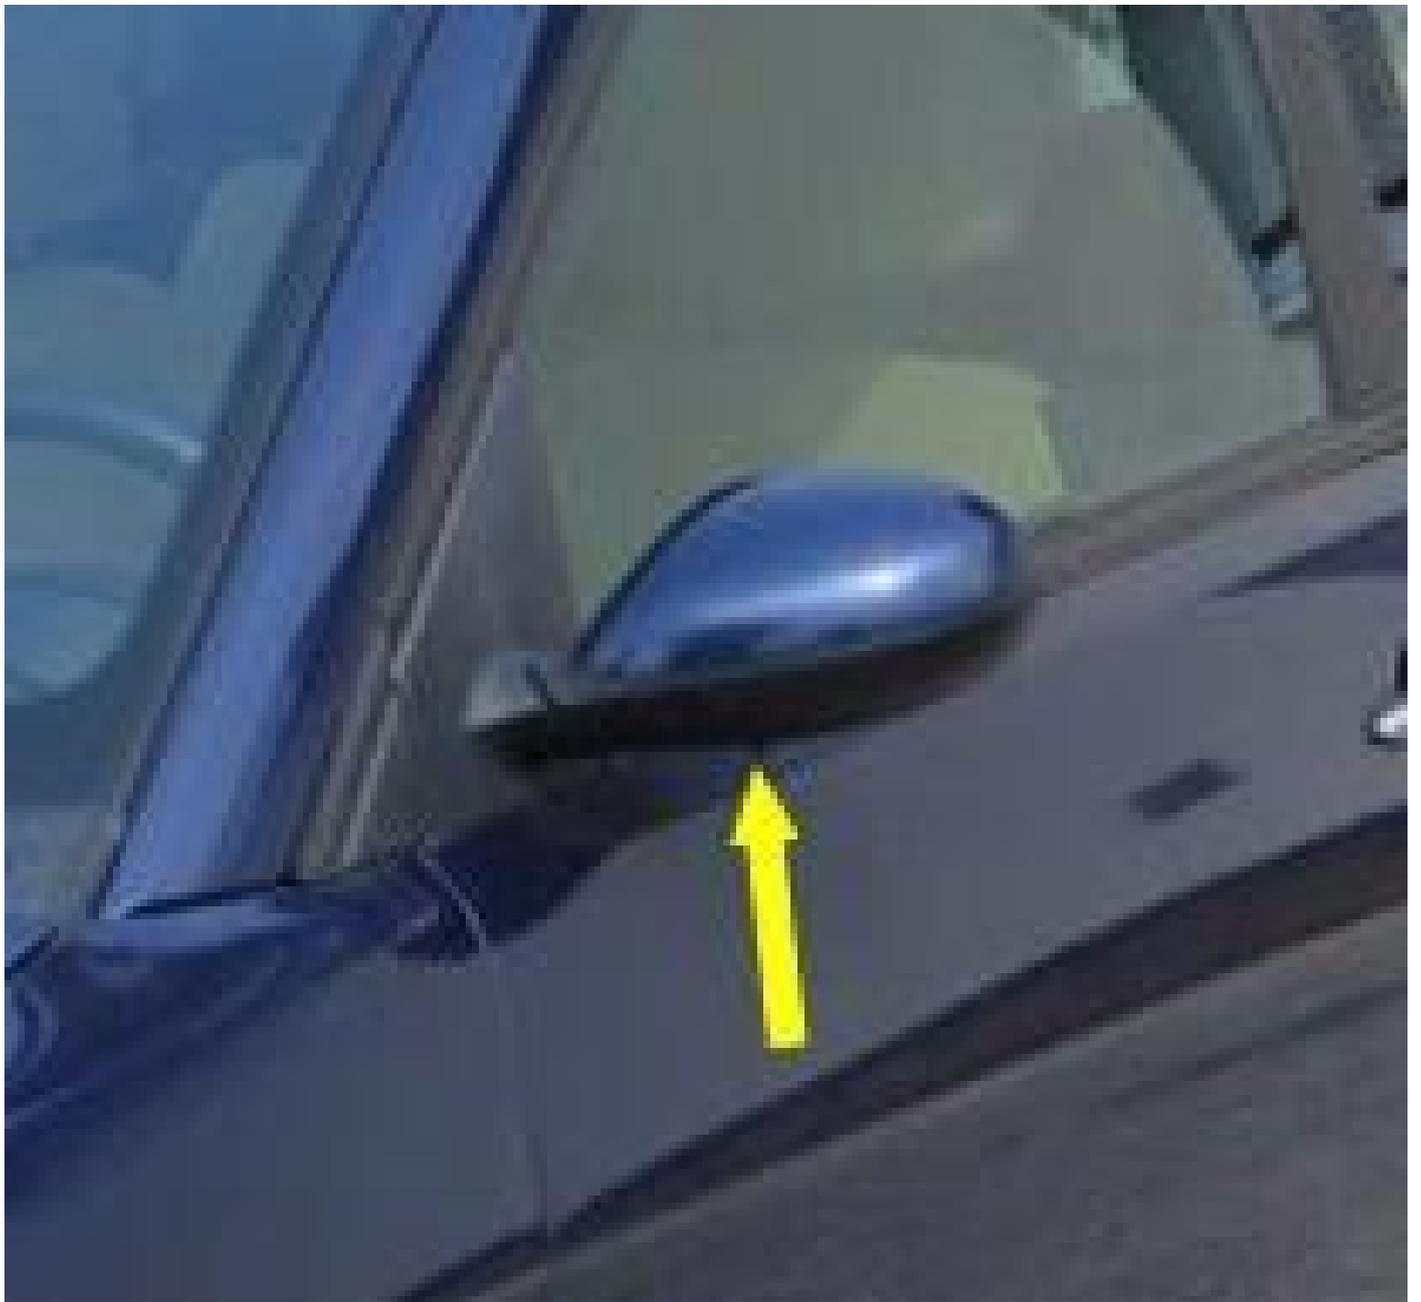
The vehicles mentioned above may experience a failure of the display for outside temperature. This affects the control of the air-conditioning system.

The outside temperature sensor is housed in the left-hand wing mirror (see figure). A broken cable in the mirror can cause a failure in the temperature display.

This leads to control problems when using the air-conditioning system.

We should proceed as follows to rectify the problem:

- Remove the rear cap from the mirror
- Remove the actuator motor
- Remove the mirror cover
- Dismantle the mirror housing
- Locate and repair the damaged part of the wiring harness
- Perform a functional test
- Re-assemble the mirror
