Lexus GS300/GS350 - Afløb for kondensvand | HELLA

GS300/GS350

Model year: 2006 - 2007

Condensation drain

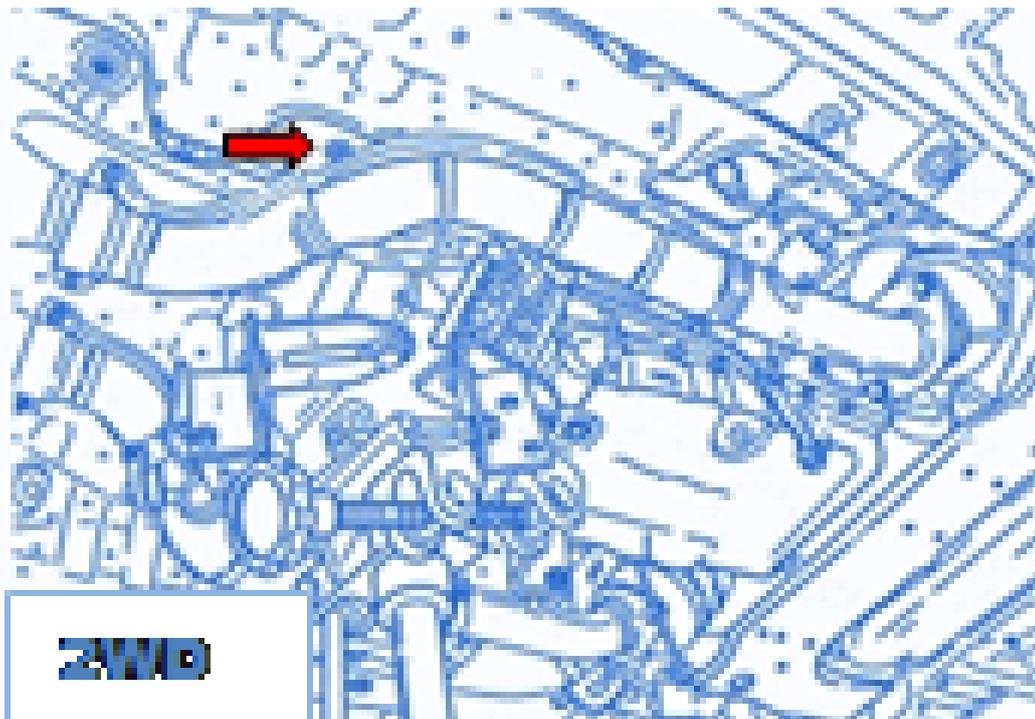
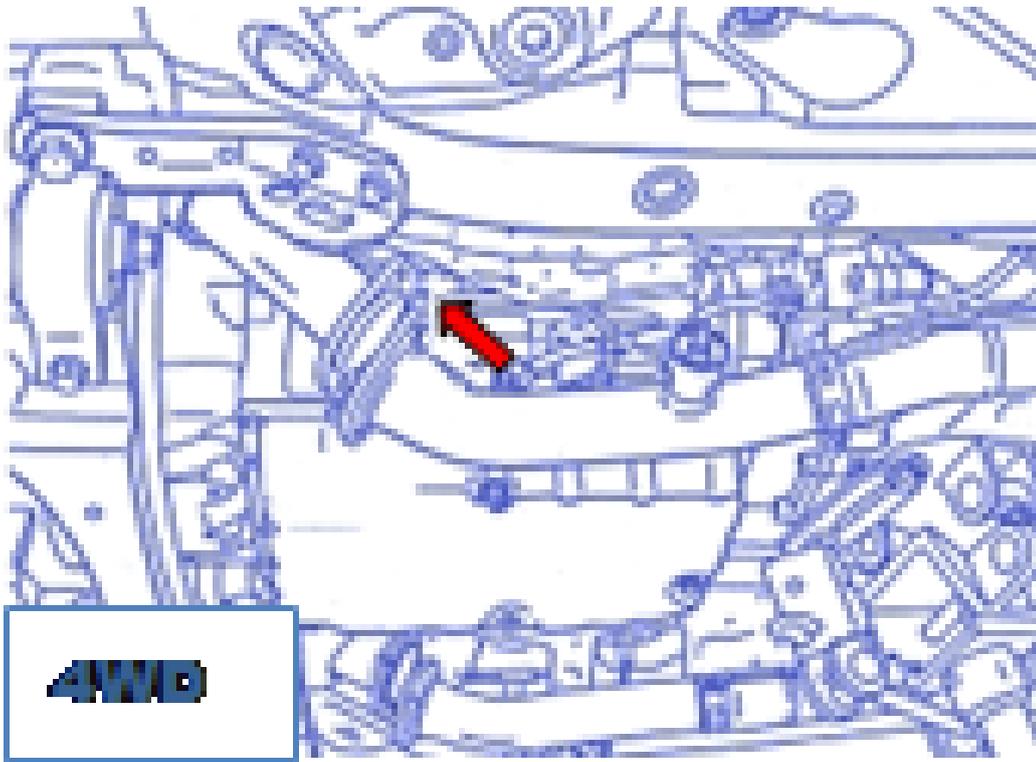
You can see the condensation drain if you stand on the transmission side and look at the vehicle undercarriage, above the transmission (see drawings).

- Lift the vehicle up using a lifting platform
- Clip out the electrical cable for the O2 sensor
- Unscrew the exhaust from each part of the Y-pipe and prop up
- Remove the transmission support and prop up the transmission
- Remove the front drive shaft (all-wheel drive only)
- Lower the transmission a few centimeters
- If necessary, remove the gear lever

You can now clean the grommet for the condensation drain using a long, blunt object or replace it with a modified version. For more information, please contact your authorized dealer.
