# Lexus IS250/IS350 - Kondensvand i kabinen | HELLA

## IS250/IS350

**Model year: 2006 - 2007**

### Condensation in interior

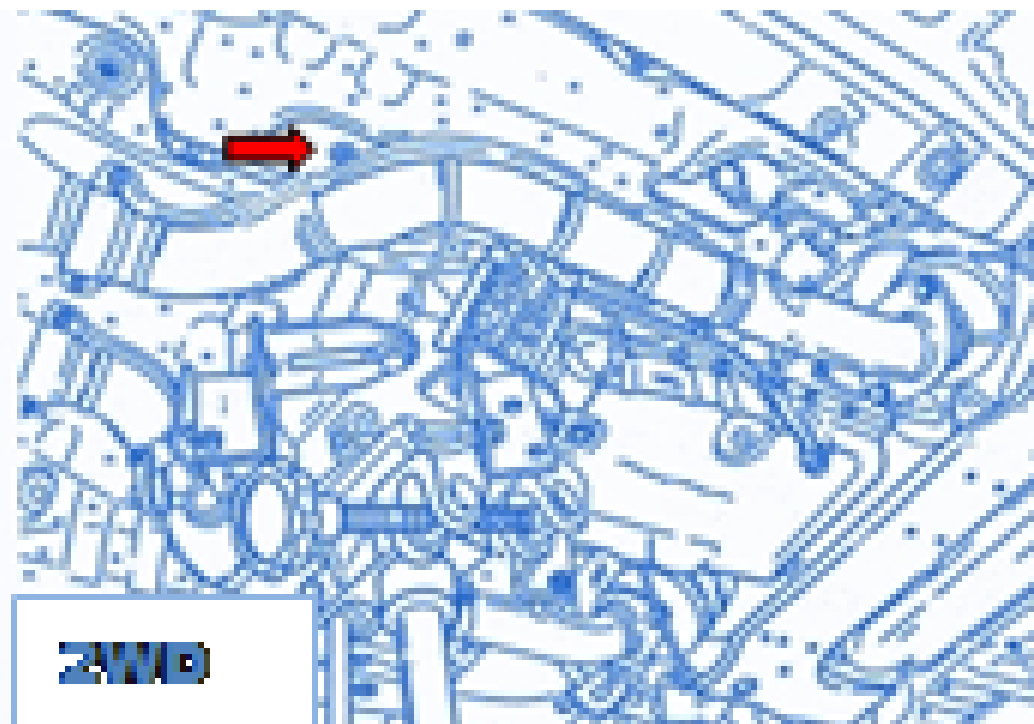
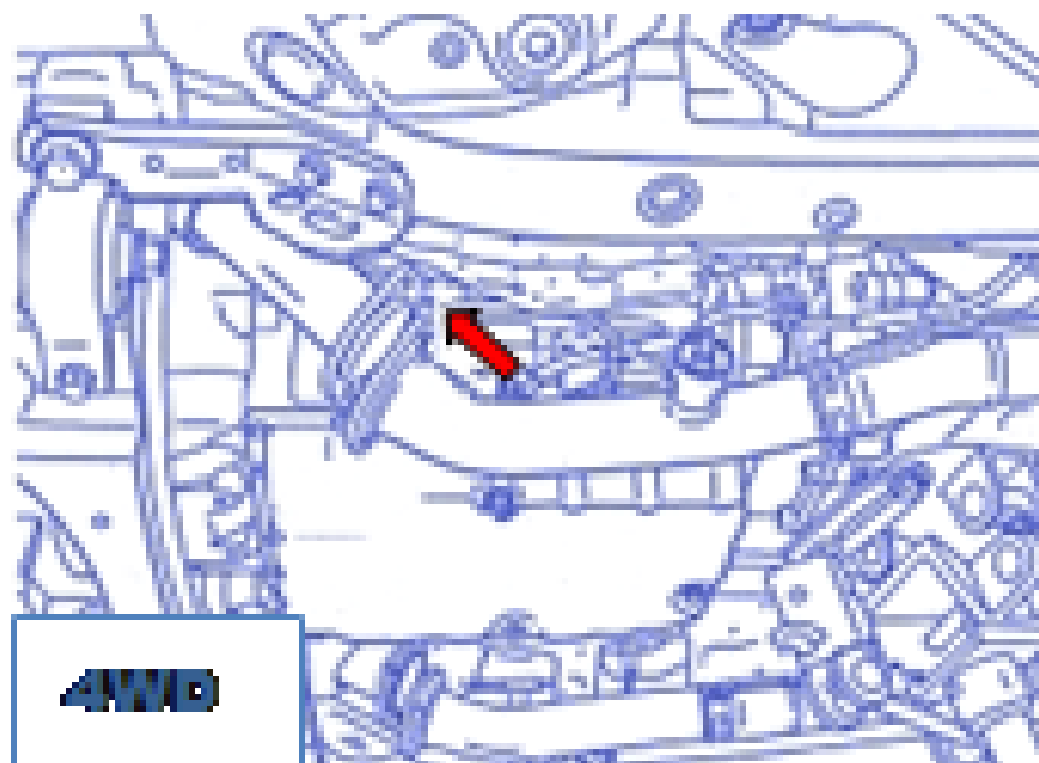
You can see the condensation drain if you stand on the transmission side and look at the vehicle undercarriage, above the transmission (see drawings).

You can now clean the grommet for the condensation drain using a long, blunt object or replace it with a modified version. For more information, please contact your authorized dealer.
