MINI R50/R53 - Svigt af kølerventilator| HELLA

R50/R53

Failure of the Radiator Fan

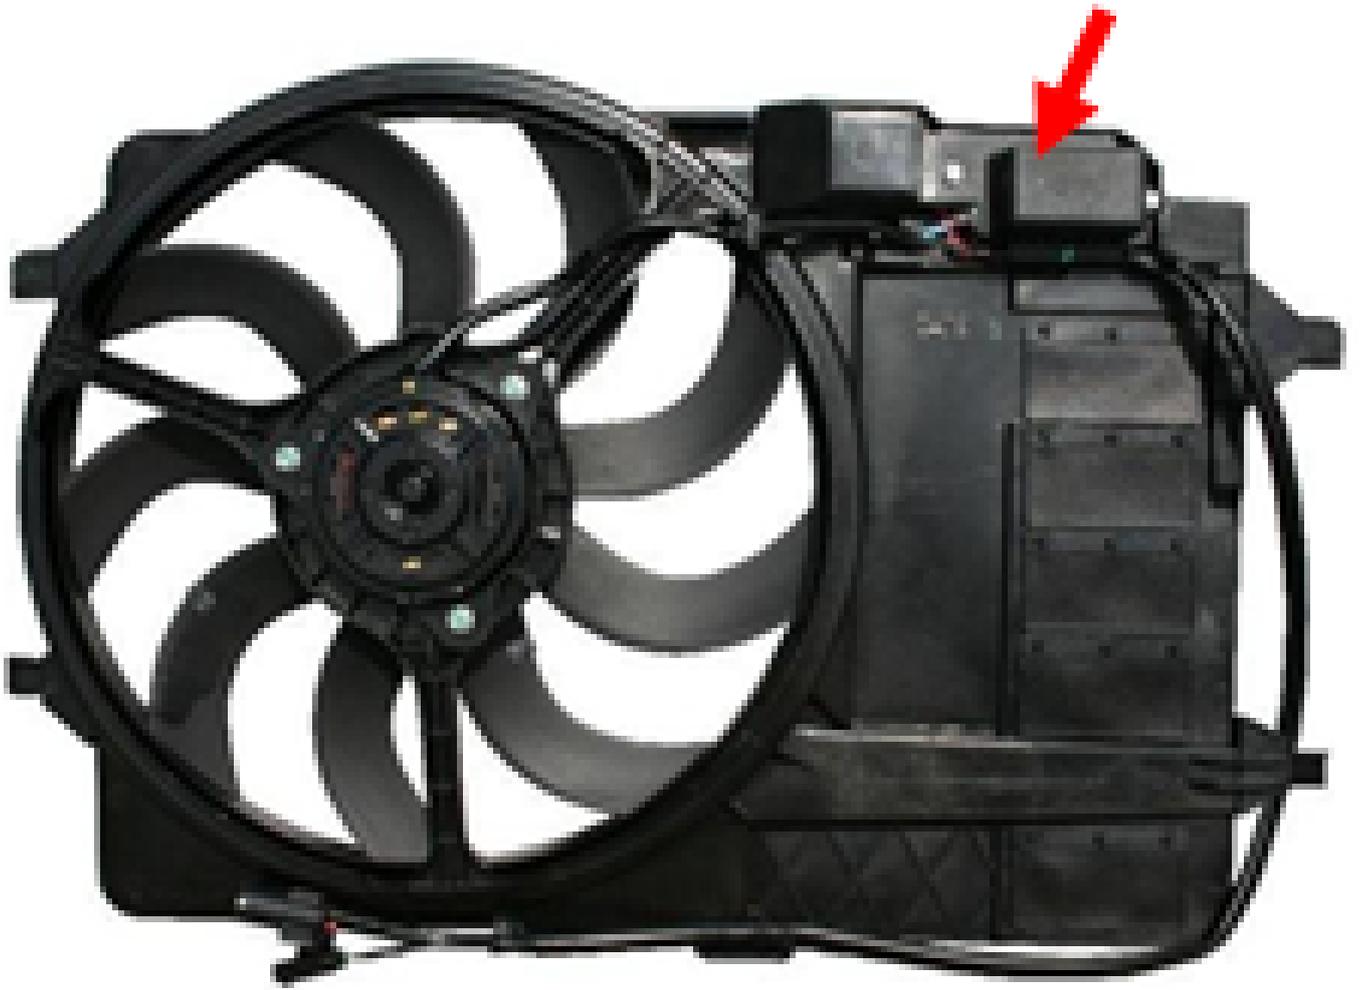
Fig. 1

The fan resistor is mounted to the fan shroud (Fig. 1). The manufacturer of the vehicle does not offer the resistor as a single spare part, but only in conjunction with the fan and shroud assembly. Independent aftermarket retailers do offer the resistor as a single spare part, however (Fig. 2).

Before installing, you should check to ensure that the fan motor is fully functional, does not have any bearing play and/or does not make any odd noises. The technical information provided by the parts supplier for the new resistor must be read and observed. To facilitate installation, we recommend that you remove the fan shroud together with the fan.
