Opel Astra H - Kondensator beskadiget og utæt | HELLA

Astra H

Model year: 2002 - 2009

Condenser damaged and leaking

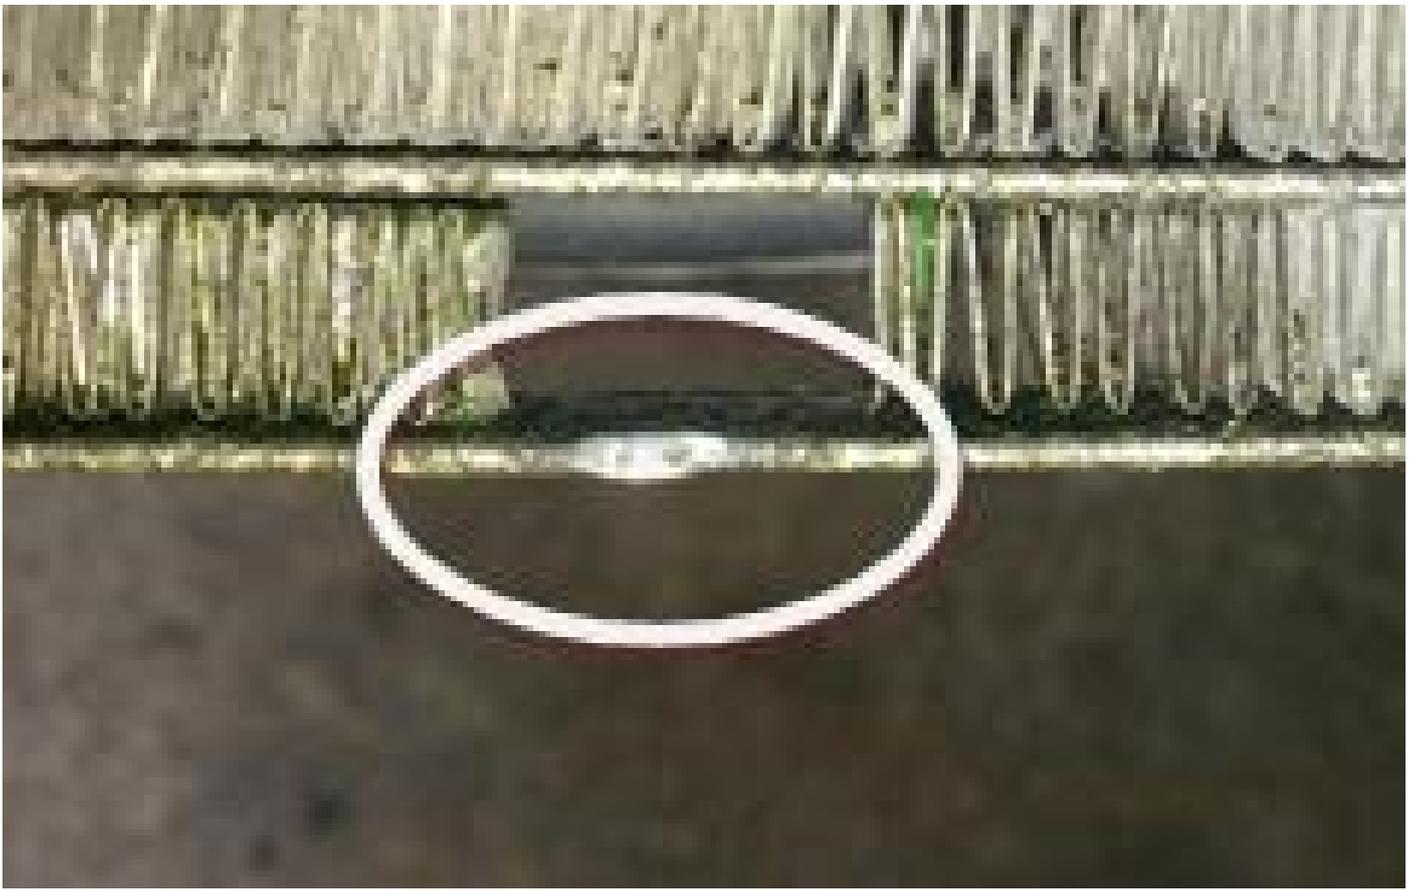
Figure 1

Failure of the fins can cause instability in the condenser network. Vibrations can cause contact with other components. This will damage the condenser (Figure 1) and, in some cases, cause it to leak.

If refrigerant loss is observed on one of the vehicles listed above, special attention should be paid to the condenser.

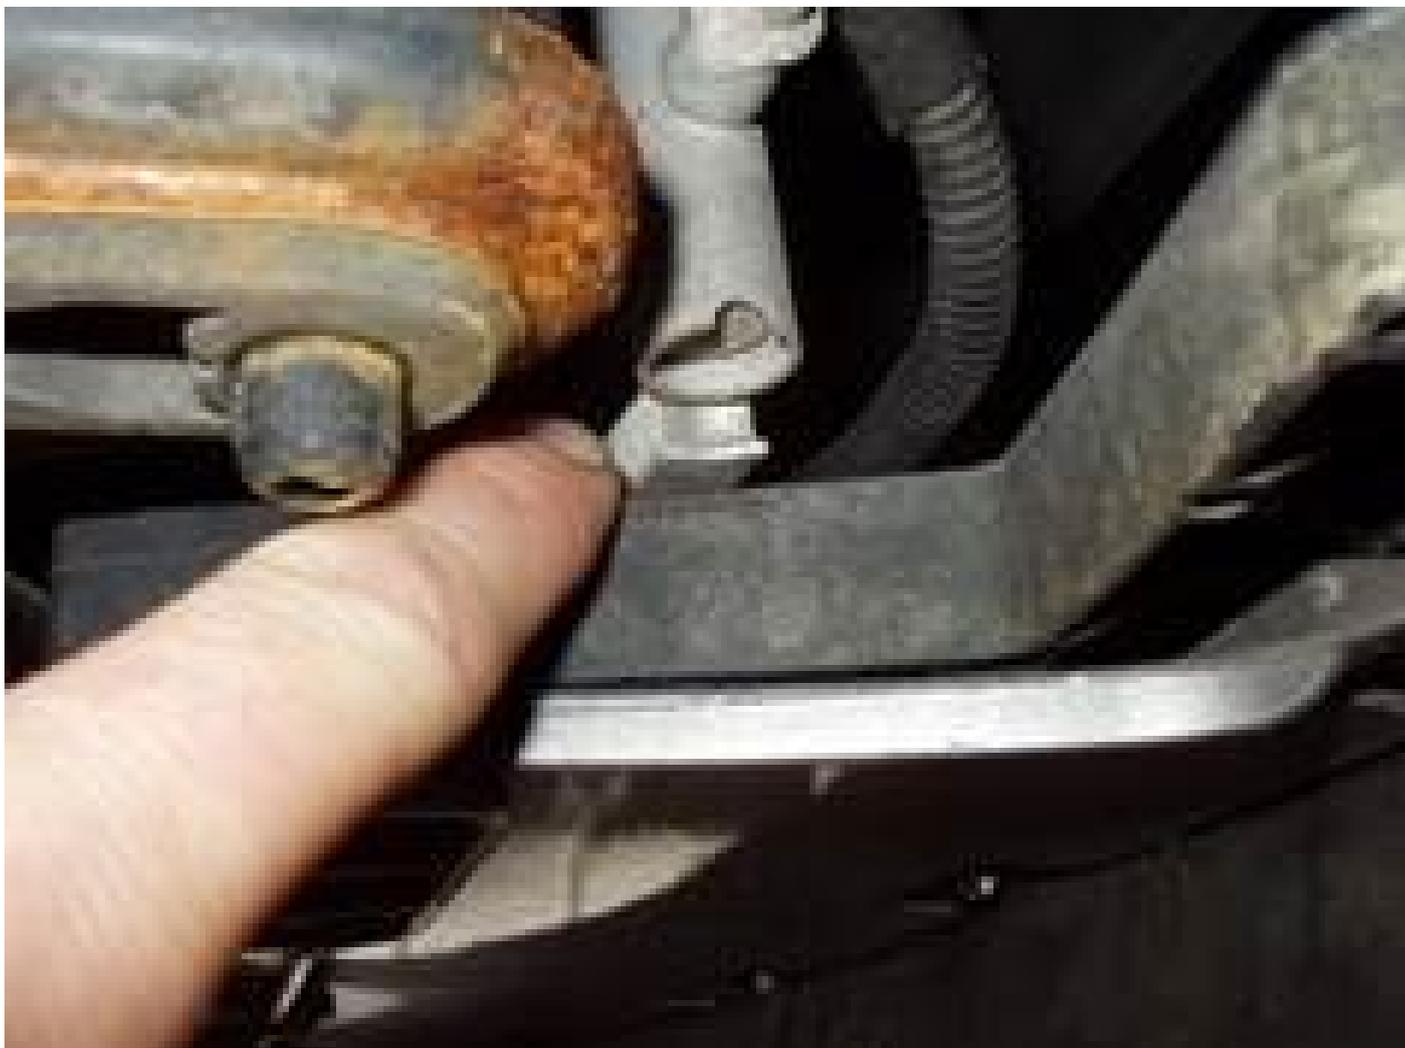
Figure 2

The condenser may also come loose from its holder and drop onto the beam (Figure 2). This can also cause leaks.
