Opel Astra J - Airbag-kontrollampen lyser | HELLA

Astra J

Airbag indicator lamp lights up

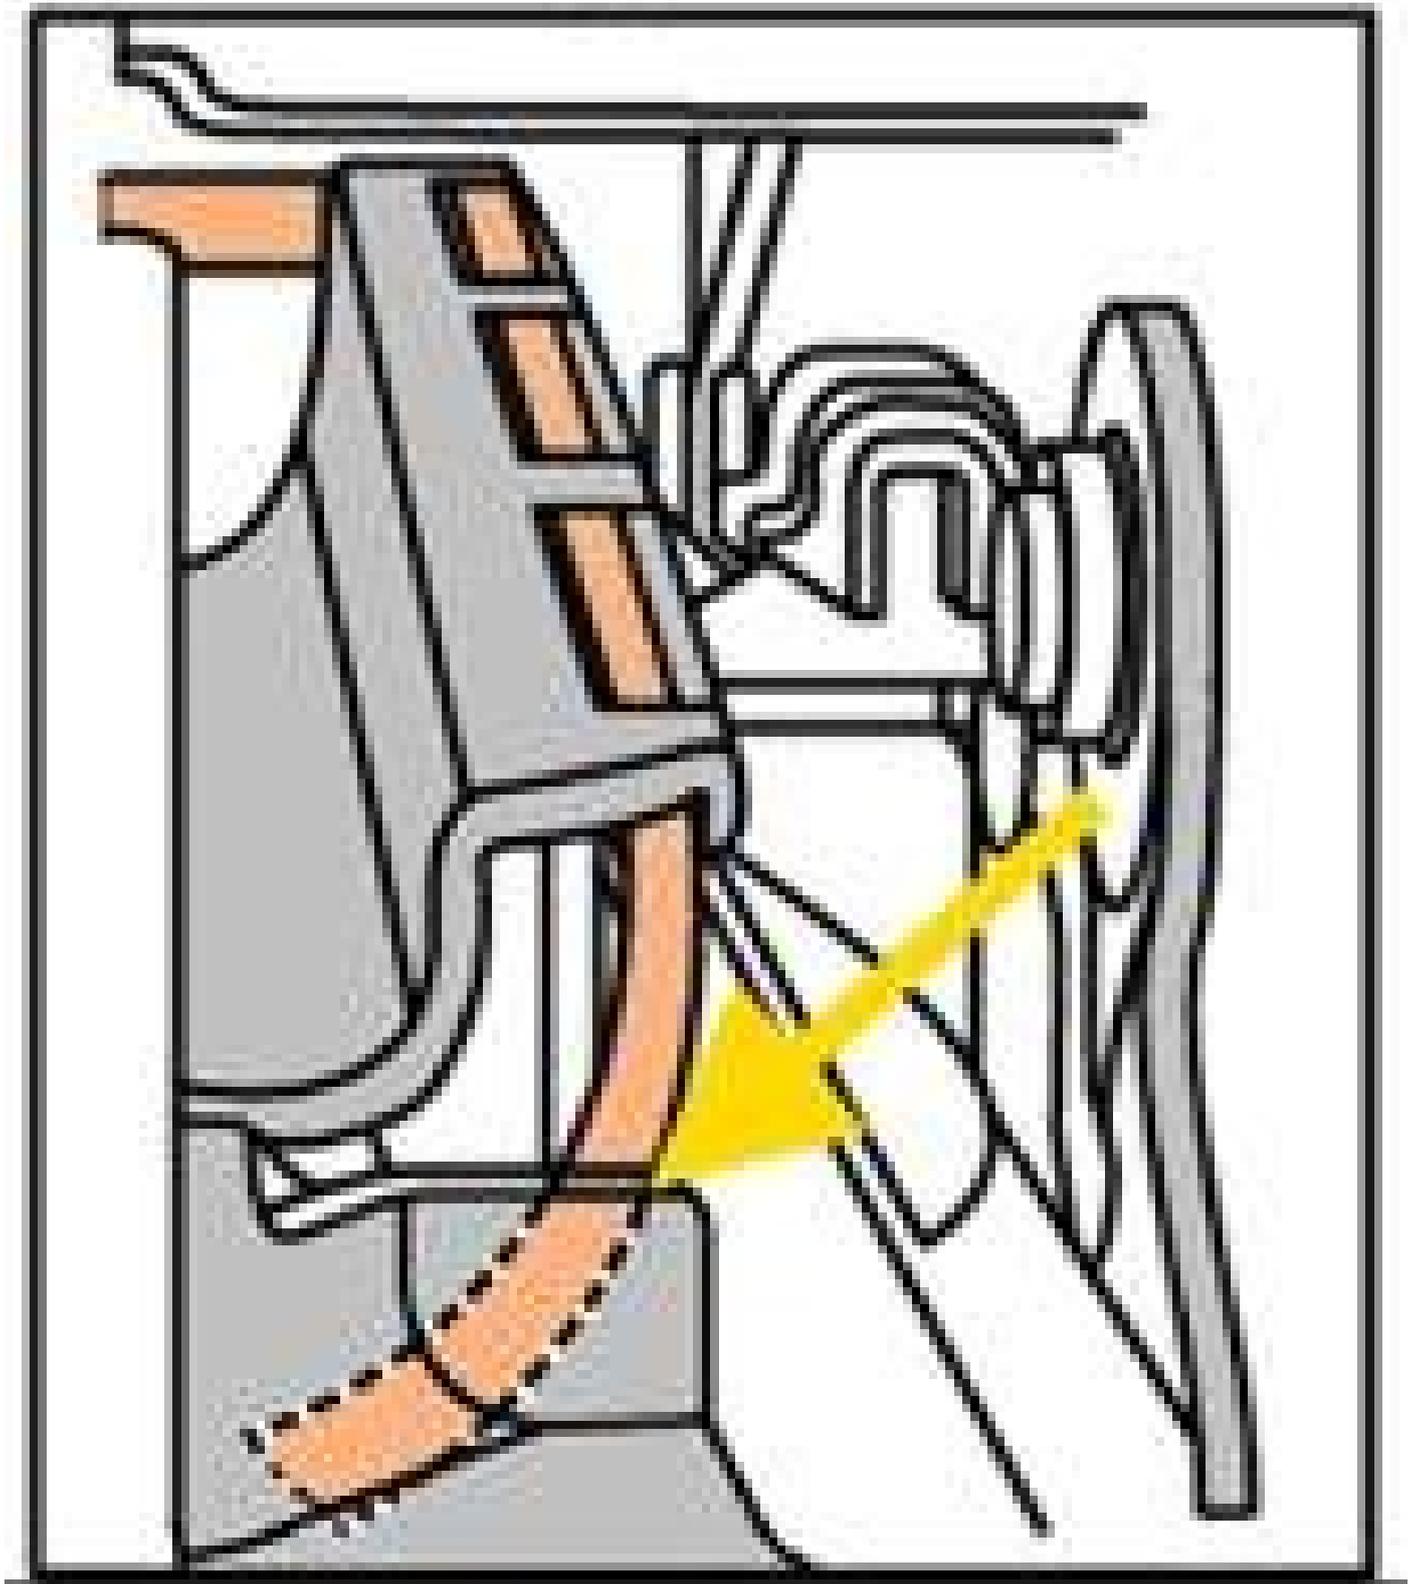
Figure 1

A possible cause could be a damaged cable strand in the airbag system (in the area of the rail system of the front seat adjustment).

If a cable strand is laid incorrectly (marked in figure 1), it may be damaged.

- Replacing the belt tensioner unit
- Re-installation and fastening of the cable strand

(make sure the cable strand is correctly installed)
