# Opel Insignia - Sæde - højdeindstilling defekt | HELLA

## Insignia

**Model year: 2009**

### Height adjustment system for seating defective

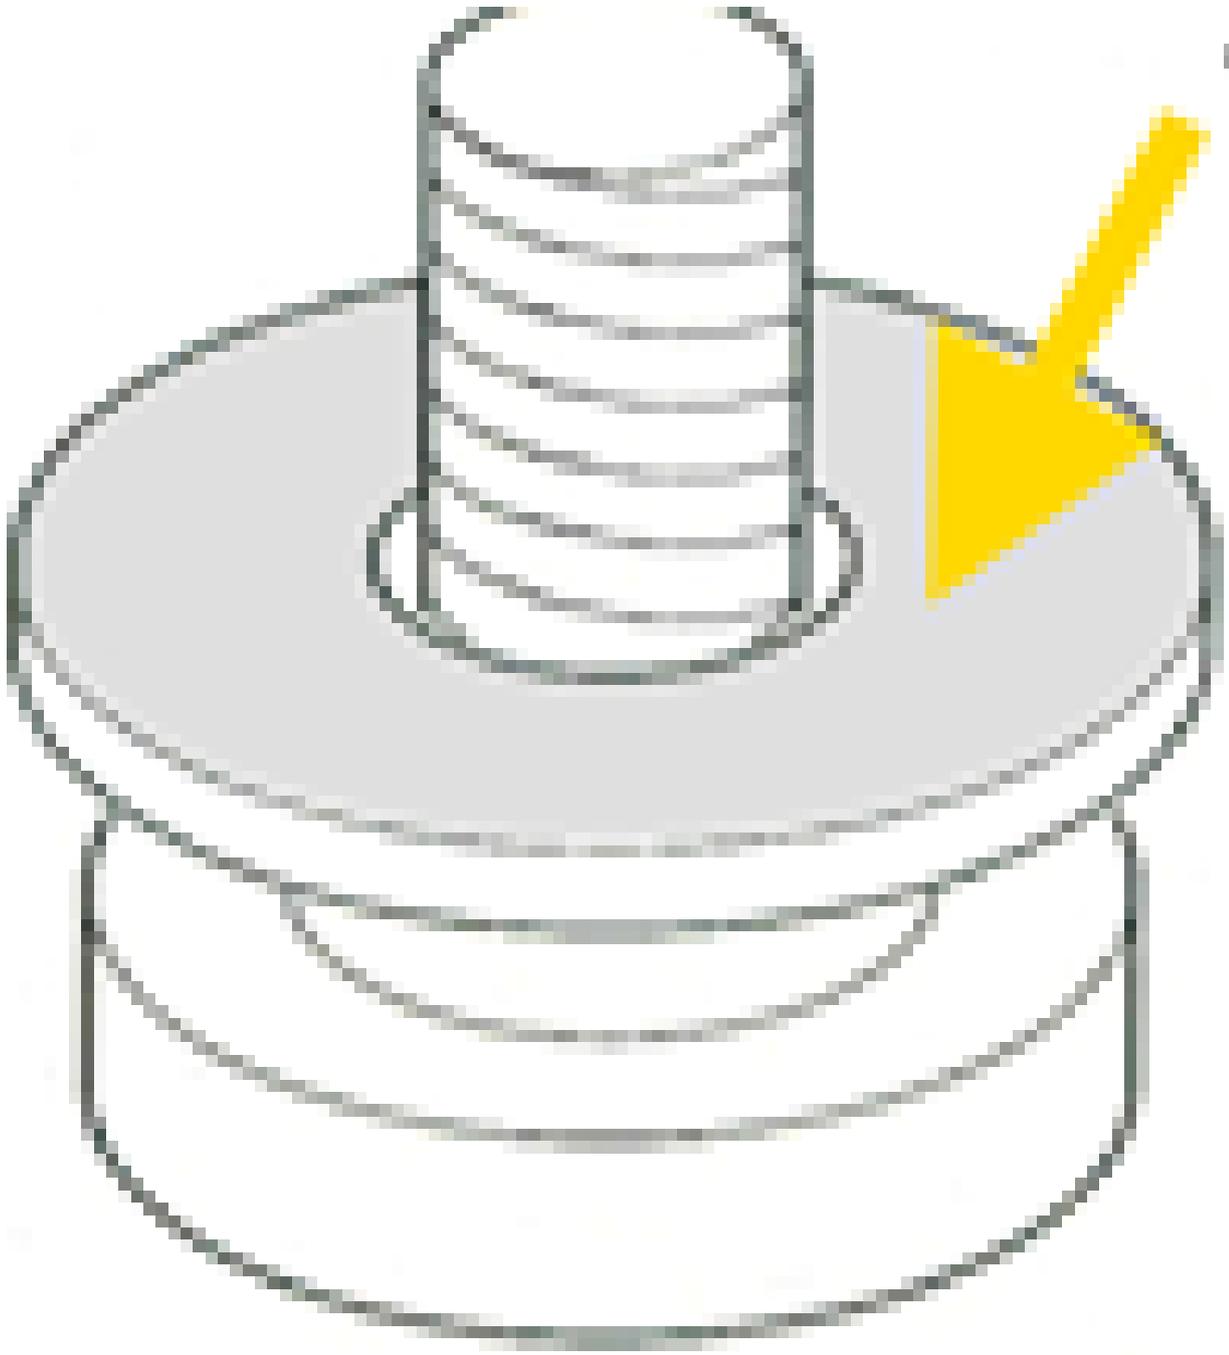
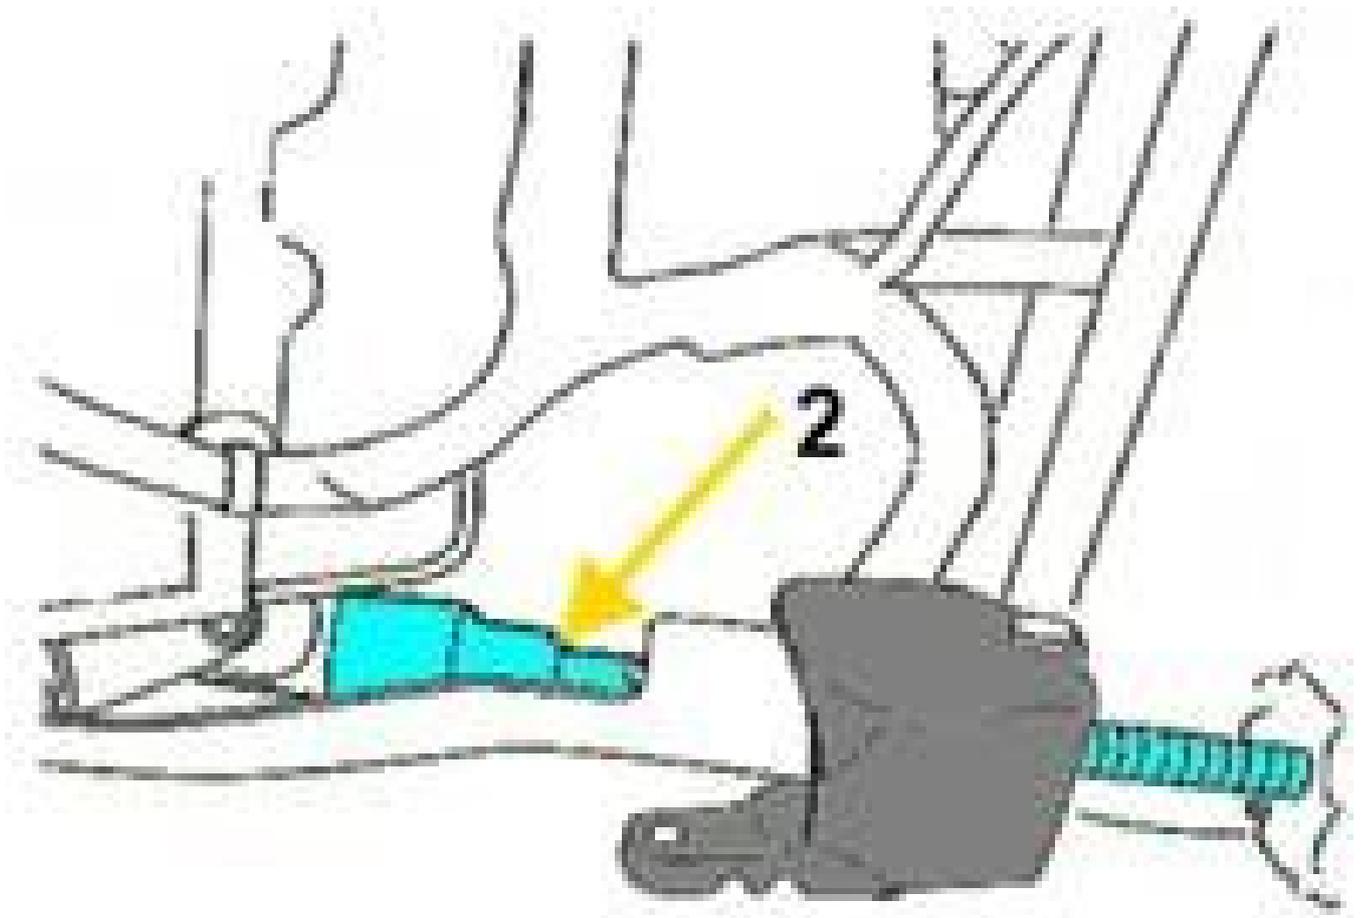
1

If the height adjustment system for the seating in the vehicle mentioned above no longer functions, it can be the fault of a blocked adjustment spindle.

The motor responsible for the adjusting of the seat height can jam between the spindle and the plastic stopper.

The problem can be solved with the help of an additional washer (1).

- Dismantle seat
- Loosen screw (2) and dismount
- Place washer (1) with the measurements 6.4 x 18 x 1.6 in position (OE No. 11035613)
- Lubricate with special grease (OE No. 13329237)
- Replace screw (2) and tighten with 10 Nm torque
- Remount seat
