Peugeot 407 - Pollenfilter tilstoppet | HELLA

407

Pollen filter clogged.

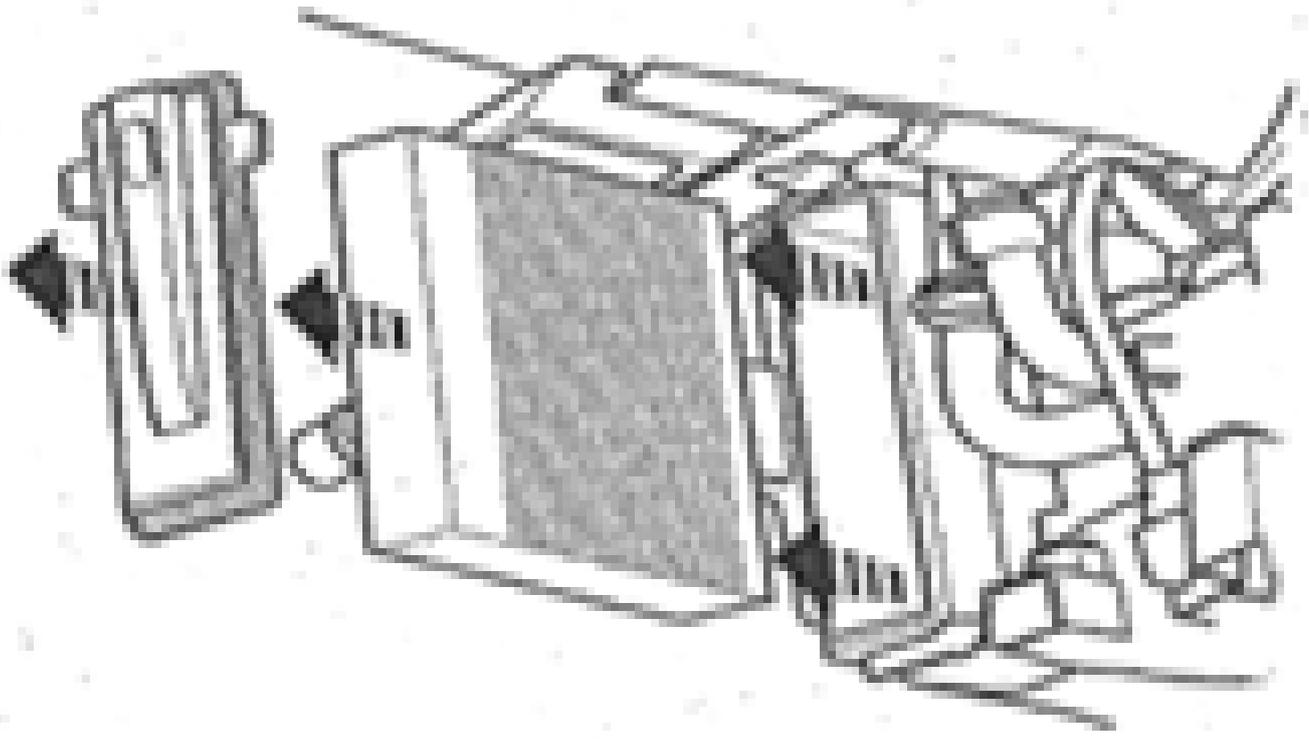
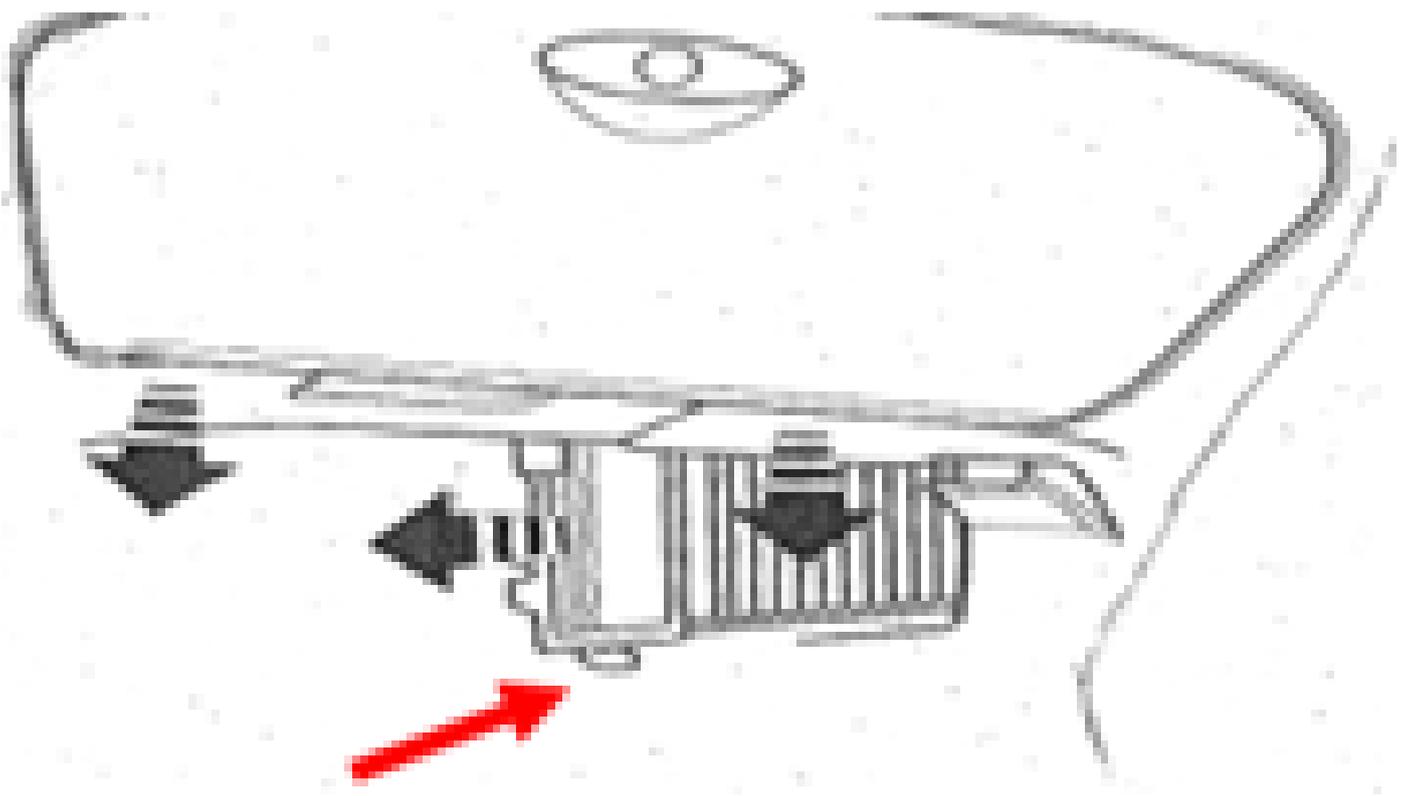
Reduced air flow into the interior of the vehicle.

If, on the above mentioned vehicles, there are complaints about a degradation in the function of the heater blower motor or air-conditioning blower motor and a reduced air flow is also apparent in the vehicle interior, the pollen filter is a possible cause of the problem.

Even though the vehicle may not have covered 10000 km since the last time the pollen filter was replaced, it still might be clogged again.

The figures show the “right-hand drive” design in the area of the passenger's footwell.

As a rectification measure fit the modified pollen filter.

One – pollen filter: (service part no.) ET no. 647904.
