# Skoda Fabia II - fejlfunktion; sideblinklys| HELLA

## Skoda Fabia II

Model year: 2007 - 2014

### Functional failure; side direction indicator

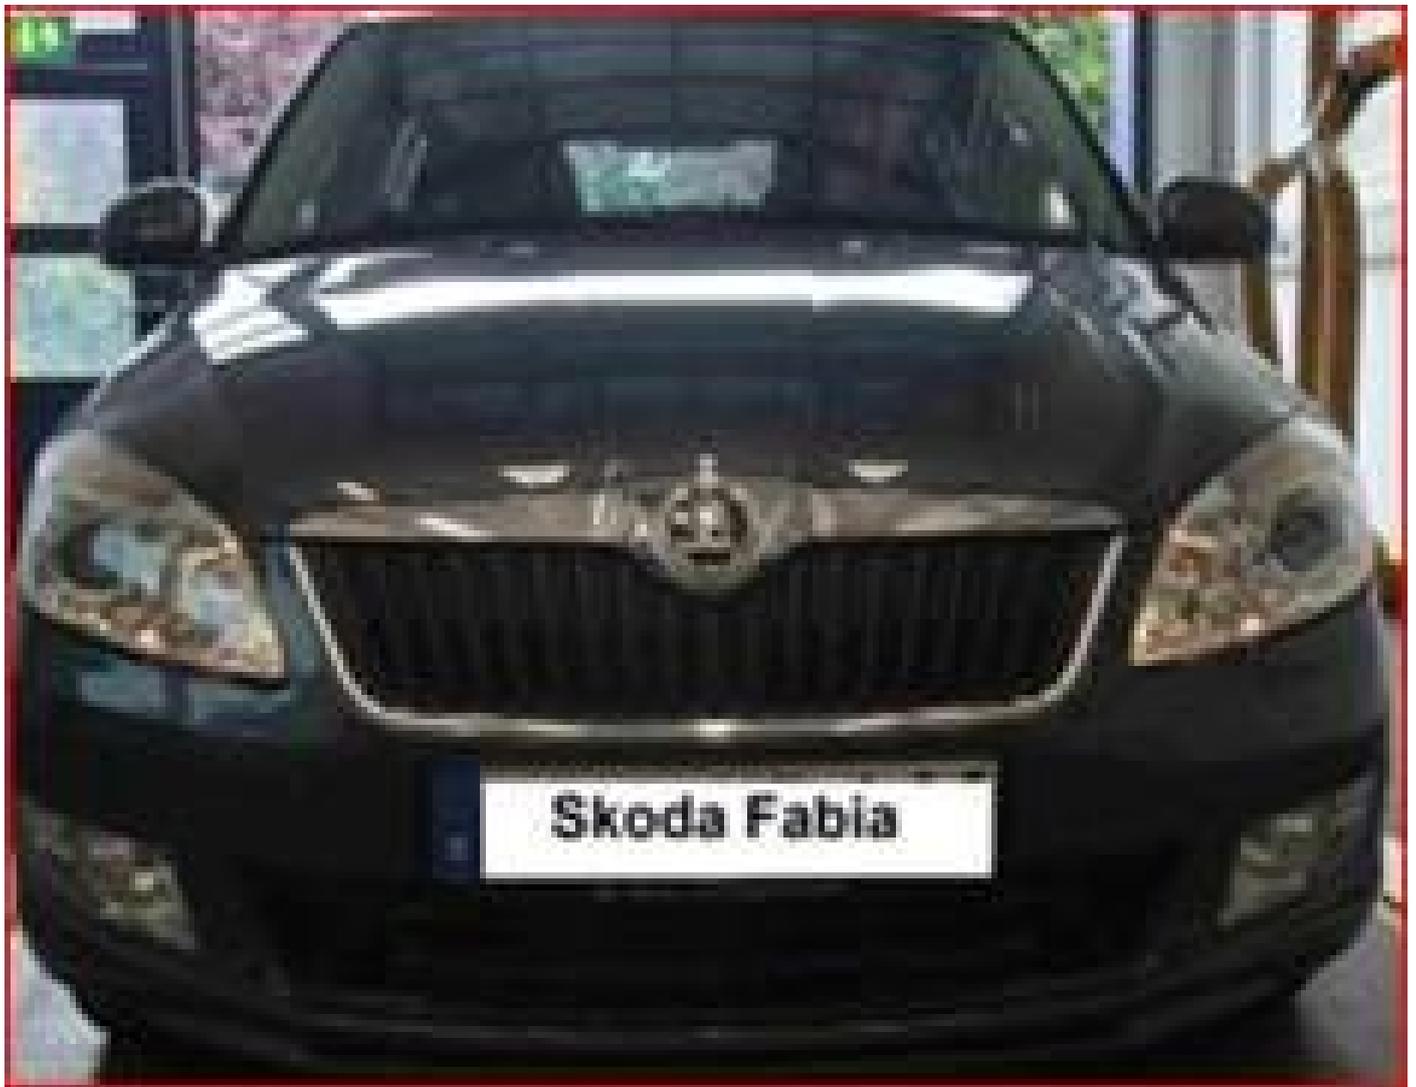
Fig. 1

If the above-mentioned vehicle (Fig.1) is found to have a malfunctioning side direction indicator (Fig.2), this may be caused by a defective connection cable.

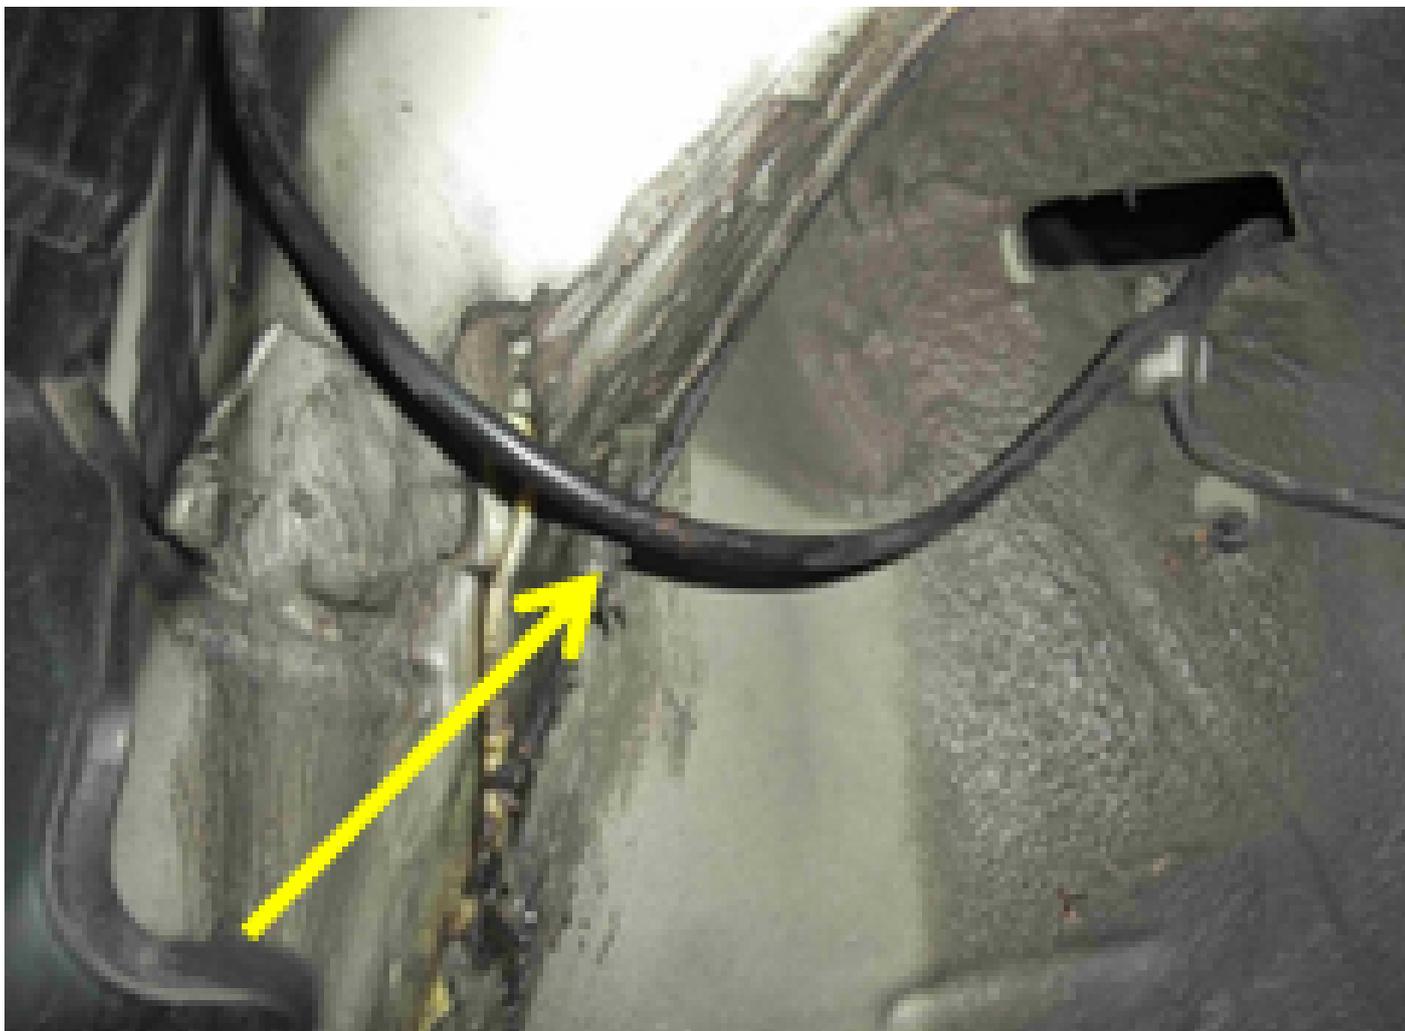
Fig. 3

If cables are not laid correctly (Fig.3), the connecting cable and insulation can wear through while the vehicle is being driven as a result of vibrations, shocks, etc. against sharp edges of the body or on sharp folded edges.

This can even lead to cable breakage/short circuit.

- For fault analysis, disassemble the wheel and the wheelhouse covering. Repair and return the defective cable to full working order. Then ensure that the cables are laid correctly (edge protection).
- Check fuses and replace if necessary.

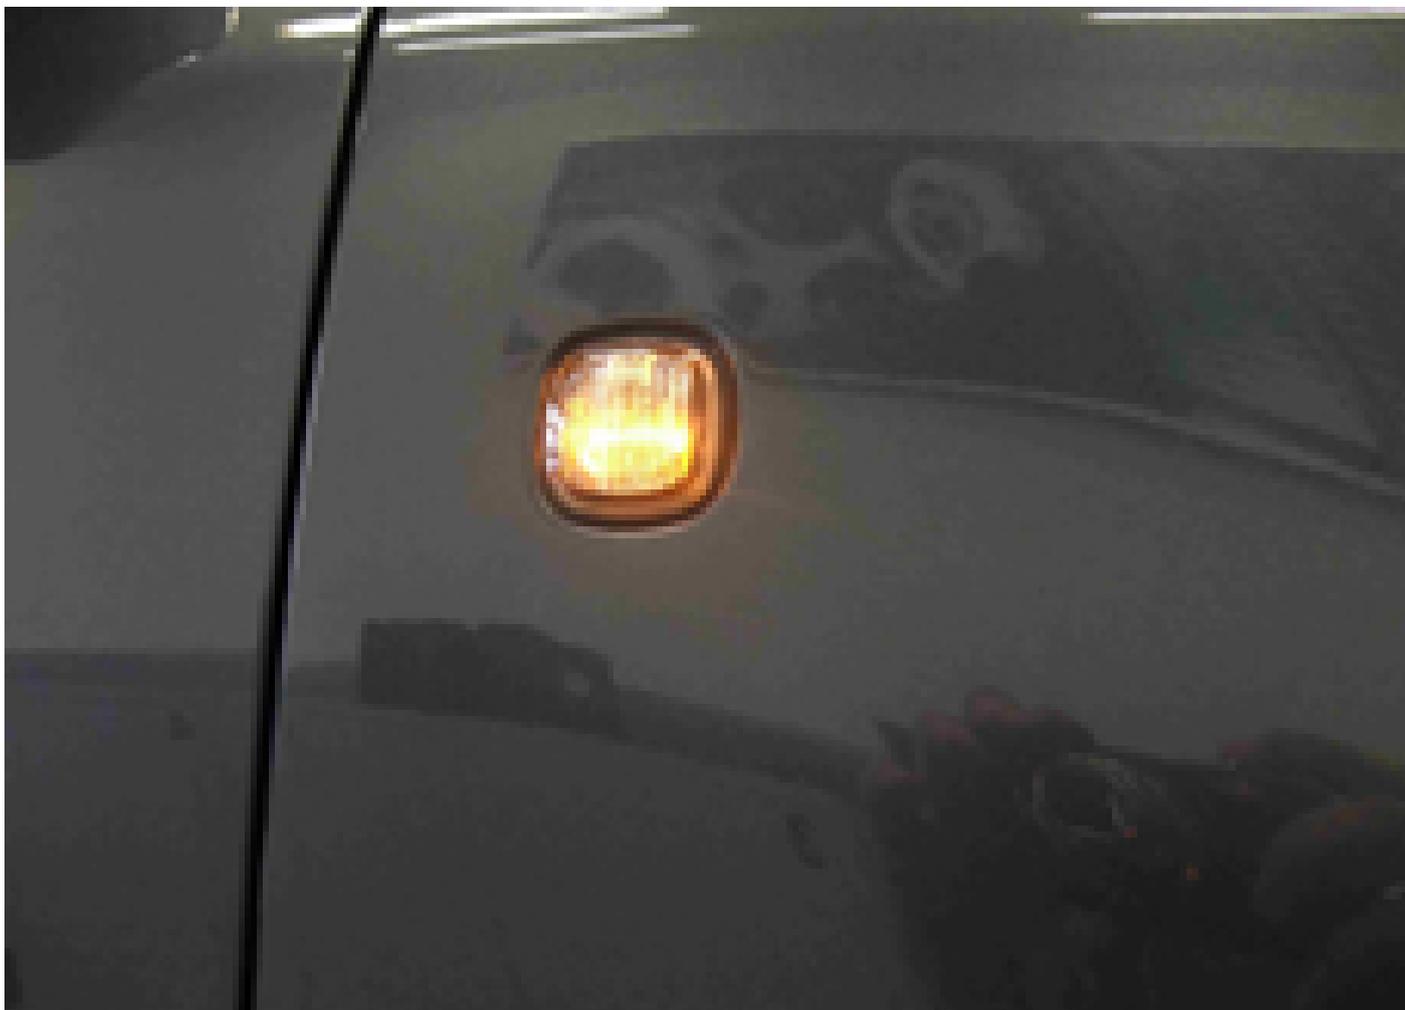
Carry out functional test (Fig.4)

Carry out functional test (Fig. 4).

Reassemble parts in reverse order.
