Toyota Auris, Corolla - Klaprende lyde fra forhjulsbremserne| HELLA

Auris, Corolla

All models with 15-inch front wheel brake

Rattling noises at the front axle wheel brake

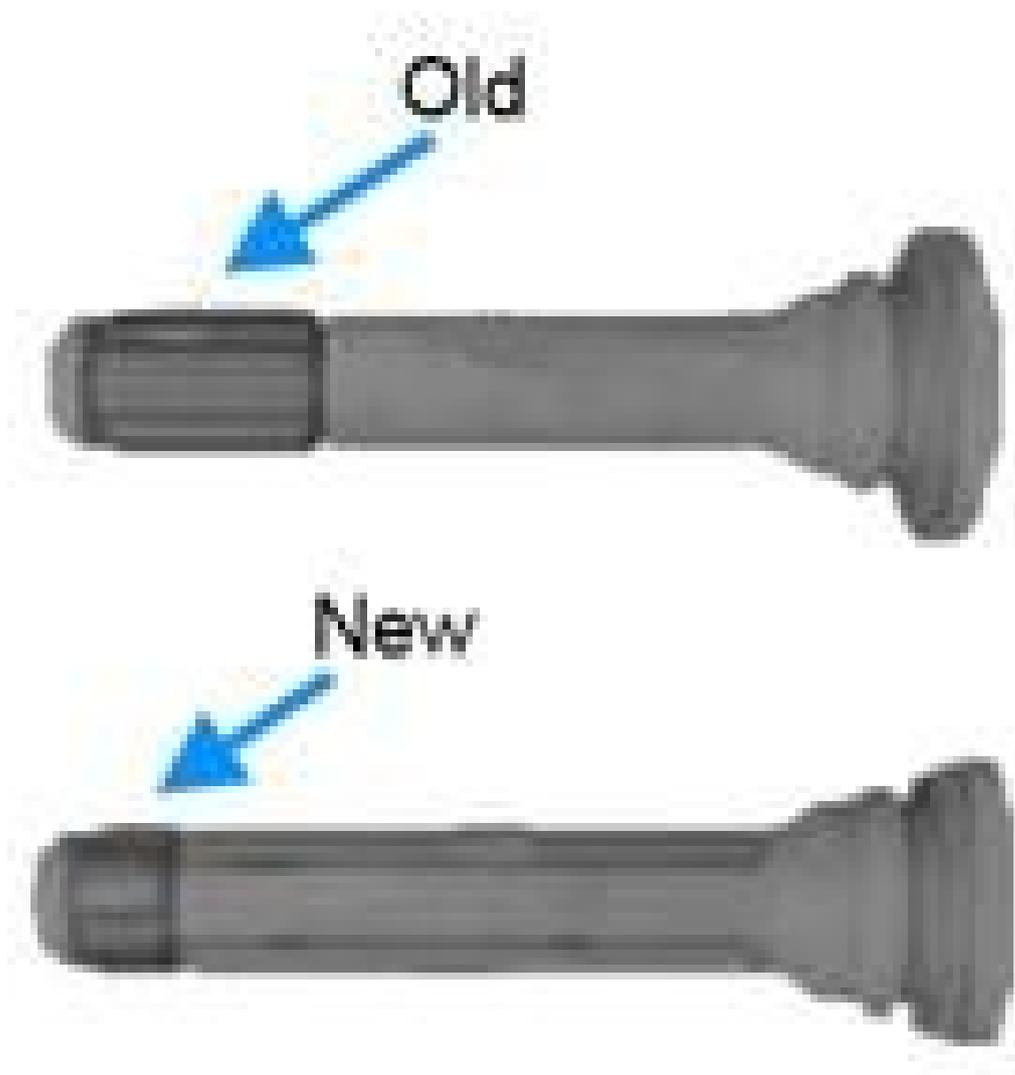
The retrofit can be identified from the modified guide bolts with bush. (Image)

Carry out a visual inspection. Check front axle brake system for damage, proper function, excessive dirt or wear. If necessary, partially disassemble the wheel brake for further inspection. If no defects can be diagnosed, check the brake calliper carriers and, if necessary, replace them with the modified parts sets.

- Brake calliper carrier 47721-09560
