VW T5 - kølemiddeltermostat

Datablad	
Producent	Volkswagen
Model	Transporter T5
Motor	1,9 TDI
Årgang	2006 - 2009
Symptom	Kølevæsketermostat

Driftstemperaturen er ikke nået Termostat og kølevæskeflange

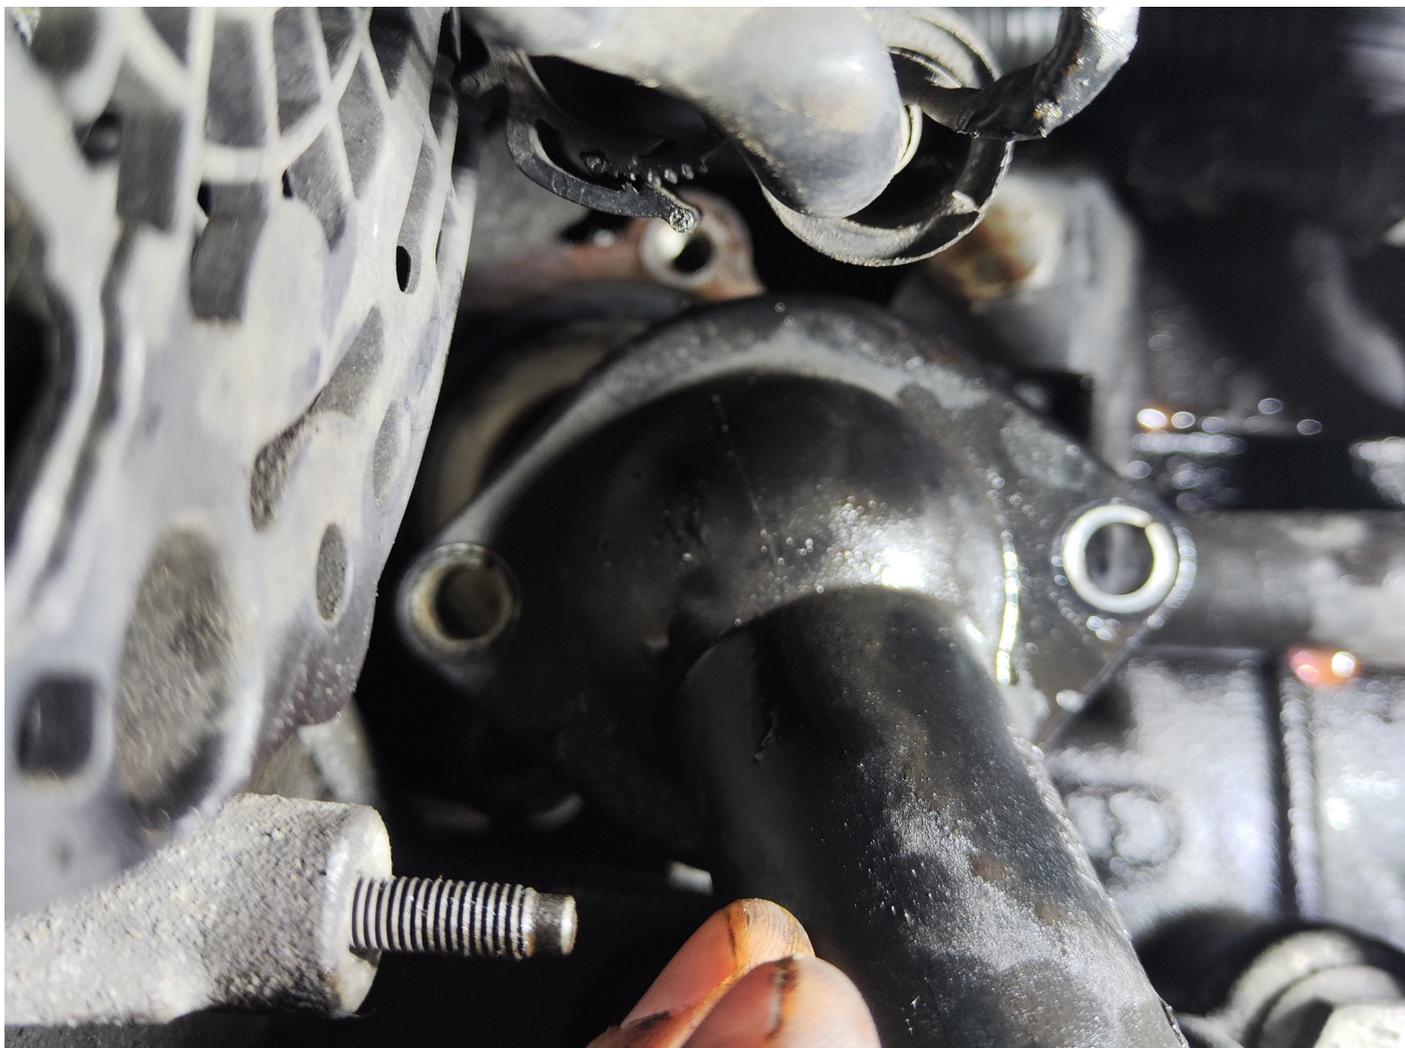
Kølevæskeflange T5

I de ovennævnte modeller kan det ske, at driftstemperaturen ikke nås. Nogle gange viser temperaturdisplayet i kombiinstrumentet en "kold motor".br/>> Årsagen findes ofte i termostaten, som ikke lukker ordentligt.br/>> Termostaten sidder på motorblokken bag generatoren.br/>> Når kølevæskeflangen er fjernet, kan termostaten fjernes sammen med tætningsringen.br/>> Før den nye termostat monteres, skal kølevæskeflangen kontrolleres.br/>> Ofte brækker en del af plastføringen (monteringshjælp) af her.br/>> Så er det en god idé at udskifte flangen.

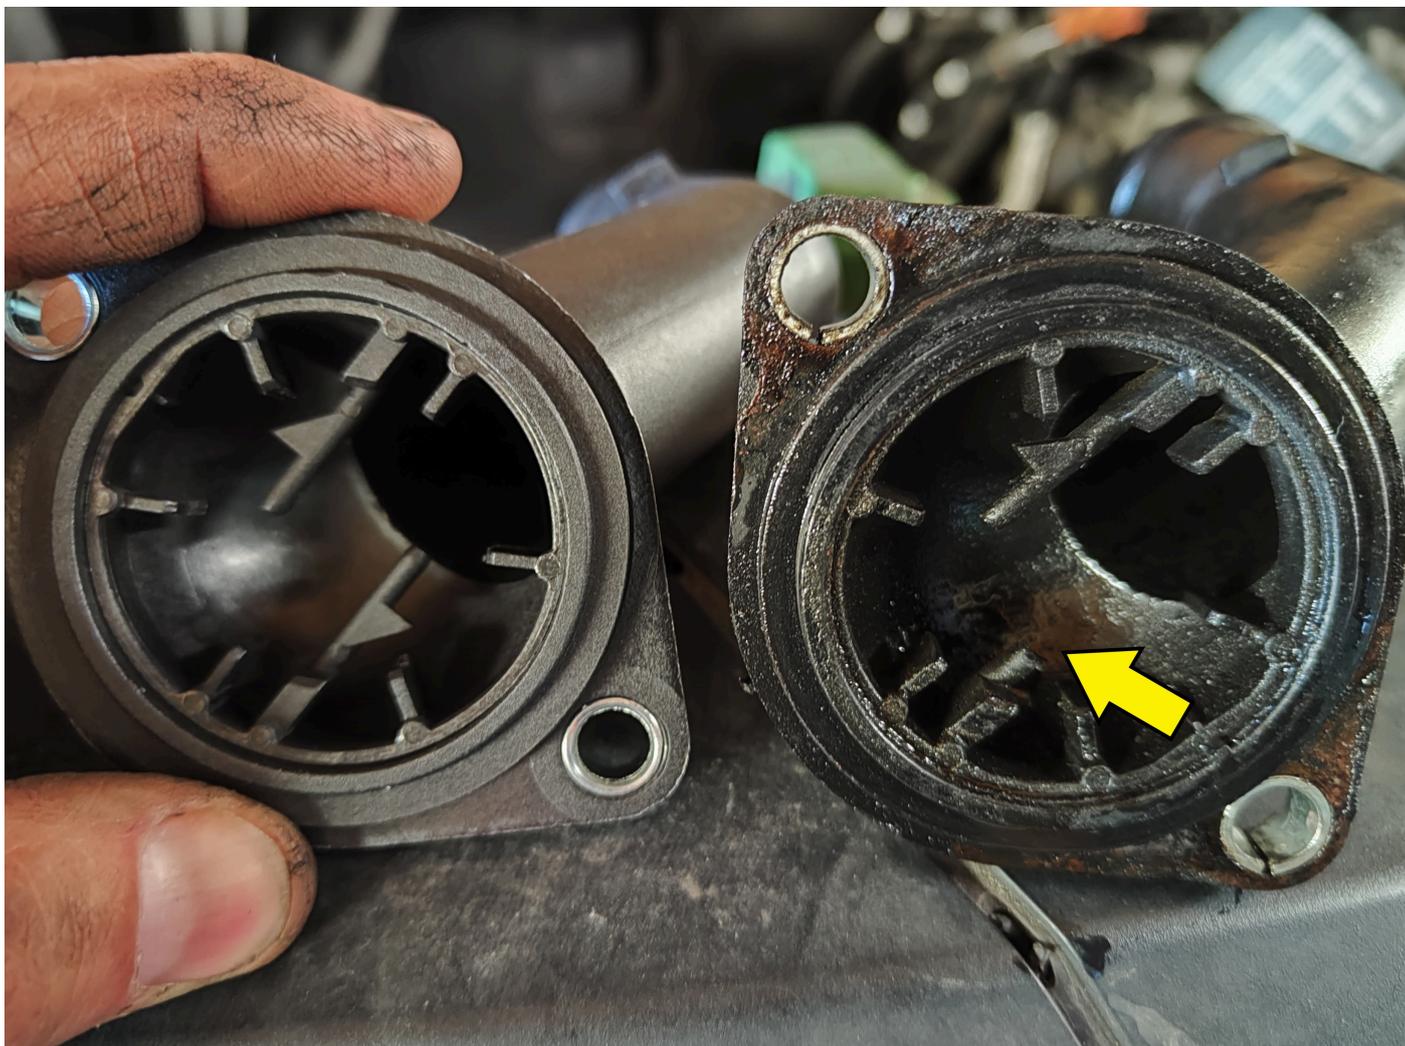
Plastføring T5 kølevæskeflange
