Kontrol af hjulnavets sidekast | HELLA

Testing the wheel hub

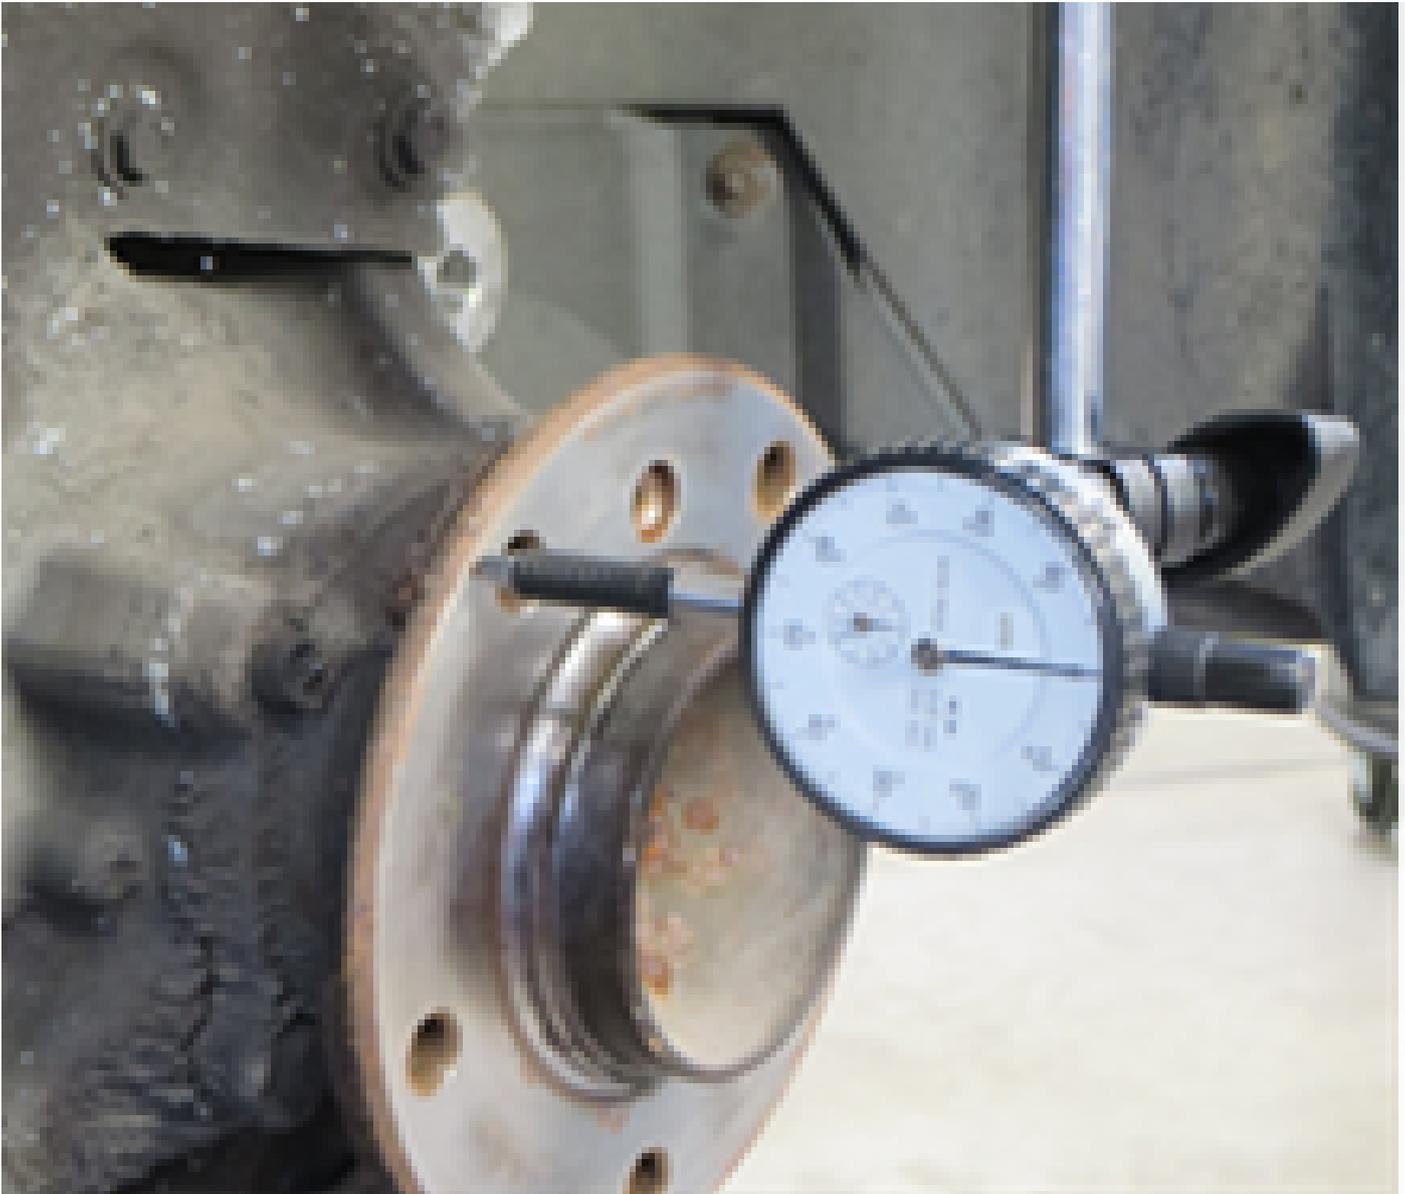
1. Fasten the dial gage with holder to the suspension strut
2. Align the dial gage at the outer edge of the wheel hub
3. Turn the wheel hub slowly and at a constant speed in the direction of travel

4. Read off the measured values

Measured over several wheel revolutions, deviations should not exceed 0.03mm. If the deviations are greater, the hub should be replaced.

- This test should be carried out before mounting the new brake discs
- Unevenness on the contact face of the wheel hub can lead to warping of the brake disc and therefore axial runout.
- Any hub runout present will cause twice the disc runout at the outer edge of the brake disc
