# BMW 530d GT F07 - driving dynamics control failure

## Communication fault in the driving dynamics control unit

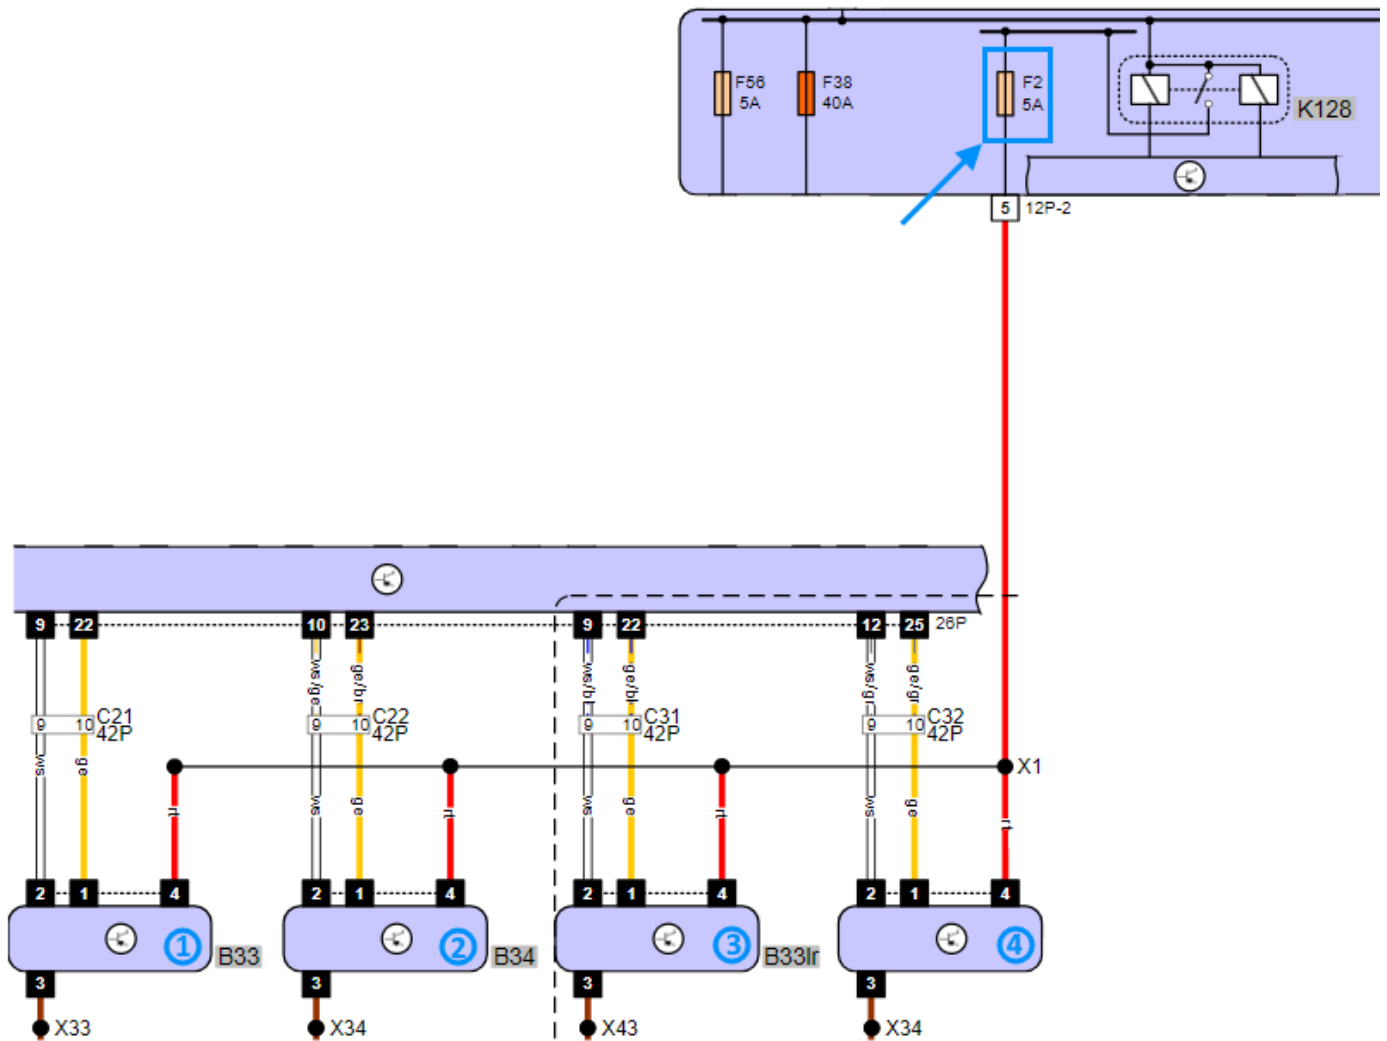
Caption of circuit diagram: 1-4 = Door handle electronics

Water ingress into the door handle and the resulting corrosion on the plug connections can cause short circuits. This triggers fuse F2 (5A). To check, the door handles must be dismantled in accordance with the manufacturer's instructions.

If corrosion or water ingress is visible at the plug connections, the affected door handle electronics must be replaced and the plug connections repaired if necessary.
