## BMW X3 G01 - check engine lamp comes on

| Vehicle model | X3 G01 |
| Symptoms | Check engine lamp comes on |

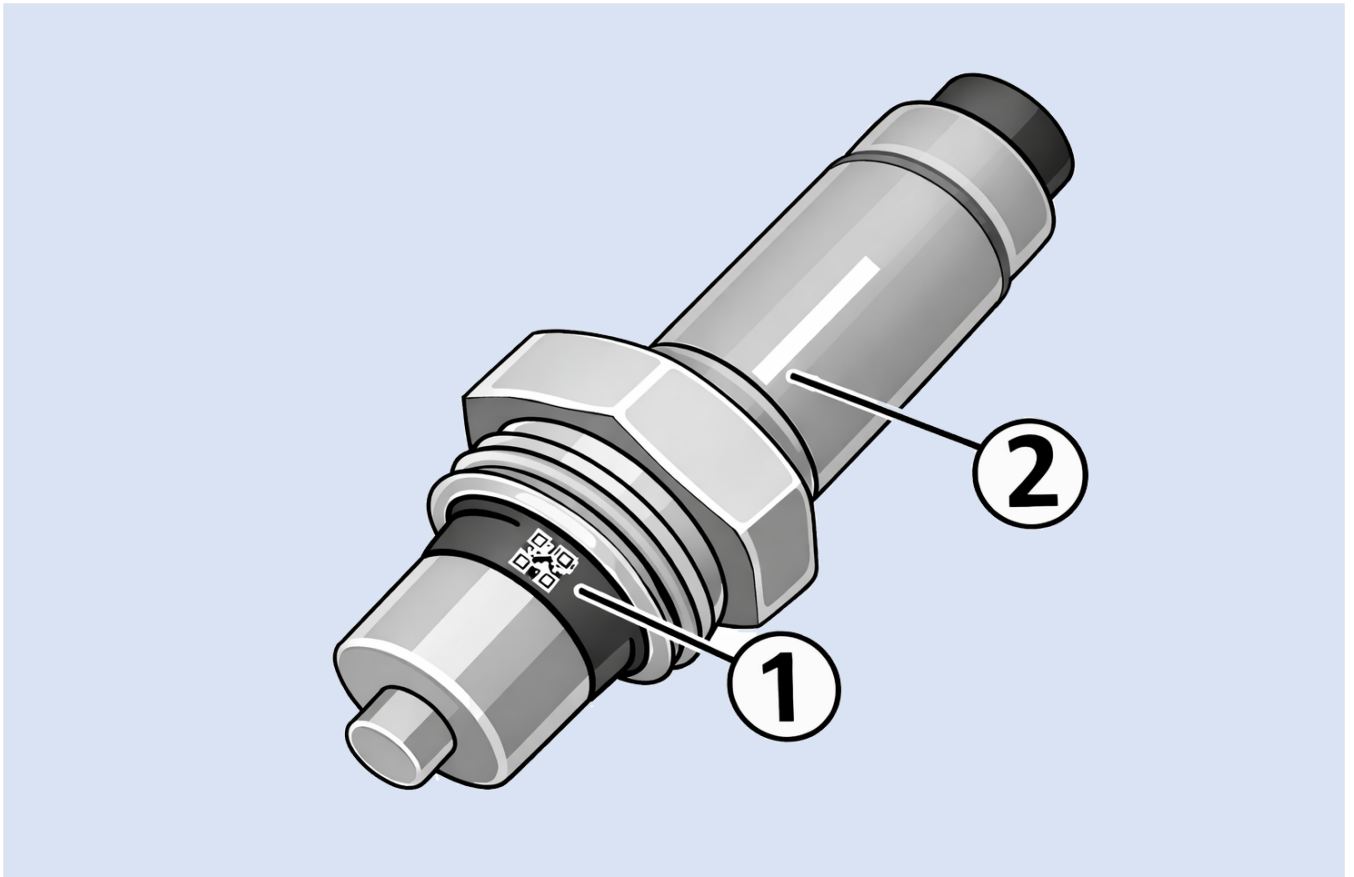
An example illustration of a diesel particulate sensor.

On models marked appropriately, the marking (2) or the QR code (1) is used to ensure correct alignment in accordance with the vehicle manufacturer's specifications

If the diesel particulate sensor needs to be replaced, it is essential to ensure that it is installed in the correct position. For models identified appropriately, the marking or QR code on the sensor housing must face downwards (see illustration). Incorrect installation may result in the sensor
