# Fendt Favorit 500 - High/low pressure connections of the air conditioning system

| Vehicle model | Favorit 500 (509C - 515C) |
| Symptoms | High/low pressure connection of the air conditioning system |

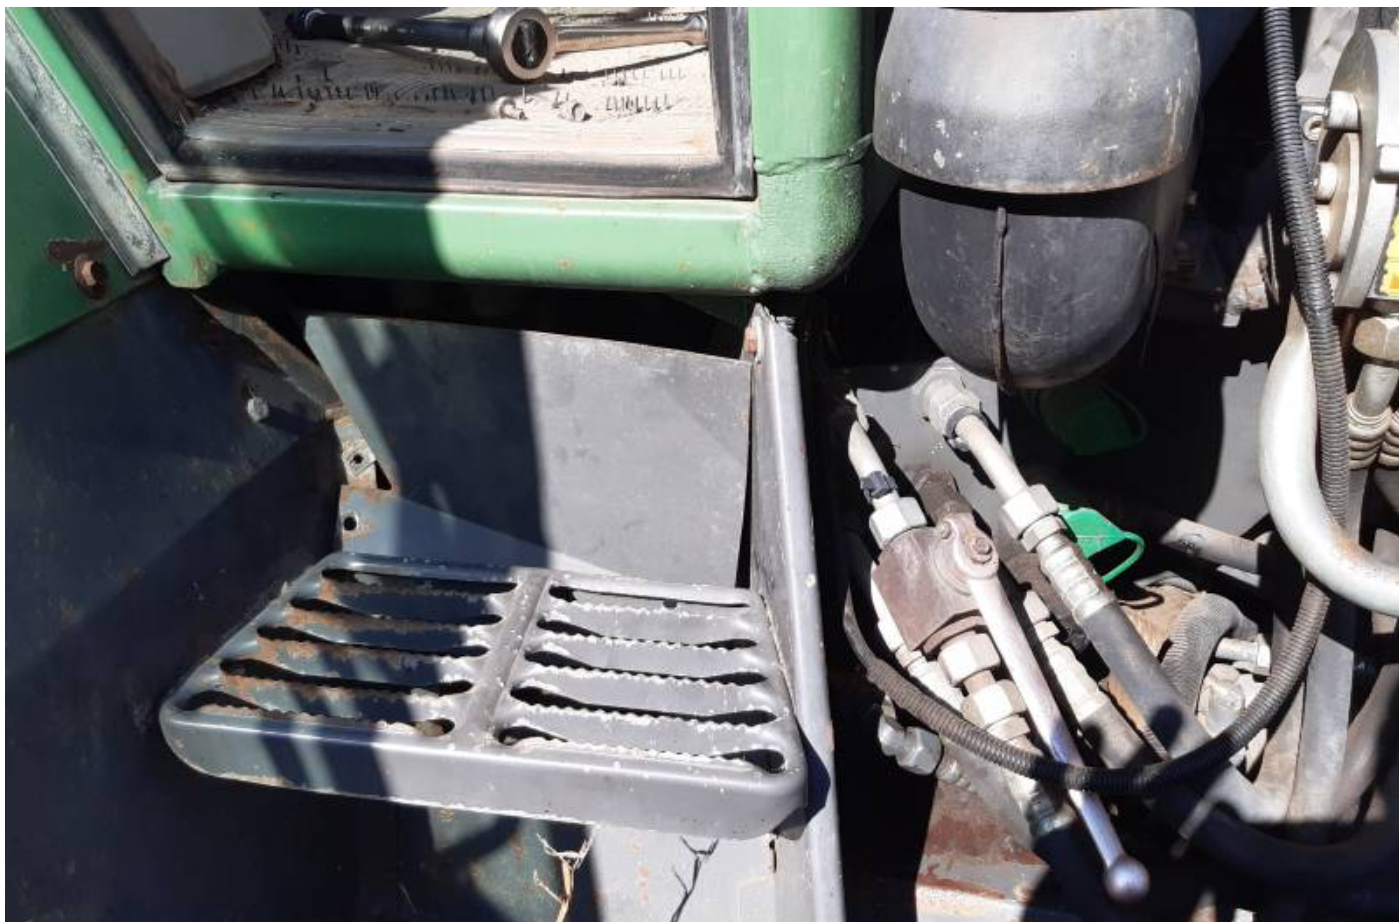
During maintenance and repair work on the air conditioning system, it is necessary to drain or refill the system. However, the service connections are neither in the engine compartment nor on the cabin roof. To access the connections, the cover plate in the area of the right steps ([Fig. 1](#)) must first be removed. High and low pressure connection are now visible. However, the area does not offer much space for connecting the hose lines of the air-conditioning service unit ([Fig. 2](#)).
