## Kia Venga - interior blower only runs at the maximum level

| Data sheet | |
|---|---|
| Symptoms | Interior blower only runs at the highest level |

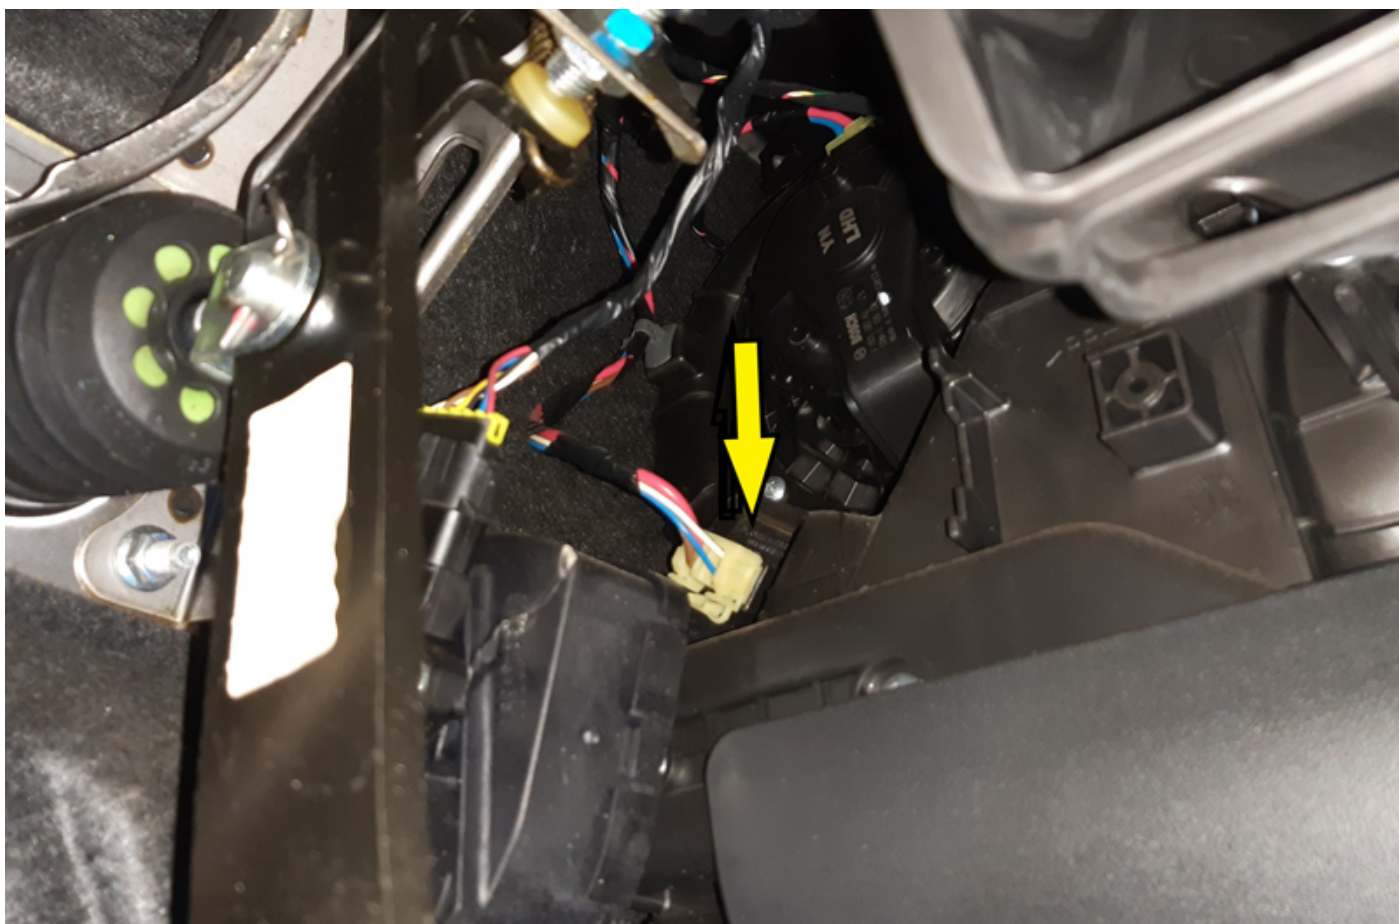
In the vehicles mentioned above with manual air conditioning, the interior blower may only operate at the highest level (maximum fan speed). This is usually an indication that the blower regulator (resistor) is defective. This is also the case with these vehicles. However, it is accessed via the driver's footwell and not via the passenger footwell as is usually the case ([Fig. 1](#)).

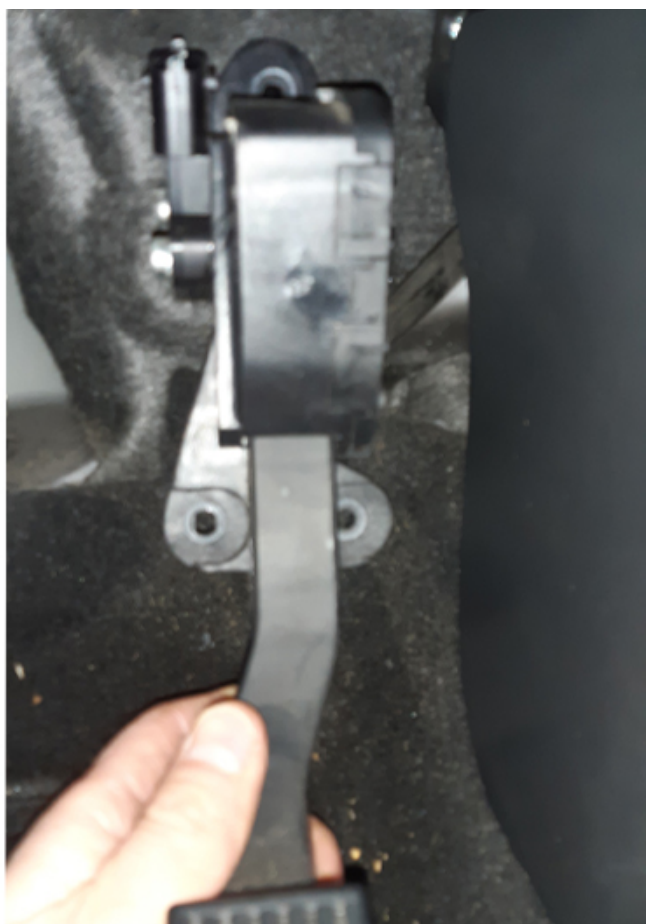
- Remove the accelerator pedal by removing the three fastening screws ([Fig. 2](#))
- Unlock and remove the connector on the accelerator pedal
- Remove the blower controller screws (2x)
- Unlock the connector on the controller and pull it out
- Replace the controller, attach, plug in connector ([Fig. 3](#))
- Mount the accelerator pedal
- Plug in the connector (make sure it is correctly locked)
