## Opel Astra-J Sports Tourer: display code 16

| Symptom | Display code 16 |

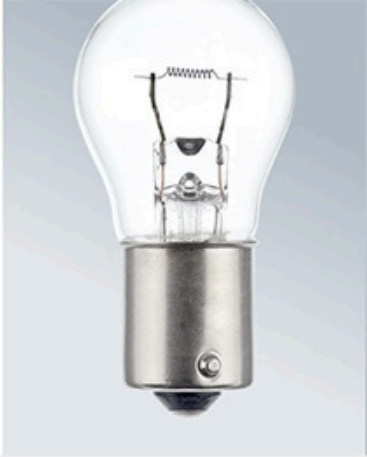
Fig. 3: P21W bulb

Replace P21W bulb ([Fig.3](#)). Check plug contacts for corrosion.
