VW T5 - coolant thermostat

Data sheet

Manufacturer	Volkswagen
Vehicle model	Transporter T5
Engine	1.9 TDI
Year of manufacture	2006 - 2009
Symptoms	Coolant thermostat

Operating temperature is not reached, thermostat and coolant flange

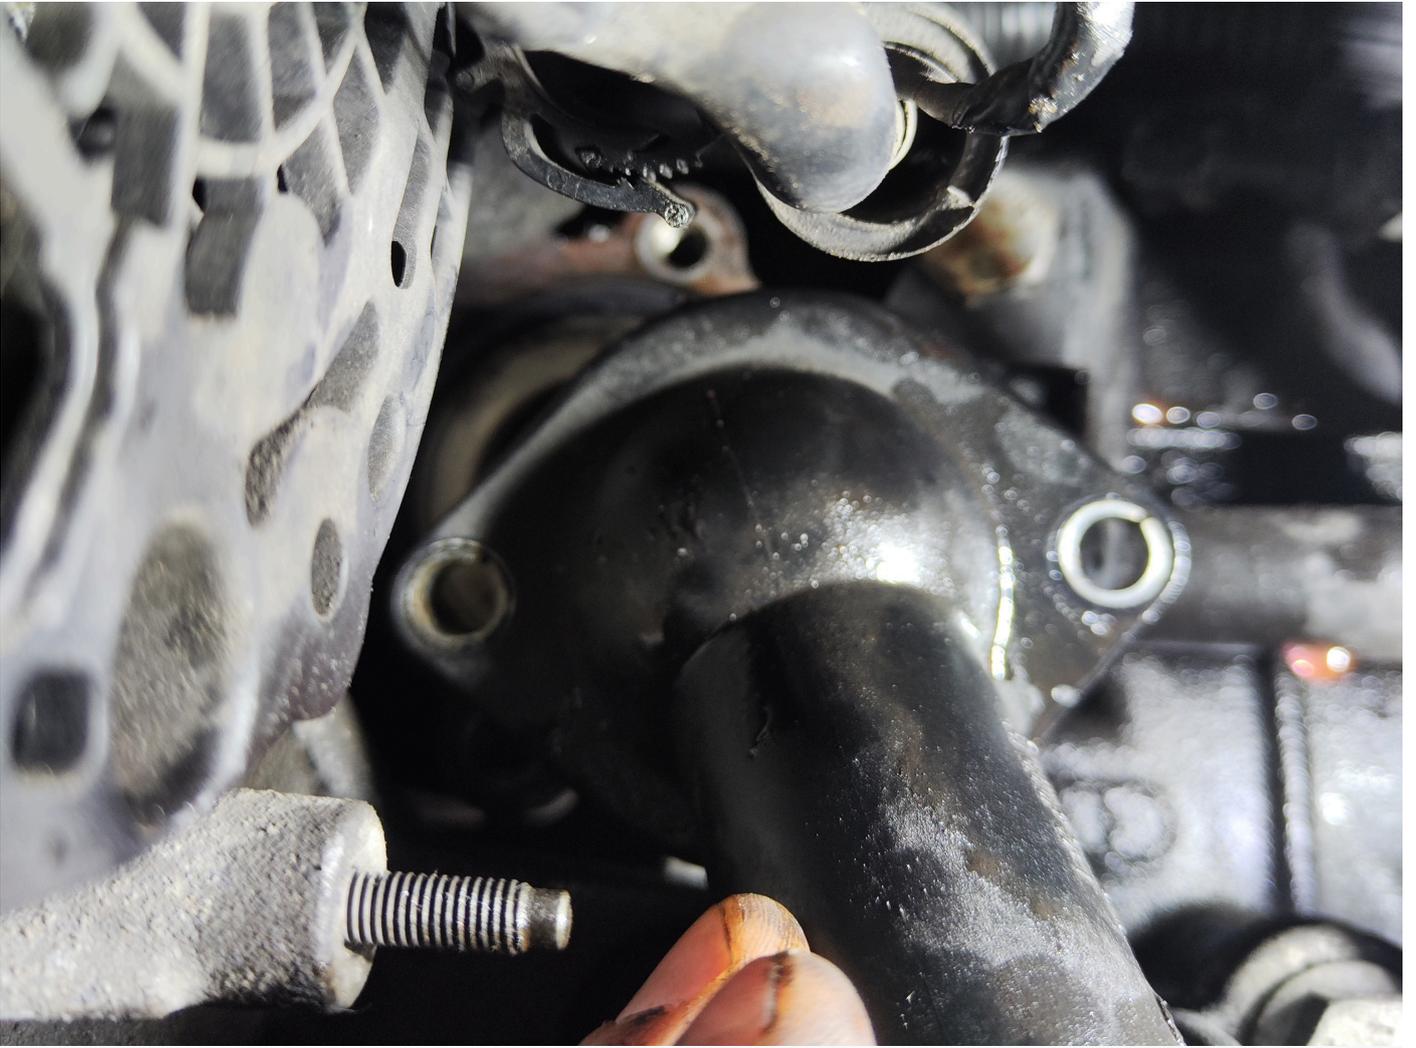
Before installing the new thermostat, the coolant flange should be inspected.

Coolant flange T5

It is then advisable to replace the flange.
