# Electrical exhaust gas recirculation valve | HELLA

## Failure causes and troubleshooting

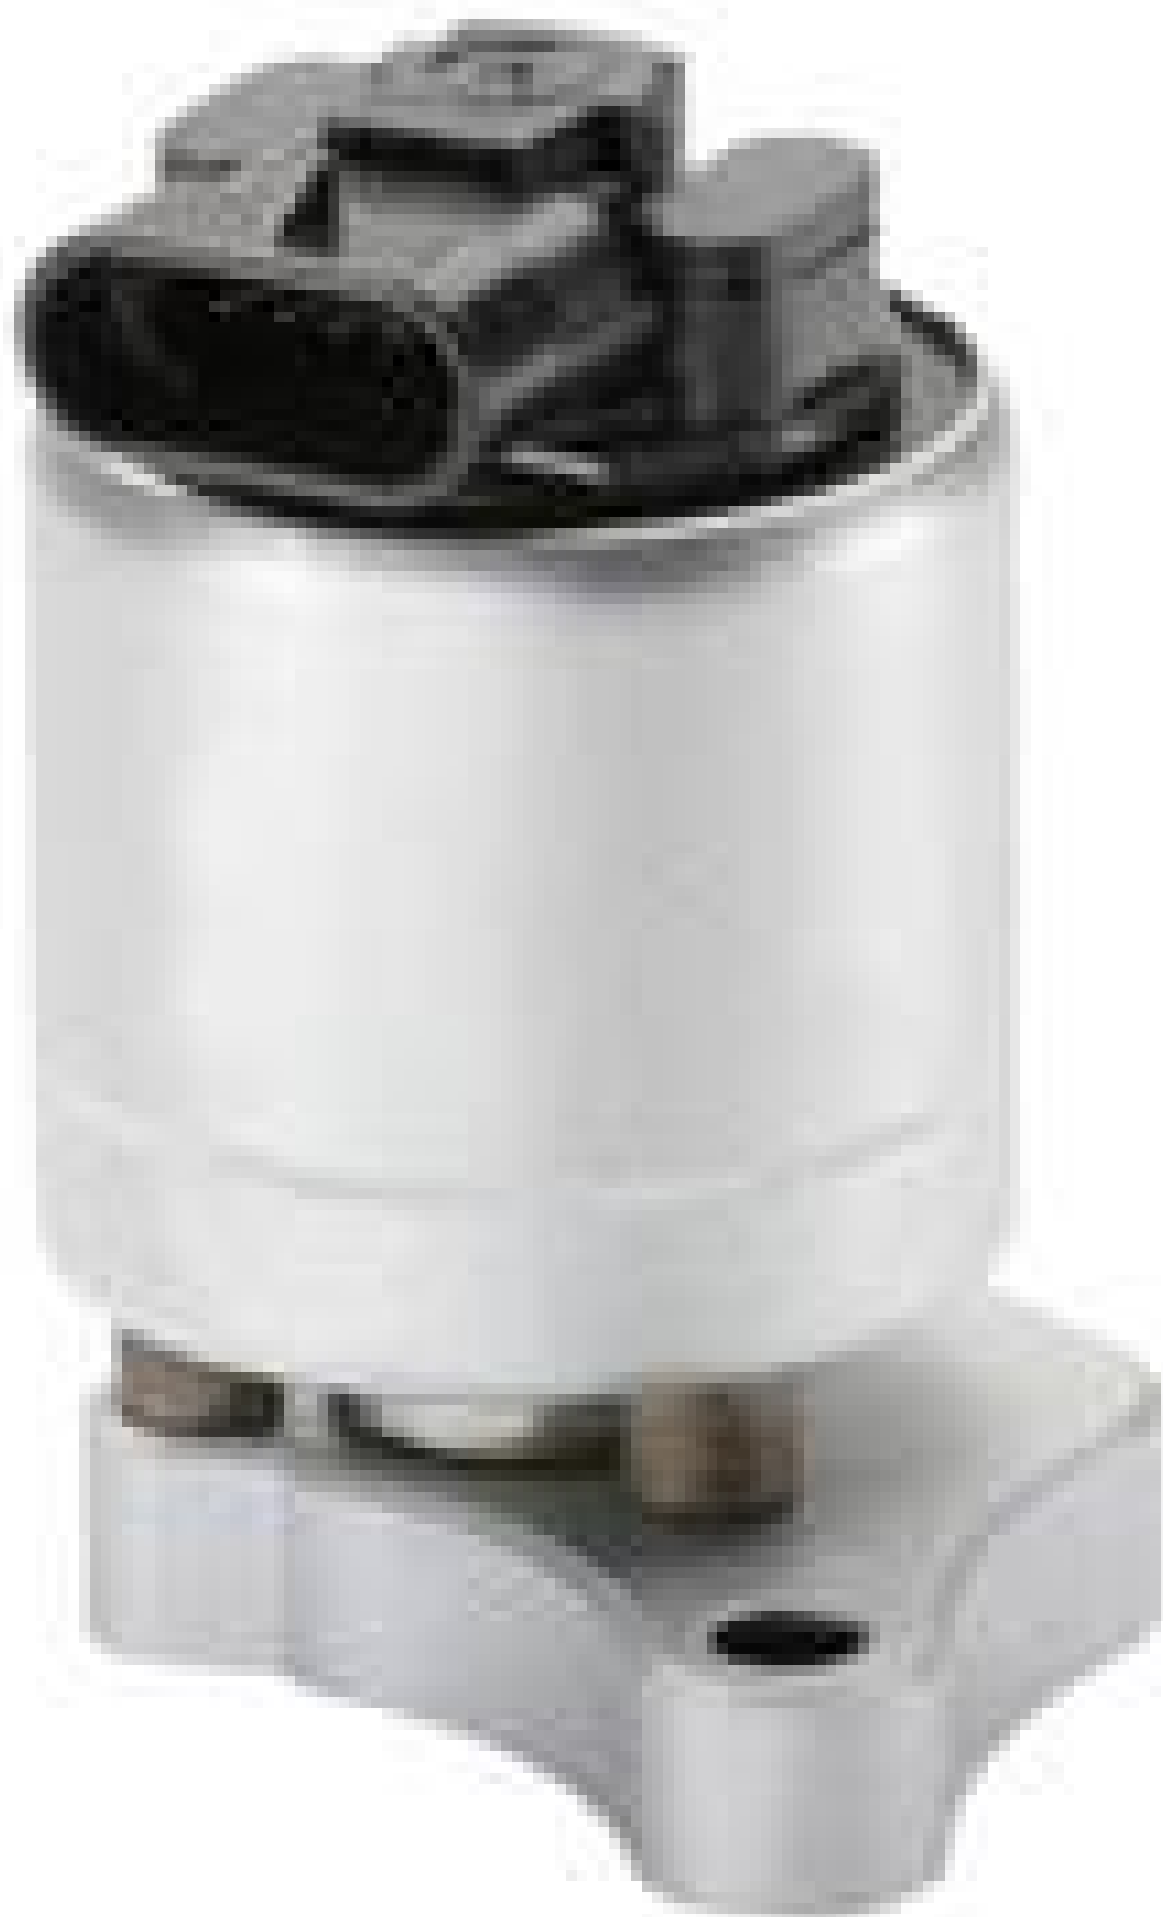
EGR valves are installed in a bypass channel between the intake manifold and the exhaust manifold.
