# Opel Astra H - Fuite de réfrigérant | HELLA

Astra H

Fuite de réfrigérant

**Condenseur endommagé et non étanche**

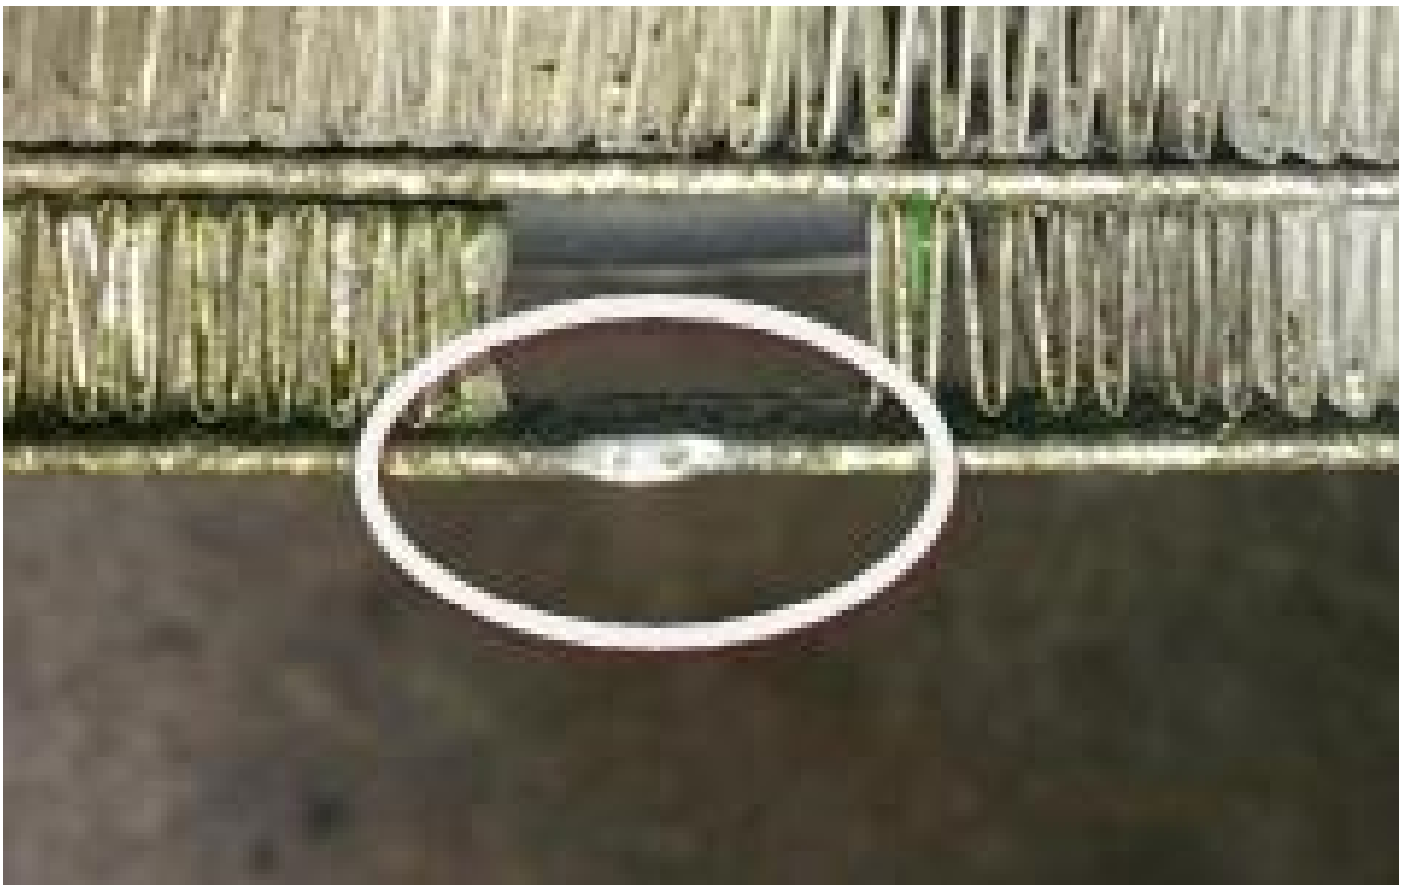
Figure 2

Des lamelles défailantes entraînent une instabilité du réseau condenseur. Des vibrations peuvent entraîner un contact avec d'autres composants. De ce fait, le condenseur est endommagé (figure 1) et le cas échéant non étanche.

Si l'on observe une perte de réfrigérant sur le véhicule mentionné ci-dessus, le condenseur doit faire l'objet d'un examen particulier.
