# Skoda Fabia II - Dysfonctionnement ; feu clignotant latéral | HELLA

Skoda Fabia II

Années de fabrication: 2007 - 2014

## Dysfonctionnement ; feu clignotant latéral

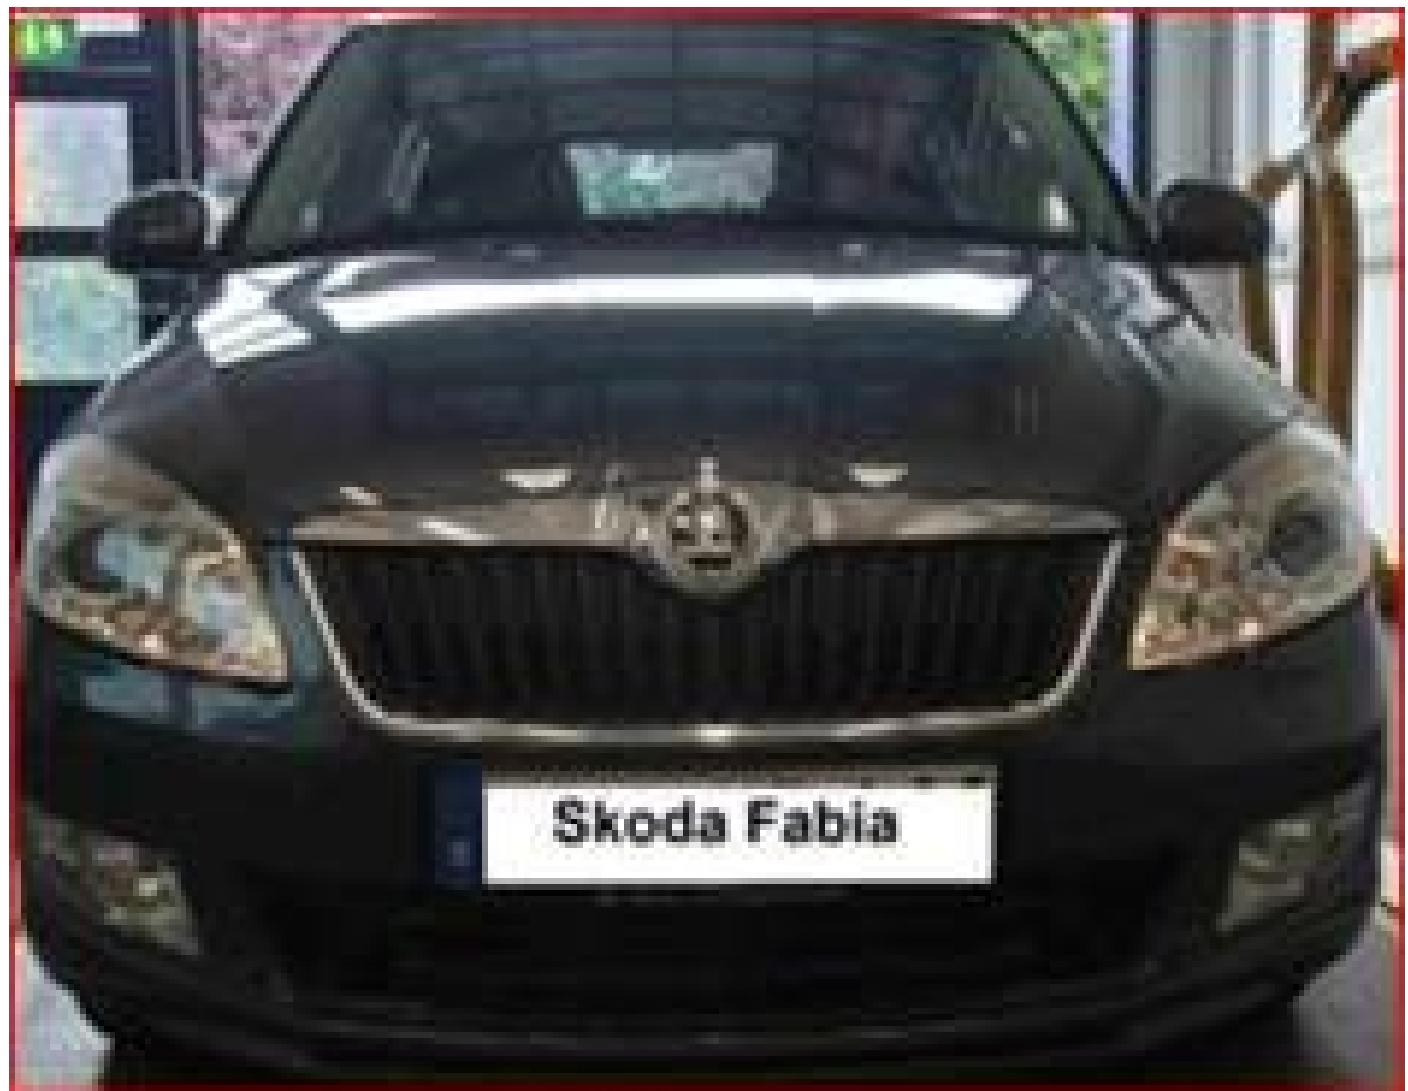
Fig. 1

En cas de détection d'une panne du feu clignotant latéral ou répétiteur de clignotant (fig. 2) sur le véhicule susmentionné (fig. 1), un câble défectueux peut être en cause.
