Skoda Fabia II - Guasto funzionale dell'indicatore di direzione laterale | HELLA

Skoda Fabia II

Anni di costruzione: 2007-2014

Guasto funzionale dell'indicatore di direzione laterale

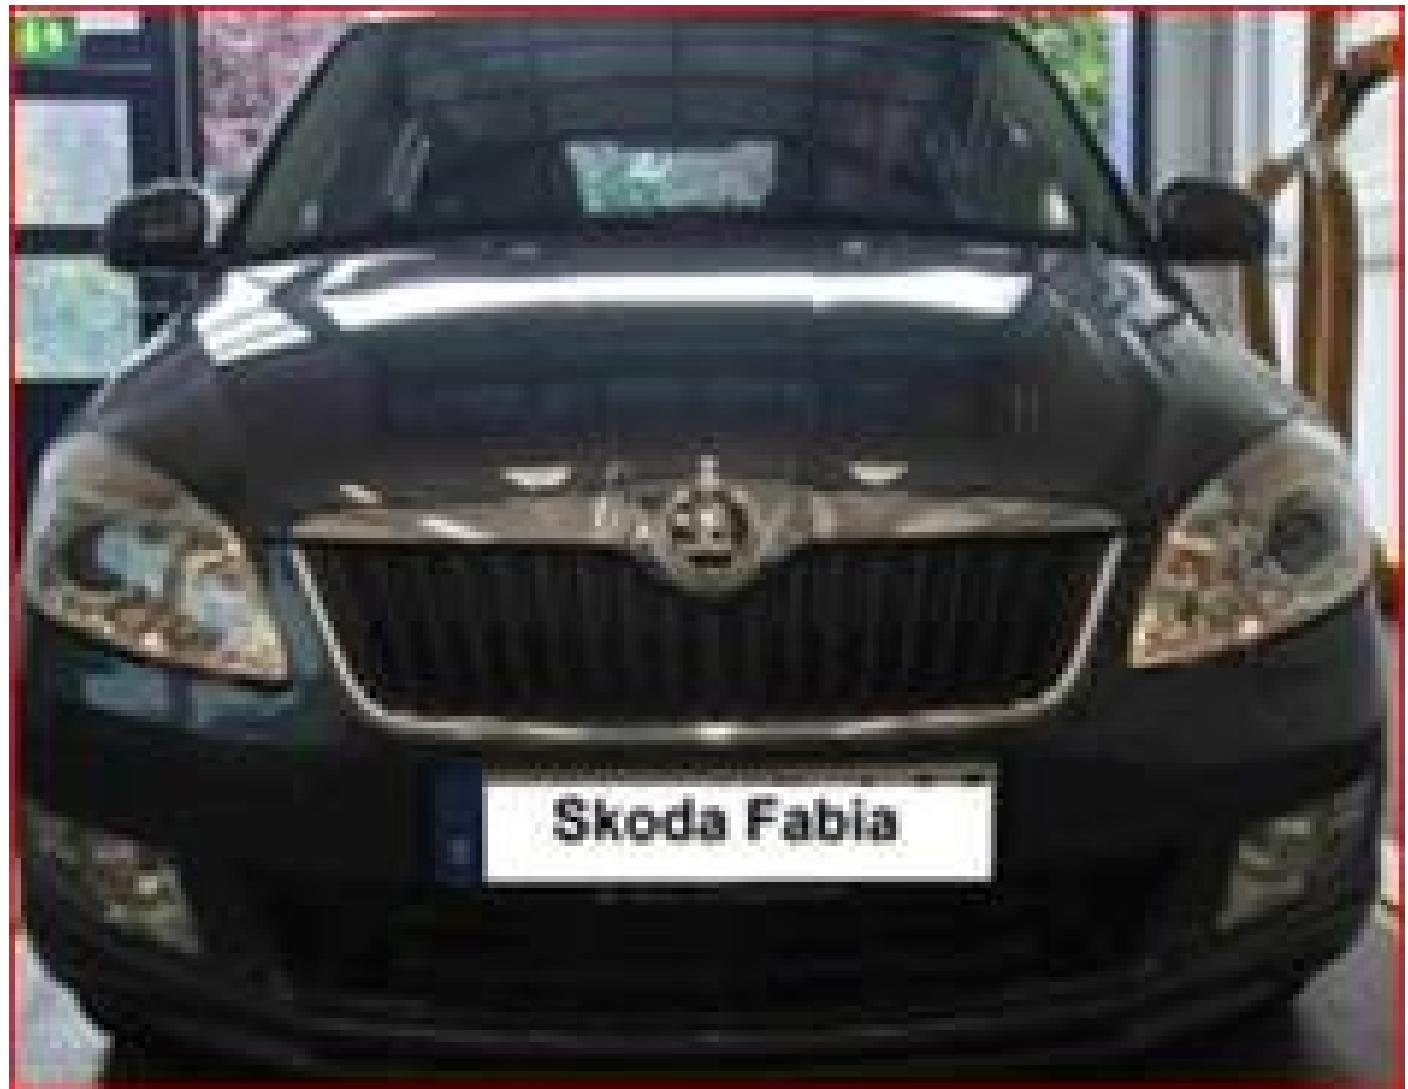
Fig. 1

Se nel veicolo succitato (Fig. 1) si riscontra un guasto funzionale dell'indicatore di direzione laterale (Fig. 2), ciò può essere dovuto a un cavo di collegamento difettoso.

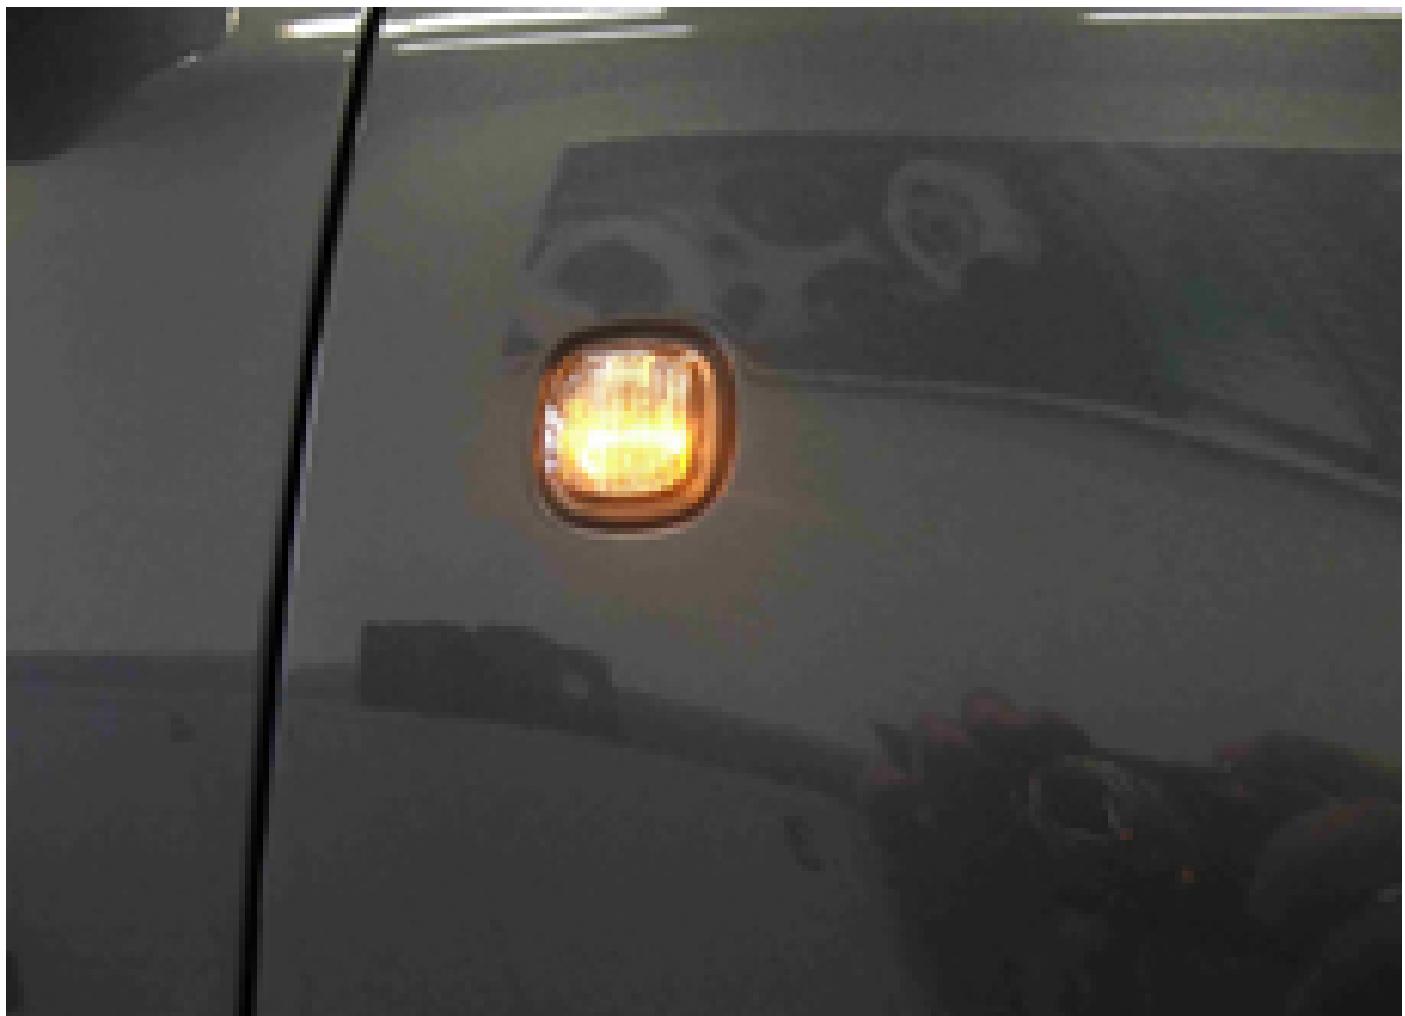
Eseguire un controllo funzionale (Fig. 4)

Eseguire un controllo funzionale (Fig. 4).
