# Skoda Fabia II - Falla el funcionamiento del piloto intermitente lateral | HELLA

**Skoda Fabia II**

Año de fabricación: 2007 - 2014

## Falla el funcionamiento del piloto intermitente lateral

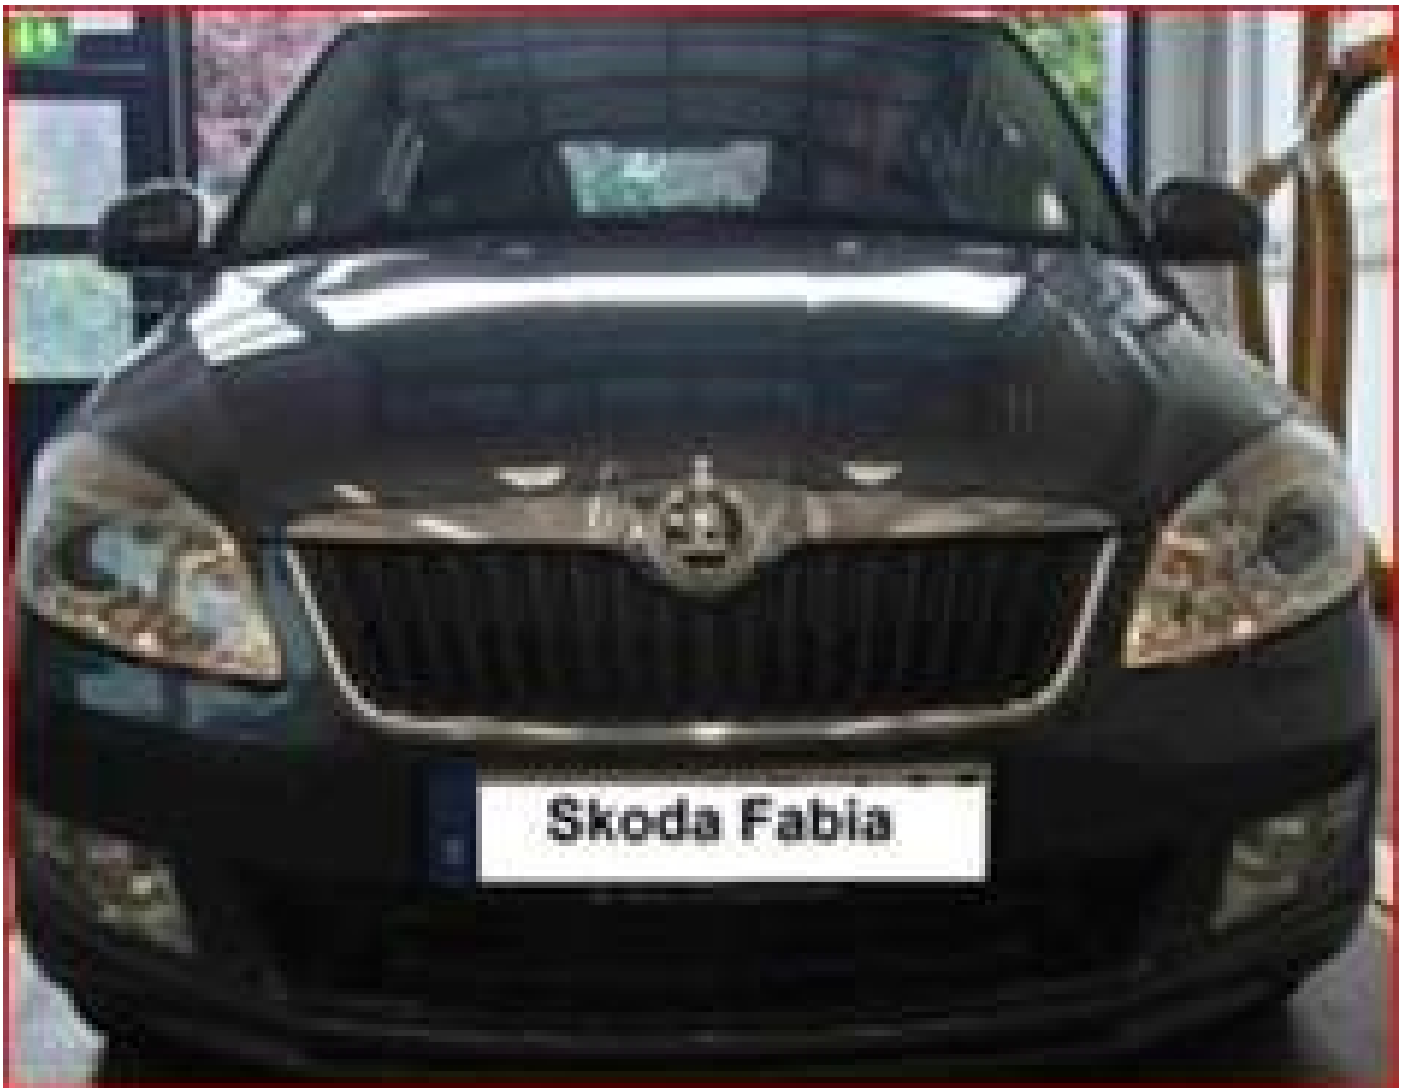
Imagen 1

Si en el vehículo arriba mencionado (imagen 1) se detecta un fallo en la función del piloto intermitente lateral (imagen 2), puede deberse a una avería en el cable de conexión.
